## 2006 – 2009 Buell Ulysses Ground Repair

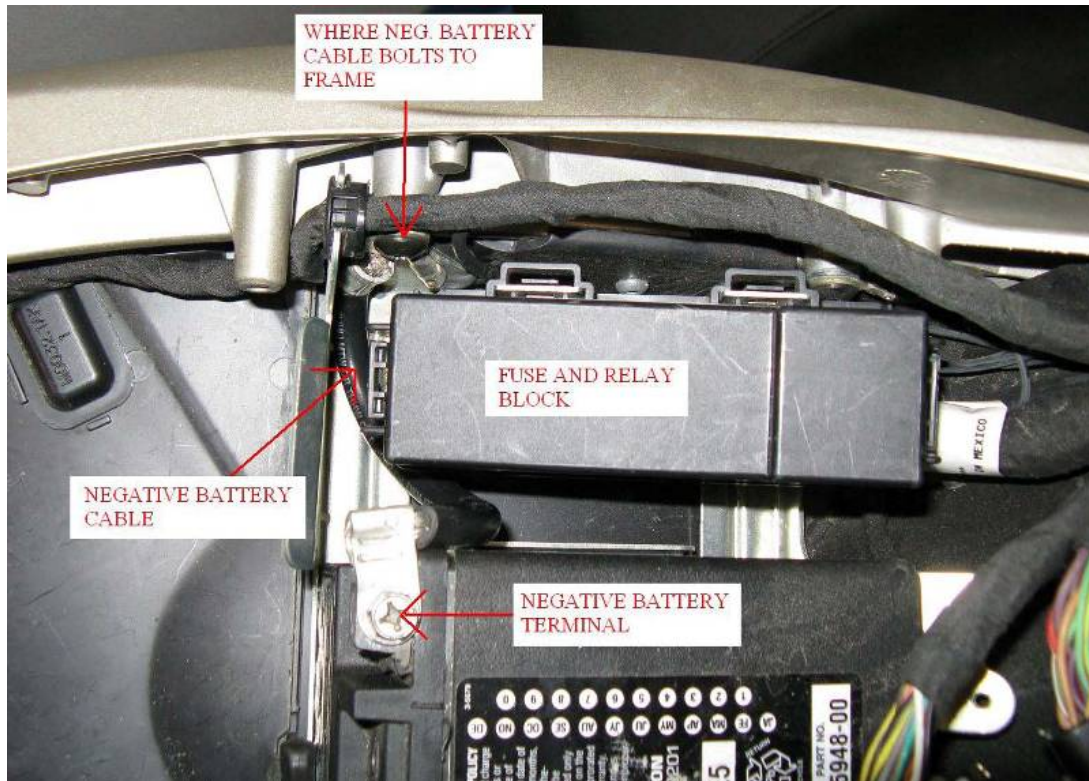
### XB Tail Section Ground Location

In the figure below, you can see where the negative battery cable is attached to the tail section of the vehicle. This ground location is essential to virtually all of the motorcycle's electrical systems. A poor contact here can cause poor running issue and no crank conditions. The instrument cluster may even stay on after the key is turned to the OFF position. These issues can also be intermittent.

To clean the ground area, you must remove the fastener that secures the ground terminals to the tail section and clean all surfaces. This includes the fastener, tail section boss, ring terminals, and battery tray. (See images below)

After all of these surfaces have been cleaned, apply dielectric grease to the fastener and reinstall to 72-108 in/lbs. (97.6 – 146.4 Nm).
