TT407A: Electra-Glide Backrest Isolator Replacement

June 25, 2009

APPLIES TO	SYMPTOMS
2009 FLHTC and FLHTCU Models	• Part Availability, Installation or Fitment Updates

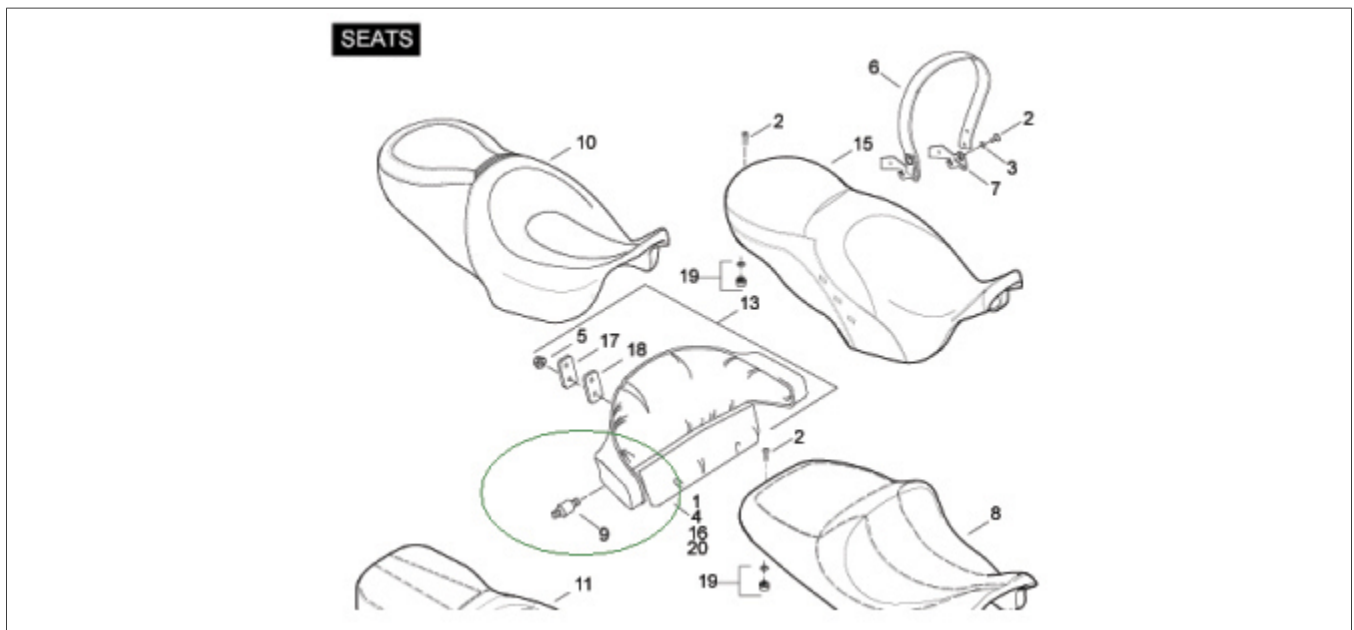
Figure 1. Passenger Backrest Isolator p/n 52192-86A

The passenger backrest on FLHTC/U models is attached to the tourpak lid with barrel-shaped rubber isolators. There was a material issue identified with some of these rubber isolators on mid-year 2009 models that could cause them to separate.

These rubber isolators for the passenger backrest are available separately through your parts department. (part number 52192-86A) See the index number 9 from the image below. It is not necessary to replace the backrest if an isolator fails. Warranty claims may be suspended or rejected for replacing the complete assembly when service parts are available, per page 28 of the Global Warranty Manual.

If you are working on a motorcycle with a faulty passenger backrest isolator, it is recommended that you replace all three isolators.
