Tri Glide Trunk Door Water Intrusion Diagnostics

Tri Glide Trunk Water Intrusion Diagnostic Steps

TT411 – June 11, 2009 – Tri Glide Trunk Door Leak Diagnostics

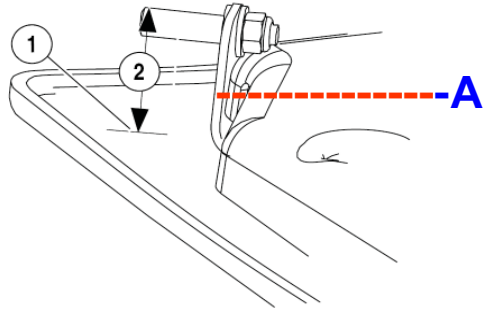
sm06539

| Failure Origin | Potential Failure | Inspection | Corrective Action | Issue |
|---|---|--|---|--|
| | | <p>Close the door and tug firmly on the door handle/license plate light. Watch for movement in upper corners to verify the latches are working properly. Close the door until it is resting on the latches; you should be able to feel the door contact both latches simultaneously. If not the latch pins need adjustment. Use the link on page one to view a video about latch adjustment.</p> | <p>Measure and set latch pin placement to 1.5" (see fig A) Slowly close door and check that both latch pins contact the latches at the same time Adjust latch pins as needed Check sealing pressure using a 2-3" wide strip of paper between door and across the top edge of the door There should be resistance felt when trying to pull the paper out and you should not be able to slide the paper from side to side Adjust latch pins as needed for both latches to engage and good sealing pressure If there are problems achieving both measure gap between latch and door seal (see fig A-1) Gap should measure between 0.060 – 0.090". If not in range refer to additional information in the linked video. If leak persists lightly powder the door seal, close door and run water over the trunk, leaks will wash the powder from the seal helping locate the source of the leak.</p> | <p>An improperly working latch will reduce the contact pressure on the seal and allow water to enter between the seal and door</p> |

- 1. Inner surface of door
- 2. Adjustment dimension
