TT413: 2009 - 2020 TOURING REAR FORK RUSTY WATER LEAKAGE

2020-06-09

Chassis

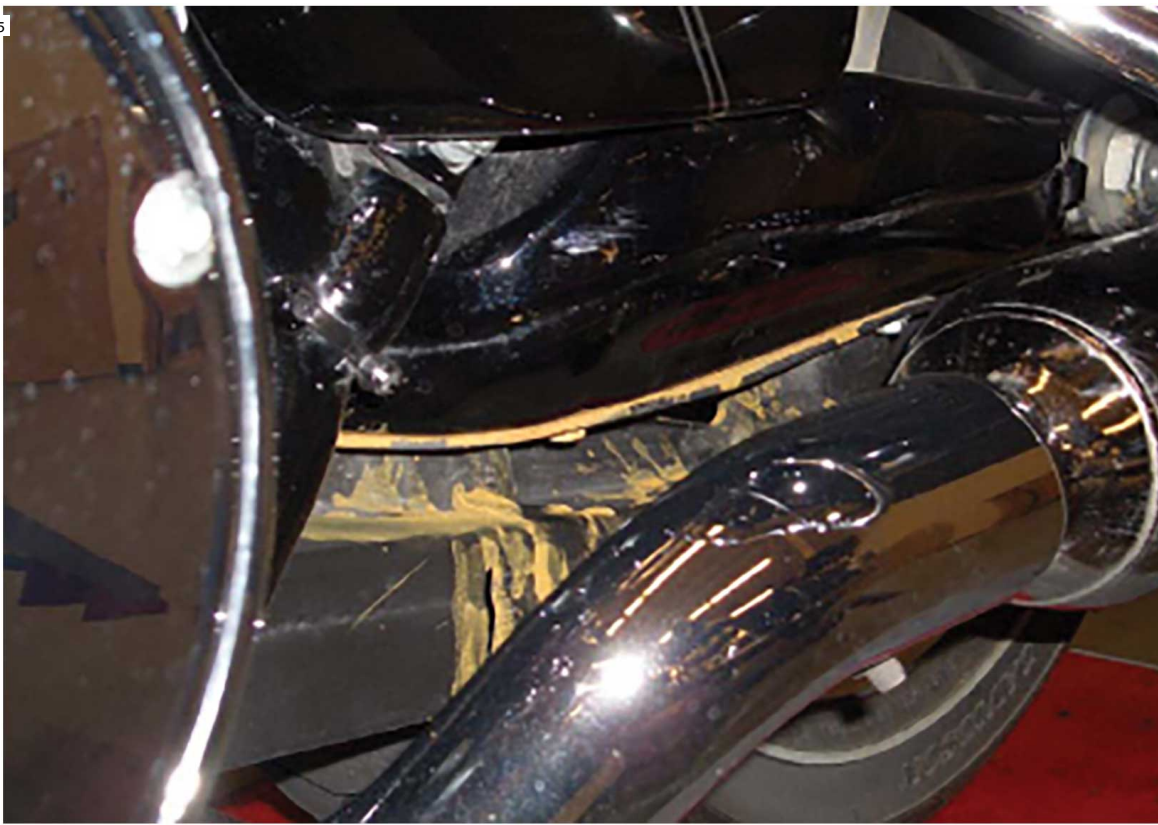
Figure 1. Rear Fork

See Figure 1. Some 2009 - 2020 Touring, Touring CVO, Touring Police models exhibit drainage of rusty water from the rear fork (where the debris deflector mounts), which has raised customer concern.

This is a cosmetic concern and not an indication of an internal issue.

The potential water entry points are a forward facing drain hole (used in production) in the pivot shaft area, the two upper holes for the brake line retention clips, and the holes underneath the lower belt guard. On low mileage vehicles this may be residual after-wash from manufacturing's pre-paint procedure that did not boil out during the paint bake process, or it may be from external sources (puddles, washing, etc.) after the motorcycle was put into service. Depending on the amount of debris remaining inside the rear fork from the manufacturing process, and the fact the belt's debris deflector runs across the lower drain hole, it is possible for the water to build up and become contaminated. Air flow from riding can cause the stagnant water to slowly work its way out of the rear fork and onto the rear of the vehicle.

Harley-Davidson recommends opening up a clear escape path for the water to exit by:

1. Removing the debris deflector.
2. Marking the location of the rear fork drain hole.
 - a. Use some grease to find the drain hole (just forward of the center mounting screw).
3. Drilling a 6.4 mm (0.25 in) hole in plastic debris deflector (not the rear fork), directly in line with rear fork drain hole.
4. Clean vehicle (if necessary).
5. Reinstall the modified debris deflector
