# TT418: DTCs P2135 and P2101 Theory and Diagnostics

November 3, 2009

APPLIES TO	SYMPTOMS
2008-Later Touring, Police and Trike Models	<ul style="list-style-type: none"><li>• Driveability or Performance Concerns</li><li>• Abnormal or Erratic Mechanical Operation</li><li>• Intermittent or Erratic Electrical Operation</li></ul>

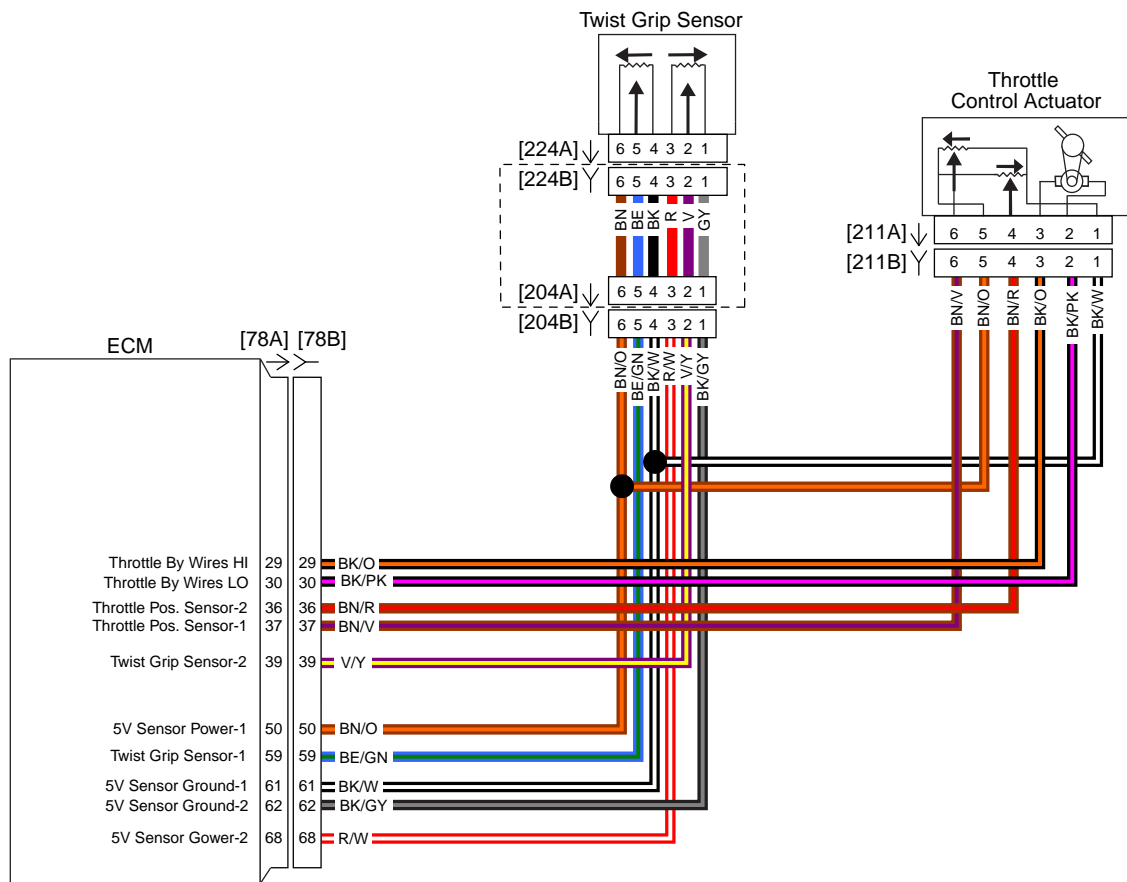
**Figure 1. Schematic**

The two TP sensors work opposite of each other. As the throttle plate opens, TPS1 voltage ranges from 0.0-5.0V, while TPS2 voltage ranges from 5.0-0.0V. The sum of the two TPS voltages should always measure approximately 5.0V. These wires are: TPS1, BN/V pin 37 of the ECM, and TPS BN/R pin 36 of the ECM.

The TP sensors 1 and 2 should never add to more than 5.13 VDC or less than 4.87 VDC. A sum of voltages out of this range should register a current P2135 code.

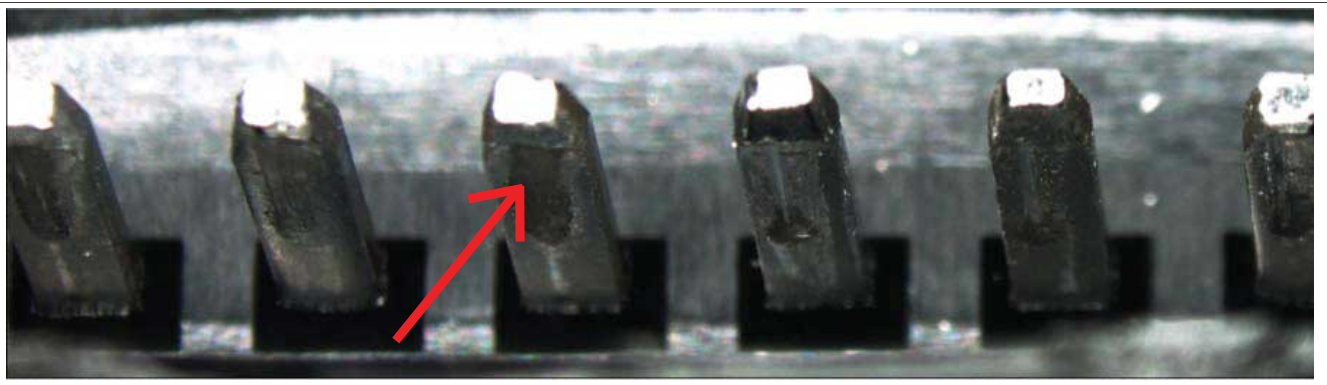
It is believed that fretting corrosion is a major contributor to this code. A poor connection at the TCA can affect the sensor voltages reported to the ECM and set the DTC. As you can see from the General Information section, the sensor voltage only needs to be altered by 0.13 VDC to possibly set the code.

The most common vehicles to have these symptoms are those with more than 8000 miles or those vehicles with 103ci and larger engines. The vibration that these connections are exposed to is believed to contribute to the fretting condition.

**Figure 2. View of Fretting on Pins**

1. While monitoring the TPS 1 and TPS 2 voltage on the DT II, wiggle the TCA and the ECM connectors.
2. If you the voltage changes while moving the ECM connector, inspect/replace the affected ECM terminals (Part No. 72605-08). These wires are: TPS1, BN/V pin 37 of the ECM, and TPS 2, BN/R pin 36 of the ECM.
3. If no voltage change is noted while moving the ECM connector, the connection issue could be in the TCA. Replace pins 1, 4, 5 and 6 at the TCA connector 211B (Part No. 72168-07).
4. Before connecting the TCA connector, clean the male TCA pins with a swab and alcohol, then assemble with dielectric grease (Part No. 99861-02 - Nyogel 760G).
