TT450: STREET STARTER CABLE ROUTING

January 14, 2016

APPLIES TO	SYMPTOMS
All 2015-2016 XG500 and XG750 Models	<ul style="list-style-type: none">• Driveability or Performance Concerns• Intermittent or Erratic Electrical Operation

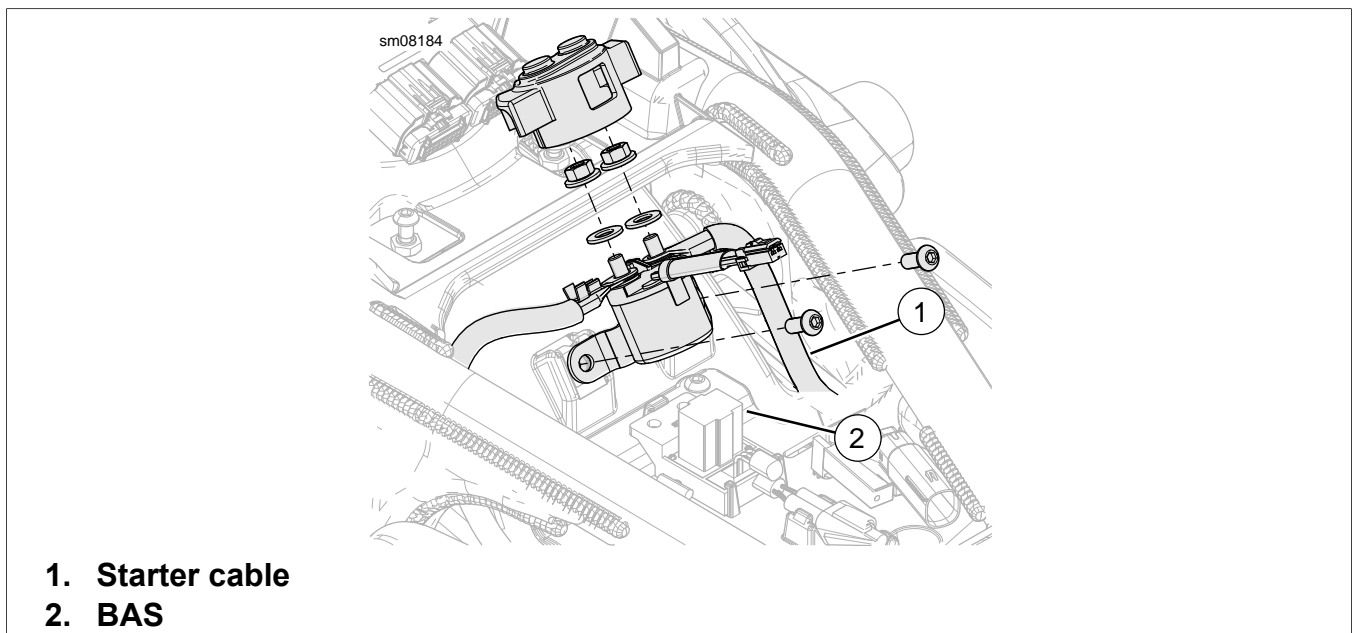
Figure 1. BAS

Improperly routed starter cable near the bank angle sensor (BAS) can cause this condition.

See Figure 1. In some cases, the starter cable (1) is routed too near the BAS (2). The resultant electrical interference can cause a false bank angle sensor signal. When diagnosing these issues, verify that the starter cable is routed under the battery box cover.
