# REF: Service Procedures 9U

## Transmission Access Door Alignment

Transmission door "alignment" explained. (Dr Dick) <sup>1)</sup>

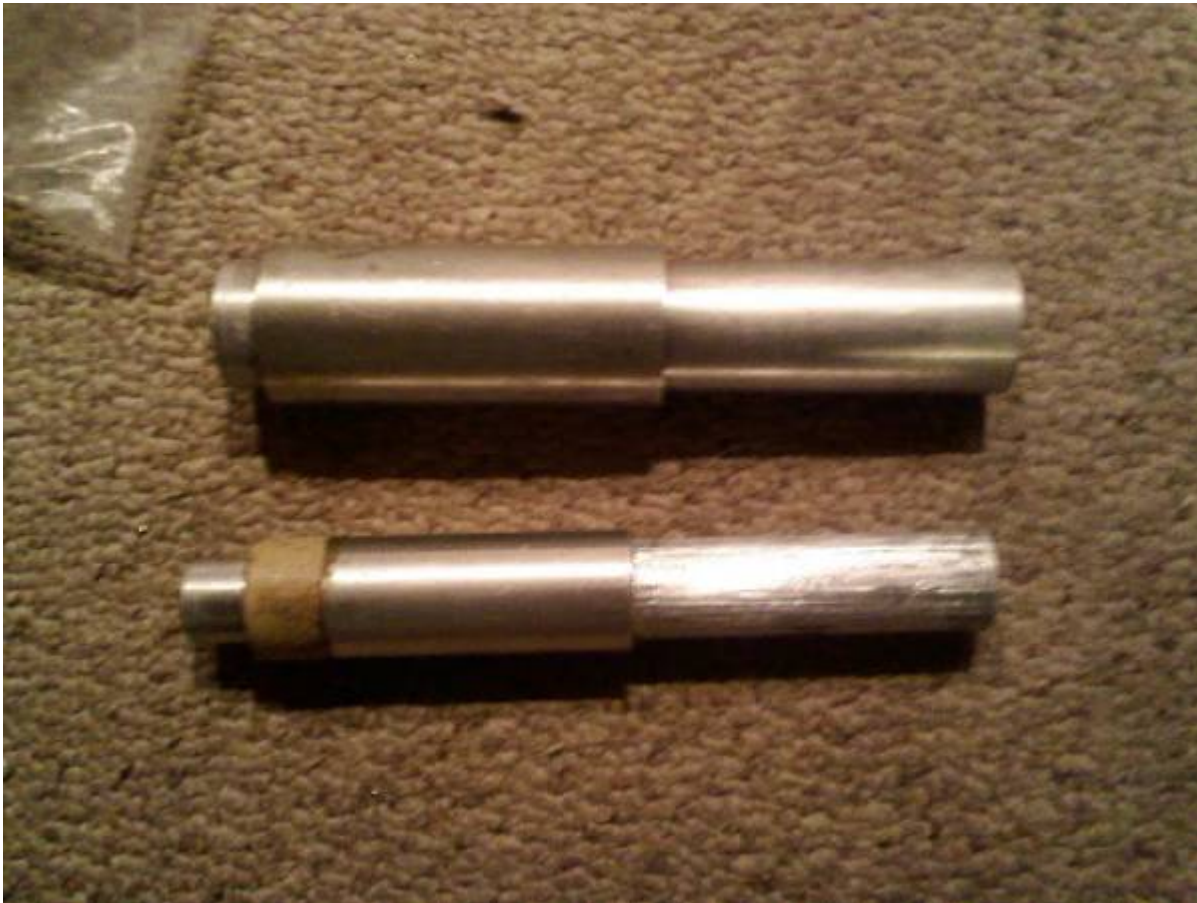
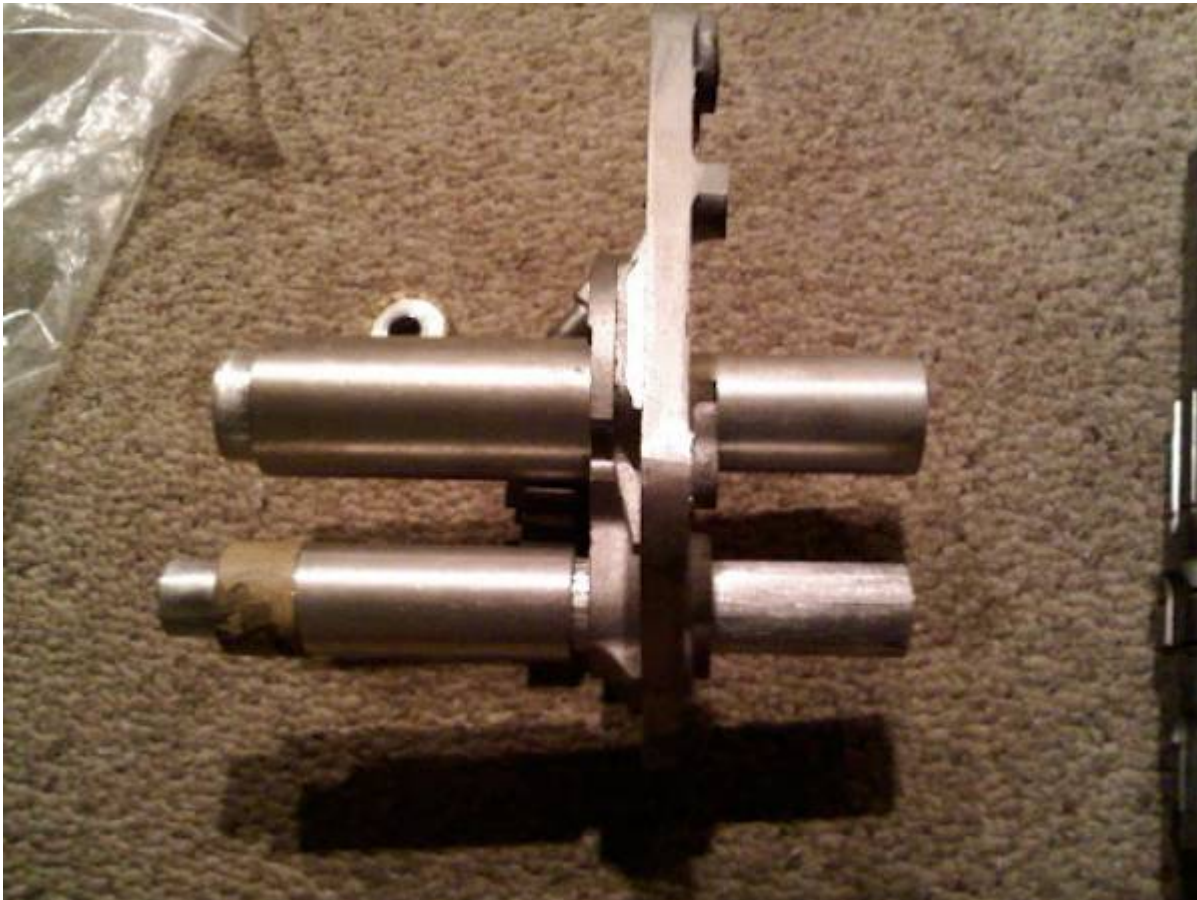
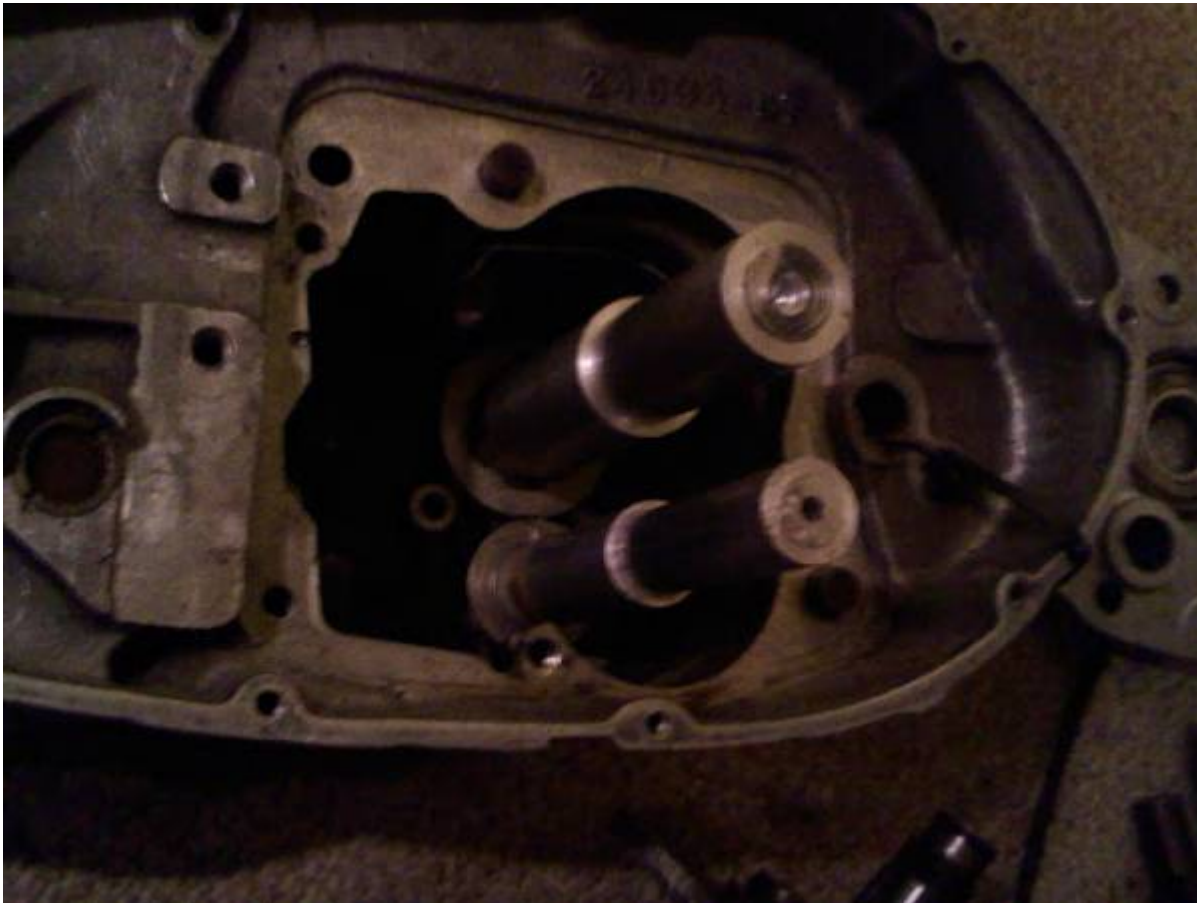
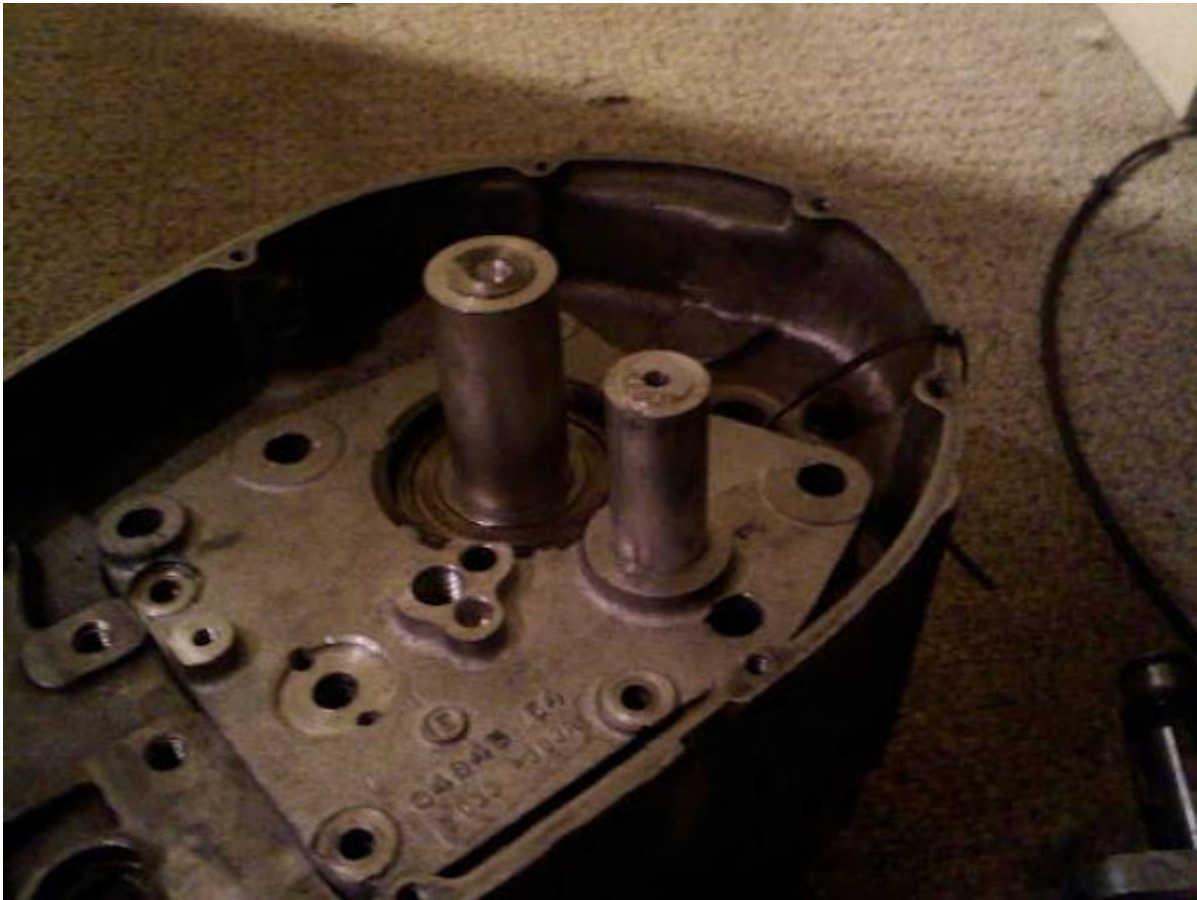
But the relative position of the 4 bolt holes to the dowels is not constant due to all the positioning variances that come into play when the door is first attached to case half. So the misalignment of the

bolts is not indictive of misalignment of the trans bearing bores.

Check out the bolt holes in this 72 door. This is very common on swapped doors.

This is how I made that happen. As chevelle said, I made concentric mandrels. One end of each fits in main and counter bear bores of right case. The other end of mandrels fits thru door bear bores.

This is how it's done with precision.
