# IH: Wheels, Brakes & Tires - Sub-01A

## Problems Associated with Drum Brake Rear Hubs

Article by Dr Dick of the XLFORUM <sup>1)</sup>

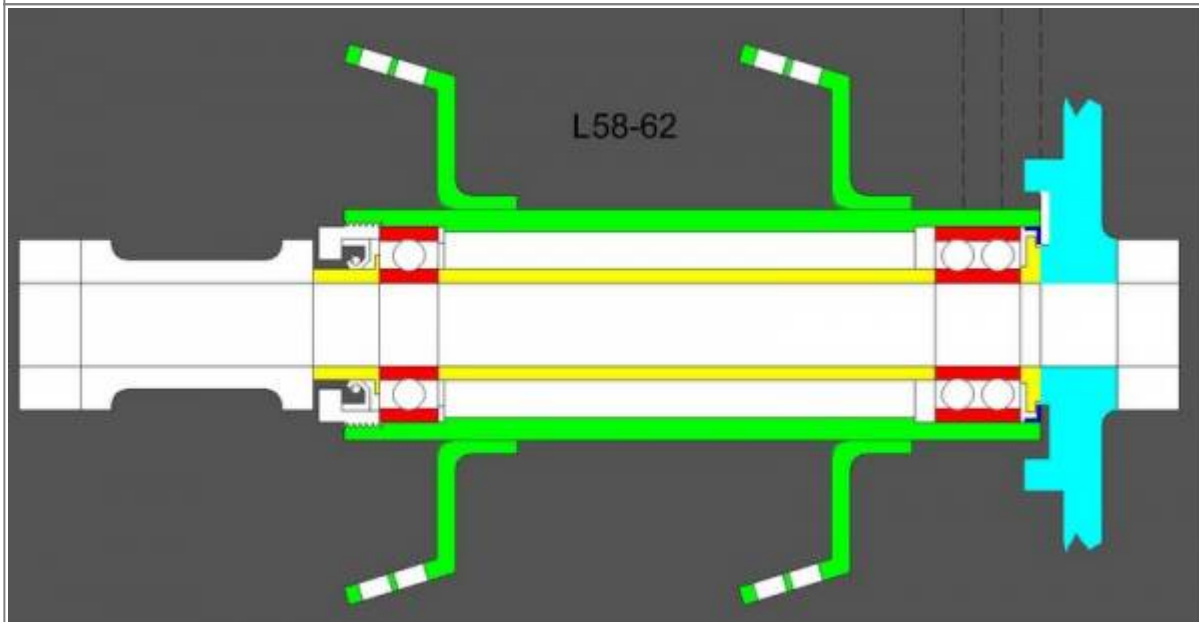
This is the L1958-1962 setup: <sup>2)</sup>

- Now look at the 62< pic at the same area. Much better. Putting the L58-62 bearing, center spacer and shield into a sweat brazed 66-72 hub gives the best bolt together setup.

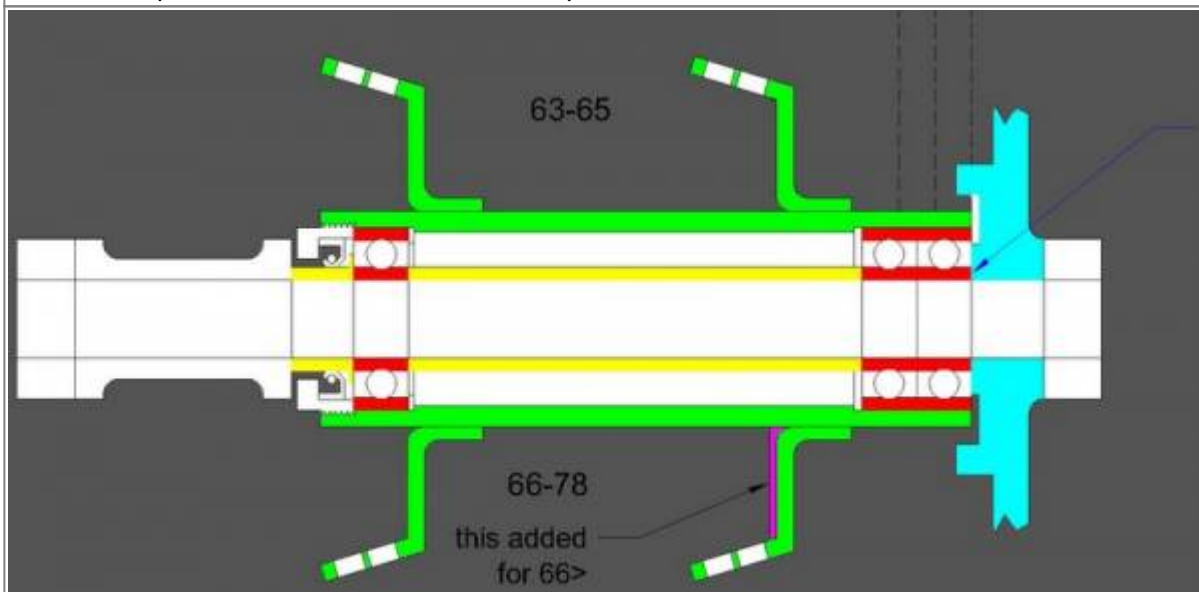
This is two pics in one. The 63-65 is the top half and the 66-78 is the bottom: <sup>3)</sup>

- In the above pics, you see everything that assembles in between the swingarm legs, (i.e. the chain adjusters, backing plate, and axle spool spacer). The dashed lines represent the chain position.
- What you don't see is the tin spool that covers the inner bearing spacer which was left out because it's not part of the structure and it's job is to take up space so you don't have to fill the entire hub up with grease.

- Go back to the 2nd pic. The added meat on the drive side flange was incorporated because the earlier hubs would crack thru the thinner flange near where the flange met the tube. The upgrade stopped the cracking but didn't reduce the forces that cracked the hubs.

- Look at the 2nd pic again where the naked arrow is. That's where the aluminum back plate butts to the bearing inner race. That race will and does plow rite into the soft back plate when the axle flexes. That's not the best scene either.
