This article is an excerpt from Hot XL Magazine, Autumn 1997 Edition: <sup>1)</sup>

# ZIPPER'S DOOR

## Installing One Of These May Fix Your Alternator Problem

Story and photos by Stephanie Feld

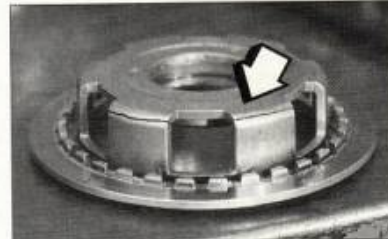
**5** This is what happens if you over-tighten the spring compression tool. No wonder my clutch had been dragging! The last time I installed the clutch myself, I over-tightened the tool which broke the delicate aluminum casting of the pressure plate (see arrow).

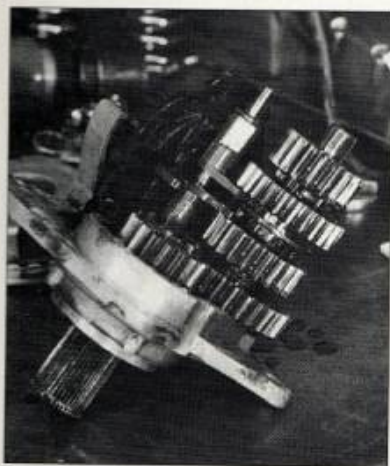
**9** After inspecting the transmission, Rich decided that the countershaft third gear, which was missing a large chunk from one tooth, was overdue for replacement. We pulled a new Andrews gear from stock. That's the old pressure plate in the background.

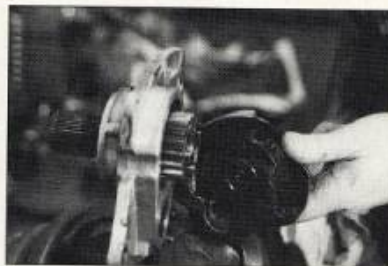
**10** Inspect the shifter cam before removing it from the old door. The thrust surfaces are pretty burred up.

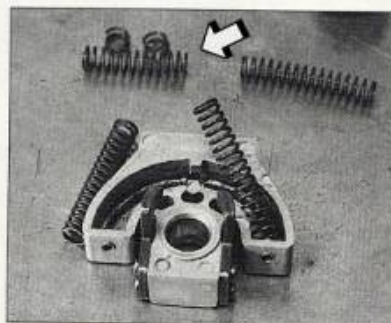
**12** More broken stuff, this time a pawl carrier spring (see arrow). The new ones are sticking out of the shifter pawl. I can't believe this bike was still shifting gears!

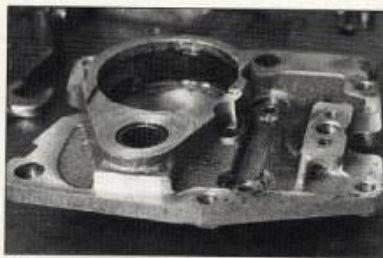
**14** This stock H-D transmission door is a cast aluminum unit as are all Sportster OEM doors. However, there is no cast iron sleeve insert for the mainshaft bearing as in the earlier models. This allows the single-row bearing to work in the door and wear away aluminum. Result: the bearing becomes loose in the door.

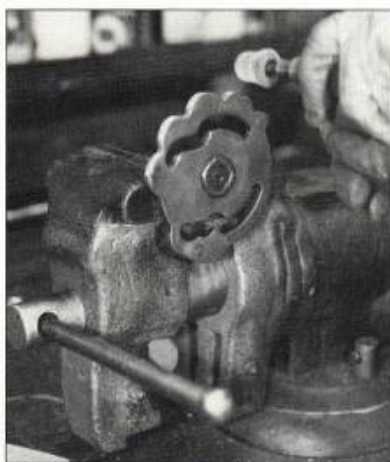
**19** The shifter cam had more burrs than an overgrown cow pasture. Rich carefully cleans the sliding surfaces of the shifter cam where it engages the shifter cam follower so the Sportster will have smoother shifts.

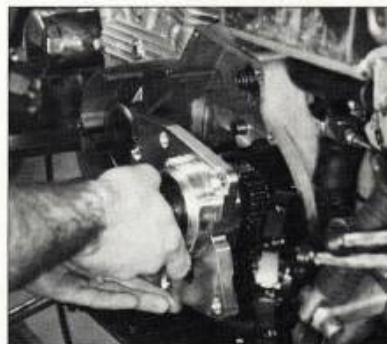
Back in 1985, somebody at the Harley-Davidson factory screwed up. The mainshaft on a four-speed Sportster transmission should have between .006" and .020" of end play when installed in the cases. Well, my Sportster's mainshaft end play was a whopping .137". In order to get it right, we needed a thrust washer — or combination of washers — between .117" and .131". Too bad the thrust washers made for the XL mainshaft only range from .0675" to .0965. No combination of those was going to help.

**23** Rich installs the transmission and is checking the mainshaft's end play when disaster strikes yet again. The mainshaft has way too much end play and there are no mainshaft shims available to bring it within tolerance. So the crack team of problem solvers at Rolling Thunder went to work and soon came up with a solution. See the above Tech Tip sidebar for what they did.

Then the Rolling Thunder parts counter staff came to the rescue! They remembered that a "45" Flathead flywheel washer (#23972-21) was very close to what we needed. They pulled one from stock and at .062" it was nearly perfect when combined with a .0675" mainshaft washer. Rich carefully ground an additional .005" off the flywheel washer to make our final end play land right in the middle of the two extremes: .0125". My transmission is now better than new and still going strong.
