Accessing Transmission Gear Damage

Understanding Spur Gear Life

TRSM0913

May 2011

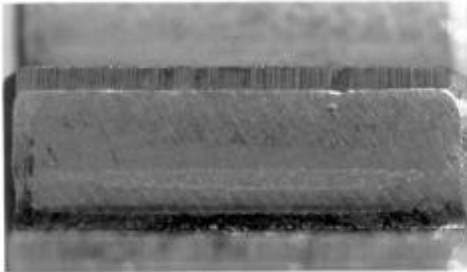
Frosting

As noted before, during mesh specific areas of the tooth surface are in contact during each stage. However, variations in the tooth form between mating teeth may produce a slight change in the contact pattern. This will result in light wear as the mating gears seek to adjust to a common pitch line. Since this wear is in a sliding zone starting near the root of the gear, it causes a form of micro-pitting. Magnification is required to see the pits. To the eye, it looks like a band of off-white discoloration called "frosting". There is a lack of sheen at this stage.

A gear should not be replaced simply because of frosting. But if it also shows other signs of distress, such as tip loading, misalignment, severe surface irregularities, etc., then further investigation is needed. These signs will be discussed later.

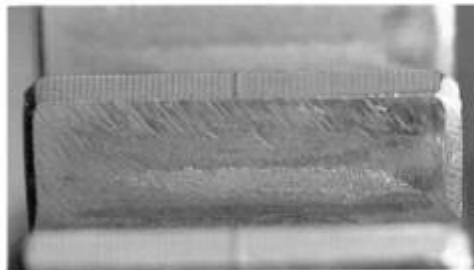
Offset Frosting

As previously stated, there are acceptable tolerances in tooth lead. Mating gear teeth can successfully operate with lead variation in opposite directions. However, a small amount of load shifting may occur. Slight wear may take place until the load is again evenly distributed across the entire tooth width. This may also result in frosting in the dedendum portion and sometimes in the addendum portion of the tooth, offset from the tooth center. Again, under normal conditions, healing will take place and gear life will not be lost.

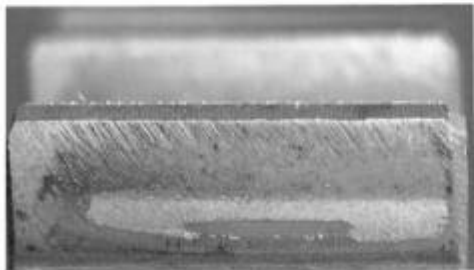
Healing

As seen in the photo, the pitch line is generally well defined. The balance of the frosting will take the shape of the contact area, no matter what it might be. Under normal conditions, the contact zone wears away; the rate of wear decreases until the point is reached where it polishes itself out and the frosting is totally replaced by a very shiny area. No further wear takes place. This is called "healing" and absolutely no gear life is lost at this stage.

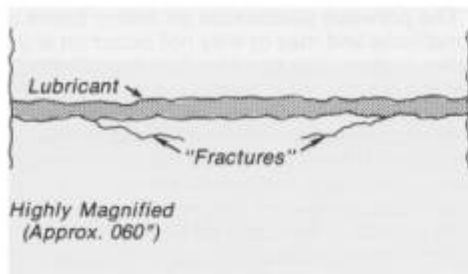
Gear Pitting

There is another surface condition which is normal in the early life of a gear and common in any carburized involute spur gear. It is the result of microscopic variations in tooth form and surface material microstructure.

Lubricant normally fills the irregularities of both teeth while in mesh. Lubricant builds a film of oil and no metal-to-metal contact takes place. Under load, oil pressures and surface stress develop between the teeth. The specific cause of this stress is debatable. One theory is that repeated high horsepower applications may cause oil pressures sufficient to overstress the microscopic areas of the tooth surface. Small surface fractures may start, and repeated loading may increase the fracture until the area is weak enough to break out, forming a pit.

The pit size will vary, depending on the depth of the initial fracture and how far the pitting has progressed. The pitting will progress until the tooth can carry the load without further distress. This rarely exceeds "initial" pitting and the distressed areas can heal

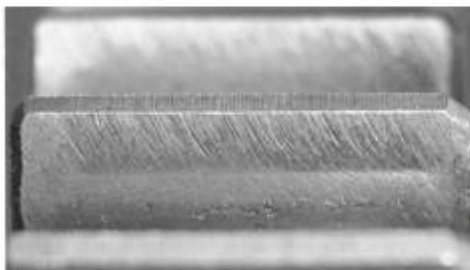
Initial Pitting

"Initial pitting" is the mildest stage of pitting. It consists of definite pits from pin hole size, just larger than frosting and barely noticeable to .030 inches (.762mm) in diameter.

Generally, initial pitting continues until the tooth is able to carry the load without further distress. Do not replace a gear because of initial pitting, as it will not cause noise and in many cases will heal over.

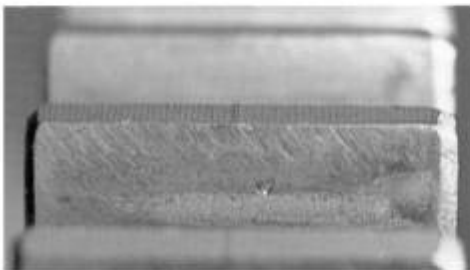
Combinations

You can see under normal operation, a gear can have a "combination" of tooth distress, frosting and/or initial pitting. Again, all are likely to heal over.

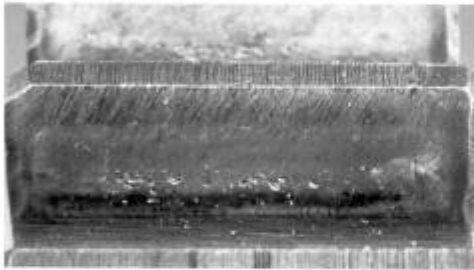
Moderate Pitting

This gear shows pit craters approximately .060 inches (1.524mm) in diameter and .005 to .010 inches (.127mm to .254mm) deep, about twice the size of craters in initial pitting. The pits are widely distributed across the face of the tooth. This gear has lived about 50% of life. The teeth have not been significantly weakened at this stage and there is no danger of breakage. As in the case with gears that show frosting and initial pitting, this type of "moderate pitting" will not cause noise. This gear can give many more miles of useful service.

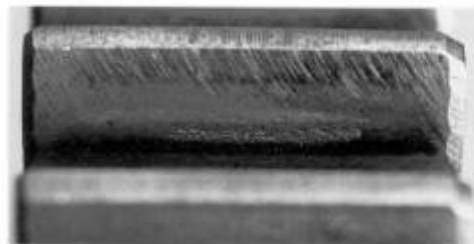
This gear also has pitting on approximately 50% of the tooth surface, but unlike the previous gear shown, this gear should be replaced. The pitting is concentrated and at the pitch line, which changes the involute form. Although the teeth have not been significantly weakened, noise can be generated because the involute form no longer falls within the tolerance band discussed earlier.

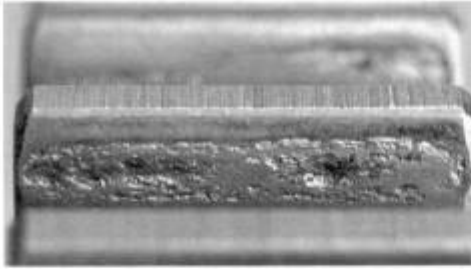
Destructive Pitting

The pitting on this gear is well advanced into a "destructive" stage. The pit craters are considerably larger and deeper than those in moderate pitting. Gears in this stage of pitting should be replaced, or noise and fatigue fractures may occur.

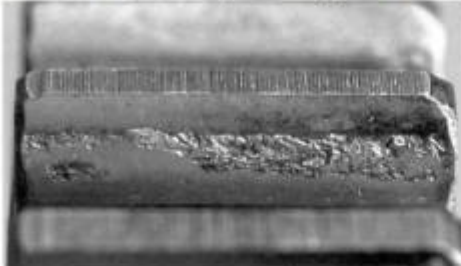
"Spalling" is similar in appearance to destructive pitting except the craters are larger in diameter and shallower in depth. Spalling occurs over a short period of time when a gear is subject to an extreme overload condition.

Major forms of distress are primarily caused by a severe case of the factors given for minor and progressive forms of distress. These forms can occur at any time in the gear's life. Whenever they occur, all gears in the set must be replaced.

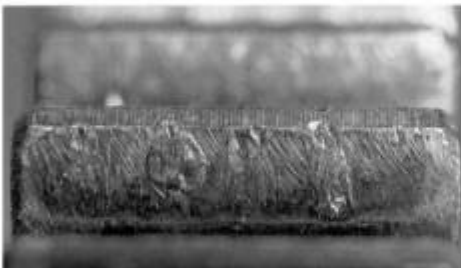
Scoring

"Scoring" is caused by an insufficient oil film between mating gear teeth, resulting in very high surface temperatures. This results in an alternate welding tearing of metal which is rapidly torn from the tooth surface. Insufficient oil film can be caused by: Low oil level, excessive transmission operating angles, high operating temperatures, poor quality, incorrect viscosity oil, and by mixing types of oil.

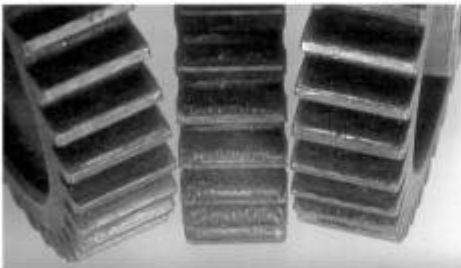
Burned Head Set

When inspecting a transmission with a "burned head set", it is not unusual to find the main drive gear badly scored, with only slight visible damage to the mating countershaft drive gears. This occurs because the teeth of the main drive gear make contact almost three times as often as the teeth of the mating countershaft drive gears. When replacing a burned main drive gear, also replace the countershaft drive gears, even if there is no visible damage.

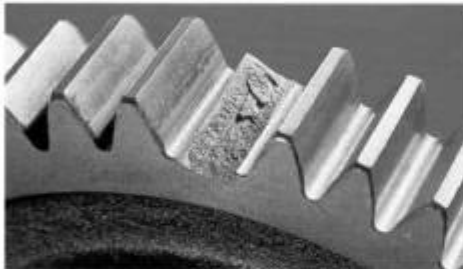
Impact Fractures

"Impact fractures" are caused by a severe shock load or a foreign object passing through the gear mesh. They are identified by a "bump" on the compression side of the fractured area. The more cycles the gear has run after the fracture, the smaller the bump will be. In addition to the gear which has a tooth fracture, the other two gears of the set should also be replaced, even though they may look undamaged. All gearing in the transmission should be inspected for possible damage caused by the broken tooth running through the transmission.

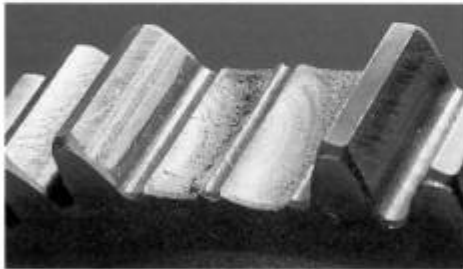
Fatigue Fractures

"Fatigue fractures" are caused by extremely high stresses on a gear tooth over a period of time.

Possible causes of such stresses could be:

- Shock loads causing a small crack in the tooth.
- Tooth damage from objects going through the gear mesh.
- An overload condition.
- Forging imperfections, excessive machining marks, or improper heat treatment.
- Severe pitting or surface fatigue.

Fatigue fractures are identified by "beach" marks on the fractured area. These marks are made as the tooth progressively cracks under a load heavy enough to enlarge the crack but not great enough to break the entire tooth off at one time.

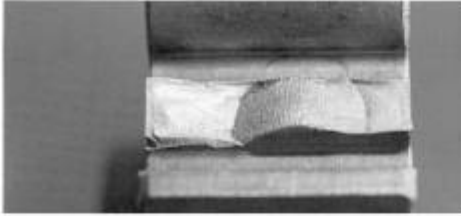
Stingers or Gas Pockets

Gears made from base metal which contain "stringers" or "gas pockets" have weak points at those areas. These fractures can be identified by the difference in fracture shape and metal texture in the break surface. Again, as with other fractures, inspect all gearing in the transmission for possible damage.
