EVO: Body Parts

Foot Controls

Kickstand

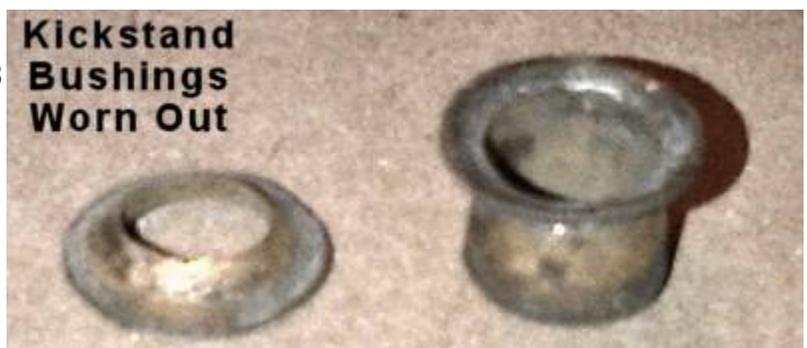
The 1998 model year was the first for using the kickstand bushings - The rest of the 1998 parts were the exact same as the previous model years:

Stock Parts

50003-89A . PIN, CLEVIS

50005-85A . SPRING, JIFFY STAND

50006-89 . . JIFFY STAND (varied by model)

but these bushings were added:

53176-08 . . BUSHING (2ea)

(previously 53158-98)

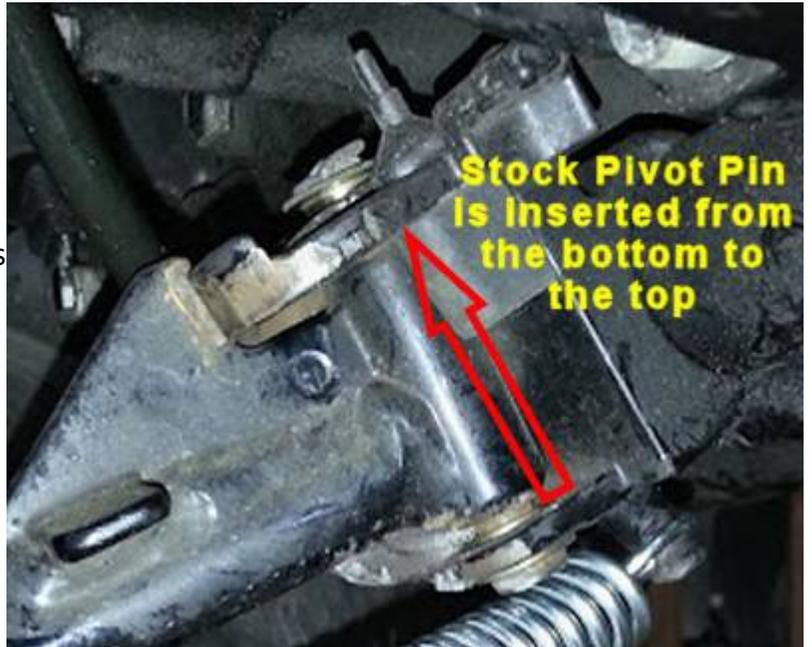
It seems the holes in the kickstand mounting tab at the frame were enlarged from that model year forward to accommodate the bushings. There are two bushings used - one above and the other below - between the pivot pin and the mounting tab. The bushings should be checked every year to see if they need replacing due to wear (such as shown in this picture.)

Inspect and grease the Jiffy Stand and parts periodically.

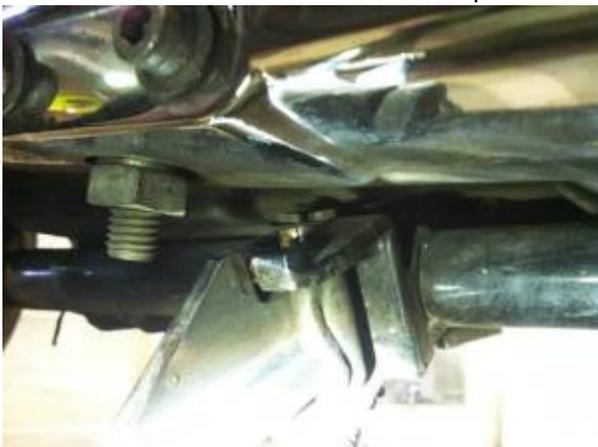
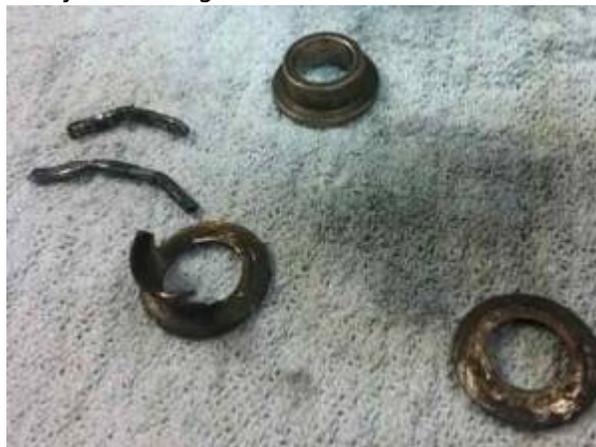
This one looked to have wear and upon dis-assembly a bushing was found to be broken.

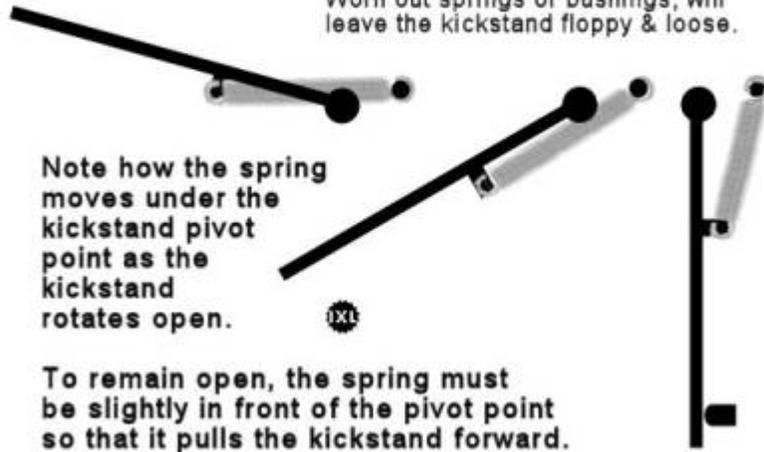
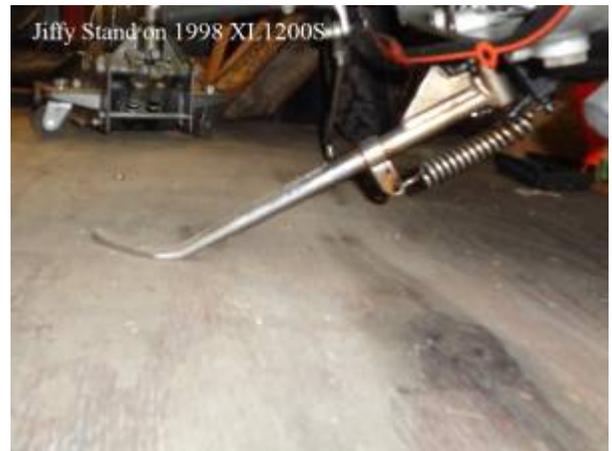
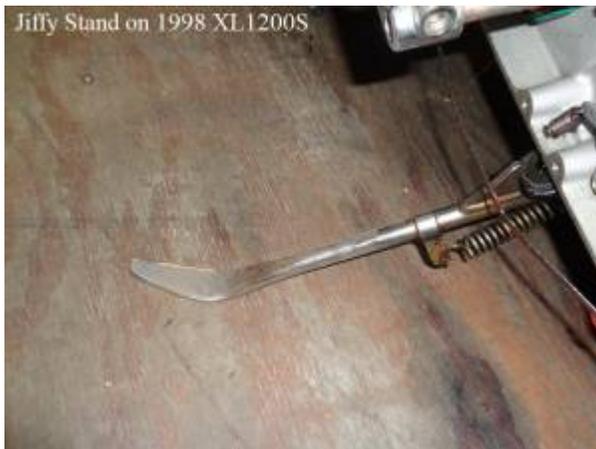
Kickstand Spring Operation

When closed, the spring must hold kickstand up against the bumper. Worn out springs or bushings, will leave the kickstand floppy & loose.

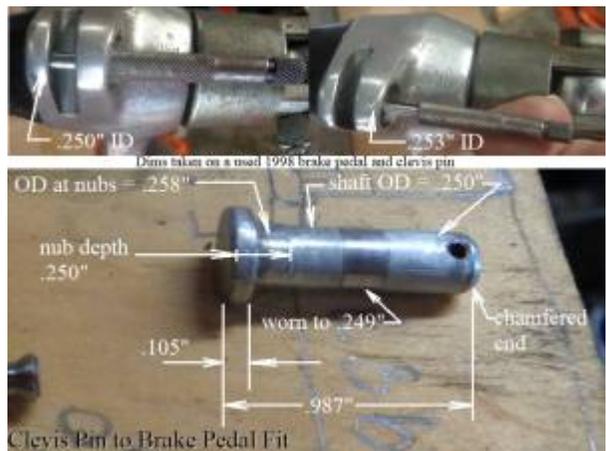
Clevis Pin

Dims were taken on used brake pedal and clevis pin below from a 1998 XL1200S.
