# IH: Engine Mechanicals

## Gearcase / Cam Cover

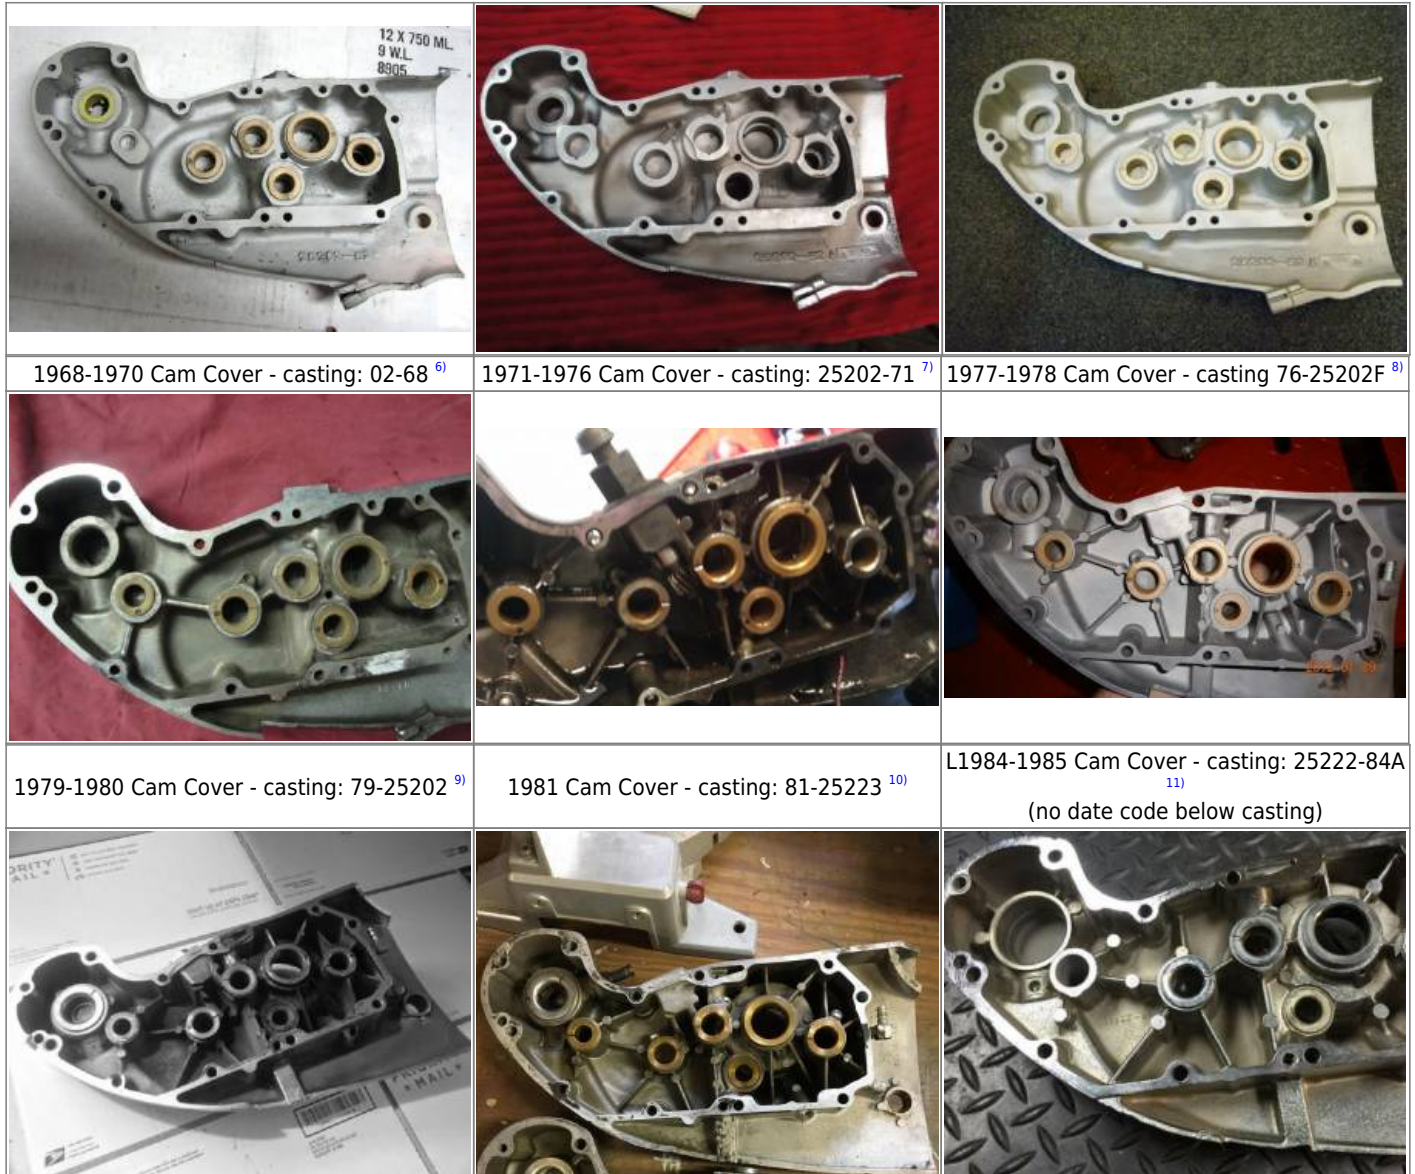
1952-1956 Cam Cover - casting: 25202-52 <sup>3)</sup>	1957-1962 Cam Cover - casting: 25202-52A <sup>4)</sup>	1963-1967 Cam Cover - casting: 25202-52A <sup>5)</sup>
---	--	--

1957-1967 XLs had the solid bar cam cover. <sup>1)</sup>

1968-1970 had the finned looking cam cover.

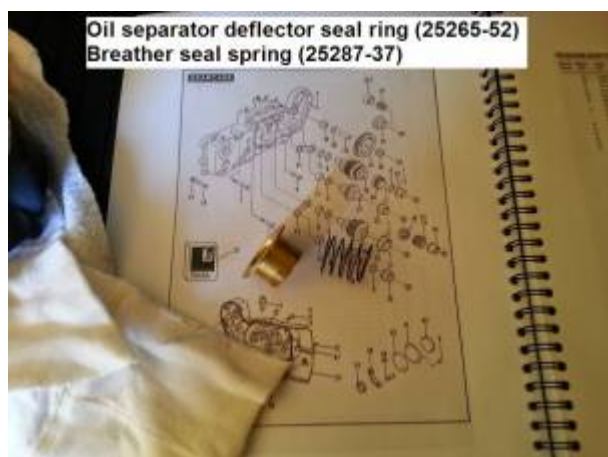
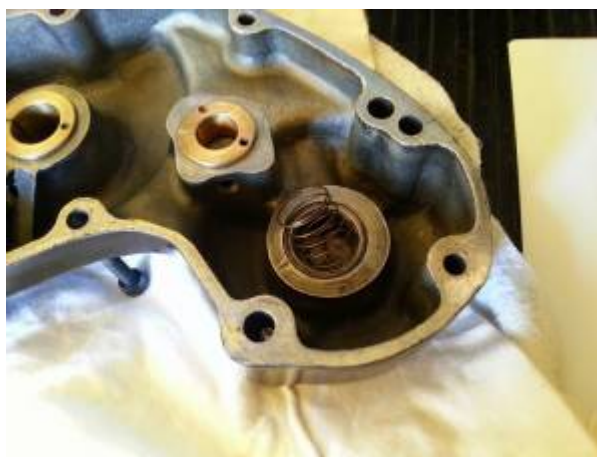
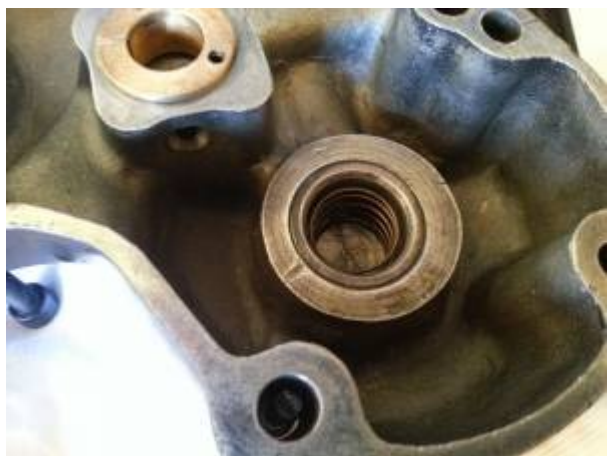
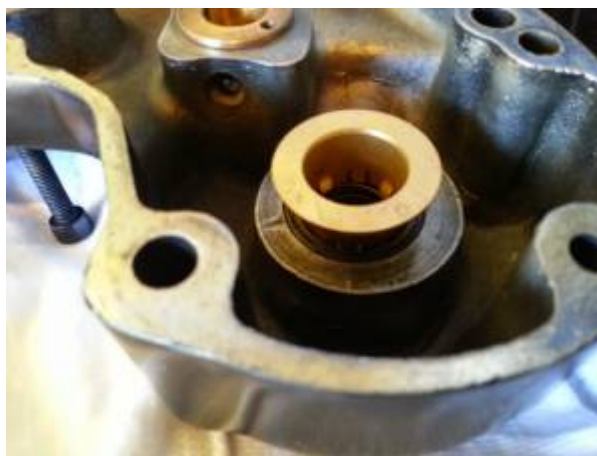
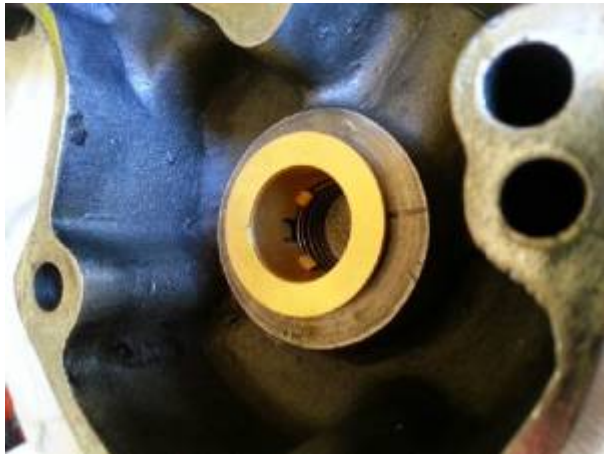
18)

Looking at the brass part, you can see how the spring catches on the inward bent tabs. There are also unbent tabs on the brass. <sup>12)</sup>

These, when bent outward just a little, fit into slots on the far side of the steel bushing pressed into cam cover.

Here's how the factory assembled this thing.

They had pre-assembled the brass to the steel before the steel was pressed into the cover.

Then dropped the spring into the cover and pressed the brass/steel assembly into the cover as a unit (and manipulated the spring to sit correctly if needed).

However, it is possible to assemble the unit without removing the steel from the cover. <sup>13)</sup>

You can bend the tangs out without having to remove the steel bush with a screwdriver and a hammer to bend the 2 locating tabs out.

The tabs must be bent outward enough that the brass stays keyed to the steel at full spring compression. You don't want the brass hat to 'unkey' when the generator compresses spring. The brass needs to be able to 'plunge' in and out under the spring pressure once the tags are bent.

These outward bent tangs do 2 things.

- They keep the brass hat and spring captive in the cover upon generator removal.
- More importantly, they key the brass to the steel to prevent the brass from rotating with the generator gear.

The brass is unable to rotate by the tangs keying into the slots.

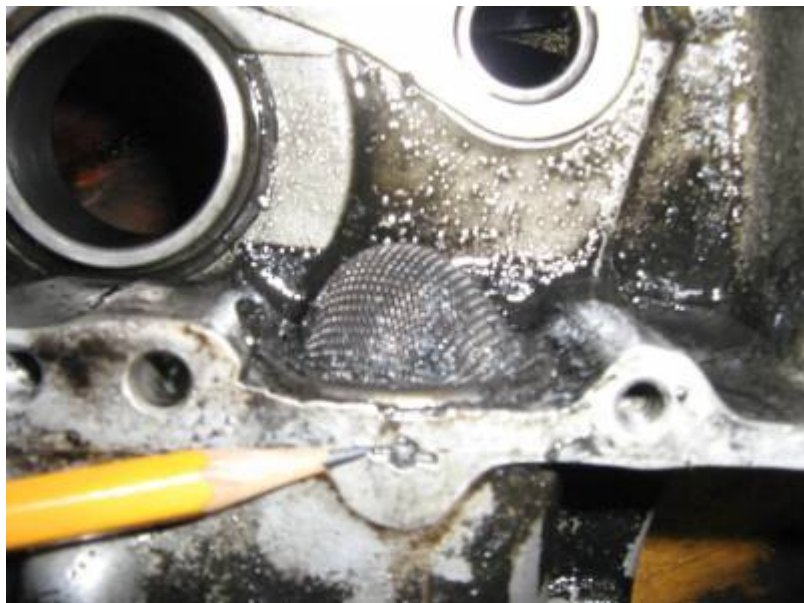
23)

- If you've split the cases and the screen is in good shape, you don't have to take it out. Hit it with some compressed air and see if it needs replacing. <sup>22)</sup>

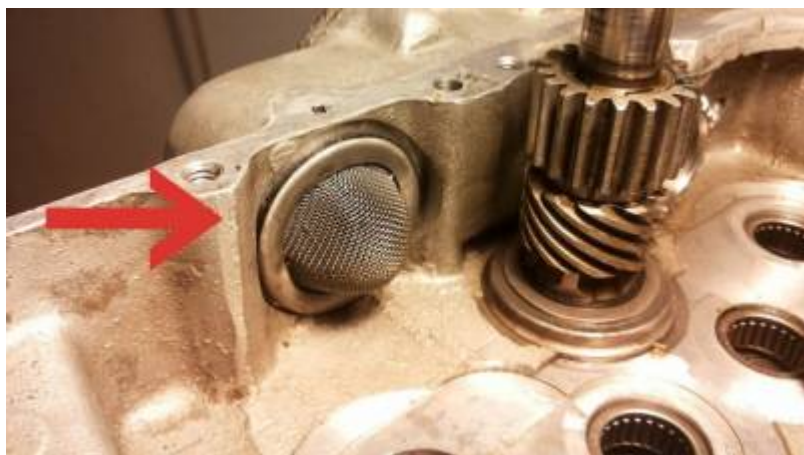
24)

The strainer is held in place by this pin. It is staked into place with the two horizontal lines radiating from the it. To remove strainer, you must first remove the pin. Tear the screen from the strainer and place pliers on the pin inside (the now destroyed strainer) and wiggle the pin out. Strainers and strainer gaskets are available for replacement. <sup>25)</sup>
