IH: Oiling & Lubrication - Sub-03C

77-85 Oil Pump Damage and Repair

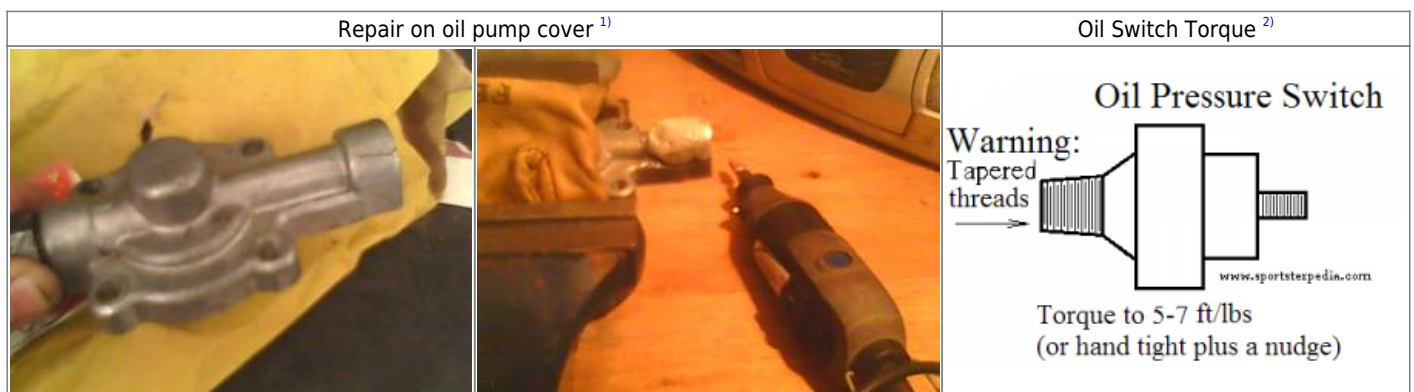
Cracks in Housing or Cover

This cover was cracked at the oil pressure switch end.

The crack was welded over and a Dremil tool was used to reshape the cover.

Due to warpage during welding, the threads need to be chased with a tap to straighten them back out.

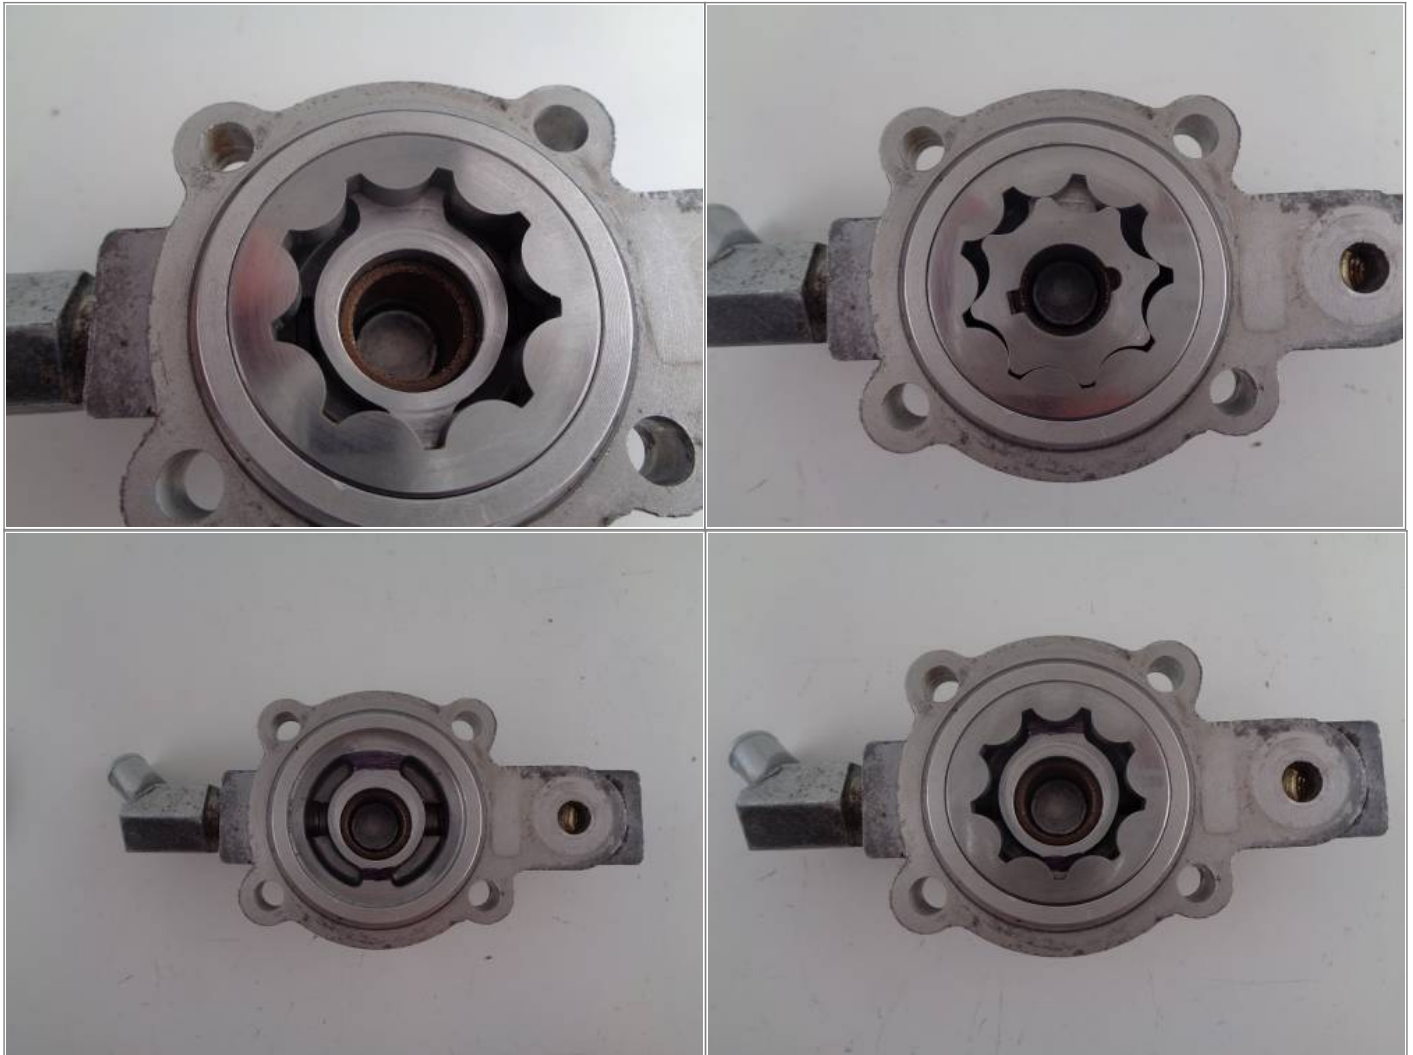
Scratches on Gerotors or Mating Surfaces

- Many used oil pumps have scratches on both the gerotors and pump surfaces that the gerotors ride on.
- But, there is one certain spot that seems to be scratched more times than others. ³⁾
 - It's on the larger of the two pads in the pump body and the cover seem to usually have more wear.
 - Sometimes, the small pad is scratched or damaged also but not always.
 - The gap between the inner and outer gerotors on both the feed and return sides tends to be scratched as in the pics below.
 - Debris caught between these two gears cannot slide over and fall to the other cavity and out of the pump.
 - It gets locked between the gears and ripped across the aluminum surface.

- There should be some reduced pressure because of the scratches.
- Pressure generated to the output cavity can squirt back to the input side through these scratches.
- How much pressure loss would depend on the width, depth, length of the scratches and oil viscosity.
- To make the pump inoperative or not make pressure (from the scratches alone);
 - The scratches would have to be proportional to the relative volume of all four gerotor reservoirs combined.
 - Then, the check valve would have to accept less pressure flow than the backpressure from the pump.
- The gerotor surface in the cover would have to be eat up pretty bad to make the pump completely ineffective.
- The pump would have less pressure loss with multi-weight or straight weight oil when cold than hot.

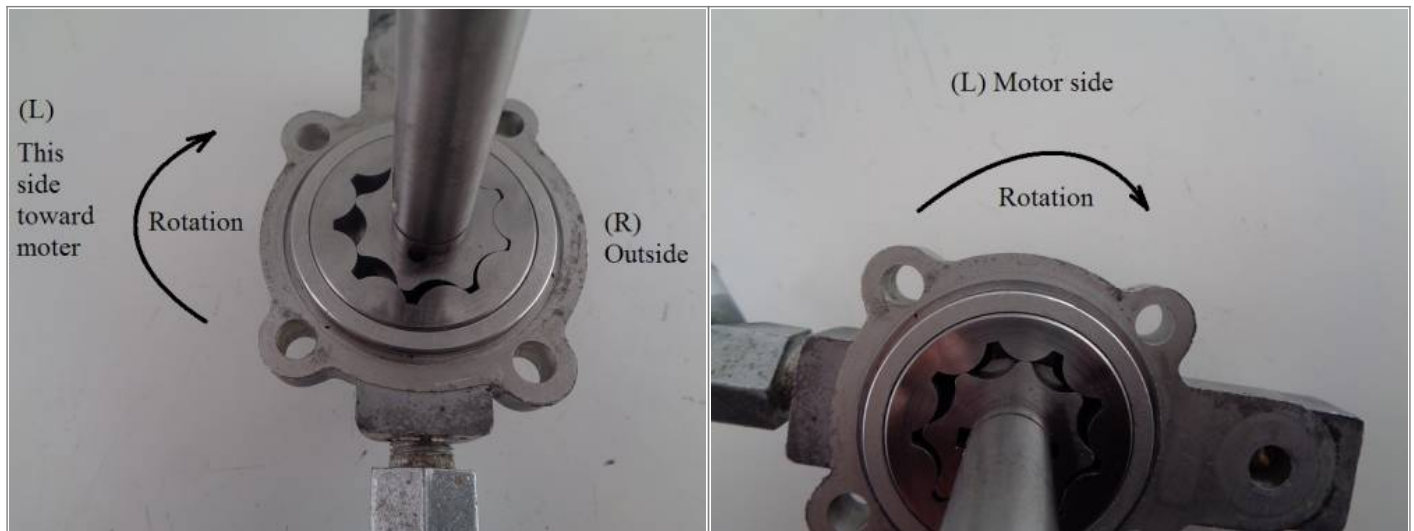
- In theory, no particles of any size should be able to spin around to the small pad due to the pressure generated by the spring washer and the gerotor spacing there.
- Also, any debris picked up from the source side cavity should drop down into the feed side cavity and out of the pump.
- The side toward the motor is where oil is transferred to and from the pump.
- The inner and outer gears come together on the other side (right side).
- This spacing relationship doesn't change between the motor side or the outside of the pump due to the offset gearshaft.
- But in reality, debris gets caught in or between the gears and gets dragged over the aluminum flats.
 - Some then find their way under the gerotors while the spring washer flexes from the stress.
 - The debris spins around under the gerotors and wears scratches in the flats (pads) or worse.

Gerotor rotation ⁴⁾

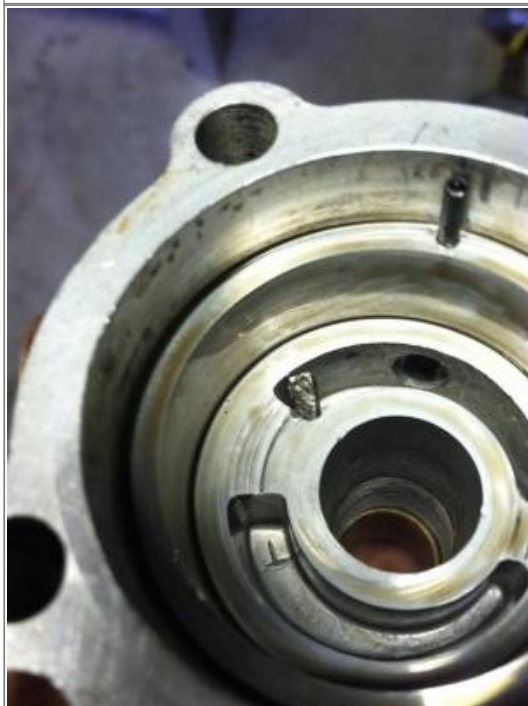
Oil pump from an 83 model ⁵⁾

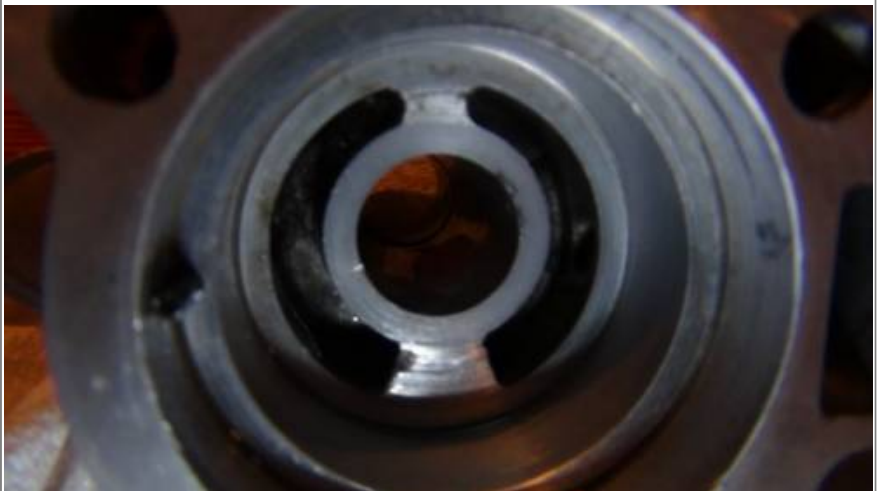
Gearshaft pin broke off into this 77 model ⁶⁾
