REF: Engine Mechanicals - Sub-01P

Removing the Rivets on the Timing Inspection Cover

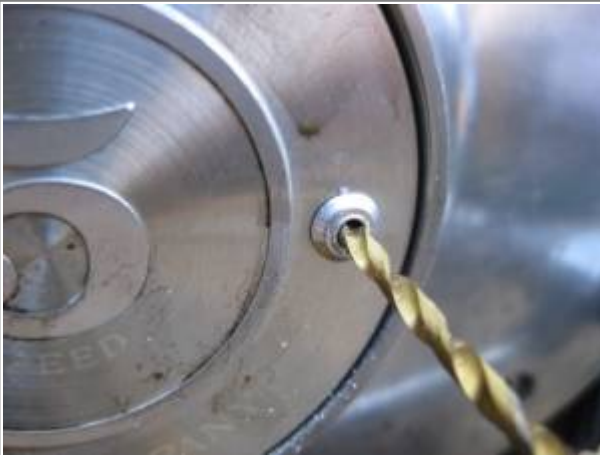
Drill the center of the rivets. ¹⁾	Chisel off the head if it didn't fall off. ²⁾

Removal of the rivets are fairly simple. Just drill out the center of each one (which is the strength of the rivet). The size drill bit used is not critical. It should be wider than the center hole of the rivet but not as wide as the rivet head O.D.

The head may start spinning while you are drilling it.

If that happens, just hold one end down with a screwdriver and continue drilling.

Try not to drill too deep.

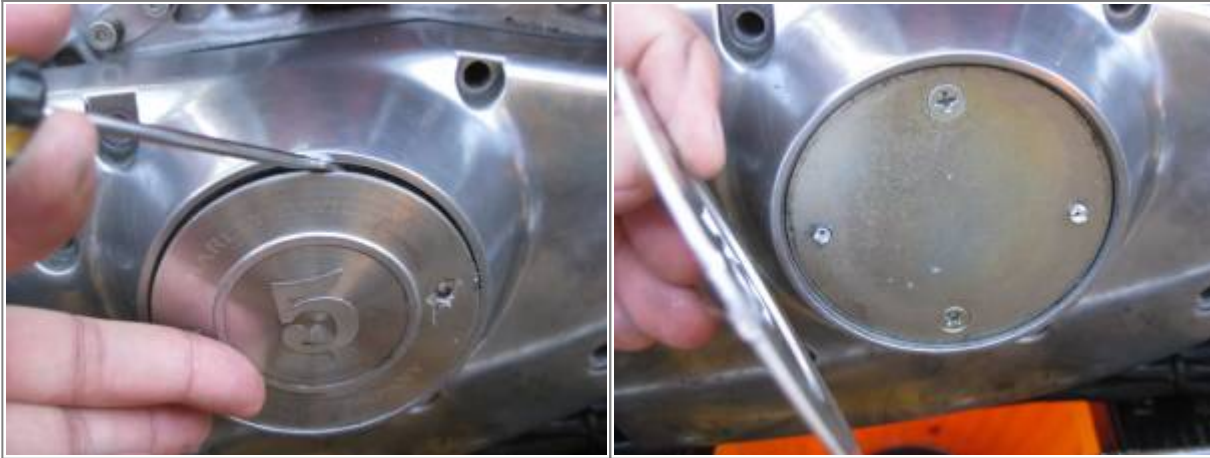
Then lift the cover out. ³⁾	This second plate is in the back. ⁴⁾
