## REF: Service Procedures 11E

# What Causes the 1991-2003 Shift Arm to Scrub the Starter Gear

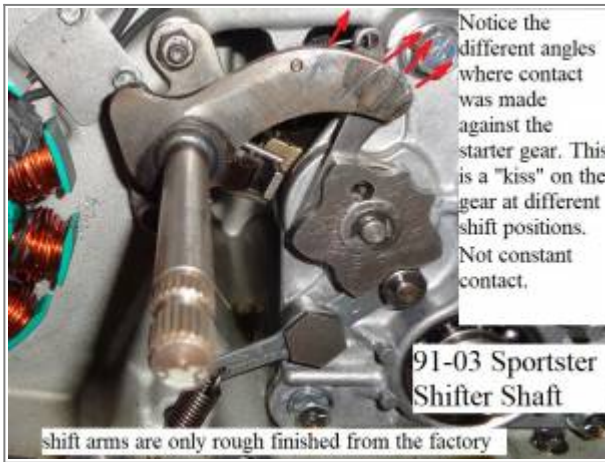
Witness marks from momentary contact <sup>1)</sup>

The loose clearances will allow for enough slop in the shift chain to let the shift arm "kiss" the starter ring gear on occasion.

You'll probably see witness marks on the arm but they should not be deep.

In this instance, the shift arm will rub the ring gear on occasion but not all the time and the witness marks should not be very deep (momentary contact only).

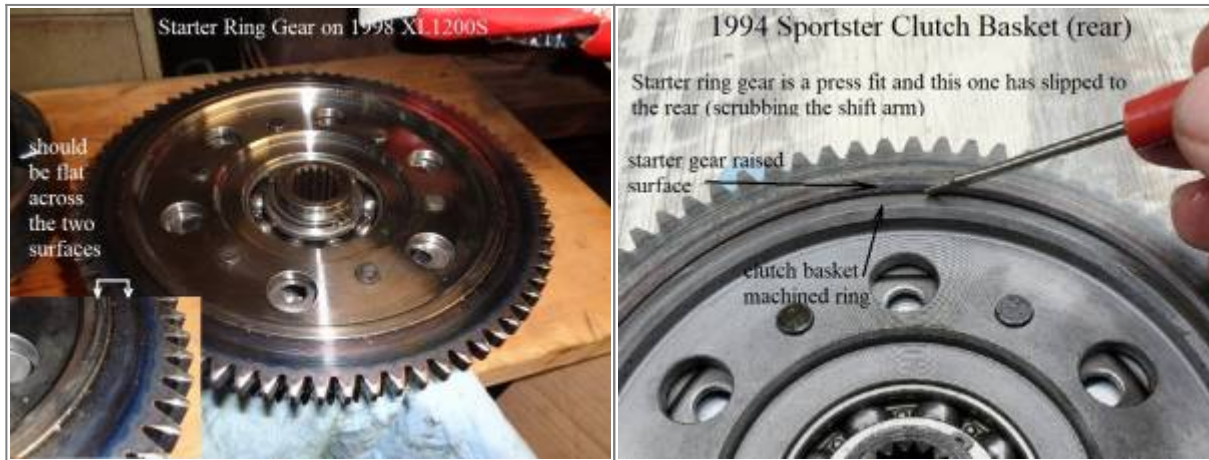
<p>Measuring clearance (results vary) <sup>2)</sup></p>	<p>Notice the gap near the gear on the right <sup>3)</sup></p>
<p>Measuring overall clearance between shift arm and starter gear. .043" feeler gauge was inserted with no scrubbing while spinning the clutch sprocket in neutral, shifter shaft lifted up by hand.</p> <p>1998 Sportster</p>	<p>1998 Sportster Starter ring gear in tact</p> <p>Slipped Starter Ring Gear</p> <p>1994 Sportster Starter ring gear slipped back</p>
<p>Correct starter ring gear position <sup>4)</sup></p>	<p>Slipped starter ring gear <sup>5)</sup></p>

**The starter ring gear is pressed onto the rear of the clutch basket and has been known to slide rearward away from it.**

But there should be clearance between the shift arm and starter ring gear if you lift the shift shaft to the upper extreme.

A measurement was taken between the arm and gear with a feeler gauge at .043" (1.0922mm) without any scrubbing noticed (shaft lifted up by hand w/ cover off).

This dim is just a dirty one and results will vary. But the point of that measurement is there is that there will be some clearance between the two.

If the arm stays against the ring gear when the shaft is lifted, check the starter ring gear for breakage or slippage.
