EVO: Engine Mechanicals - Sub-01A

91-03 Timing Inspection Hole and Plug Pics and App. Dims

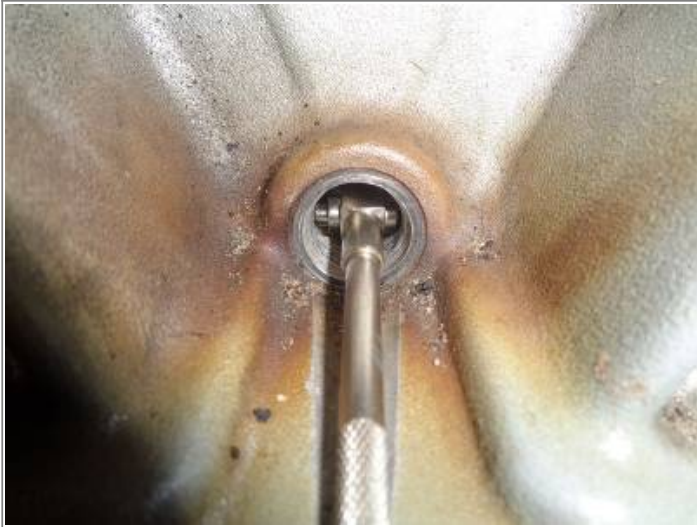
Straight threads in the case. Same drag on bore gauge - front to back. No taper ²⁾

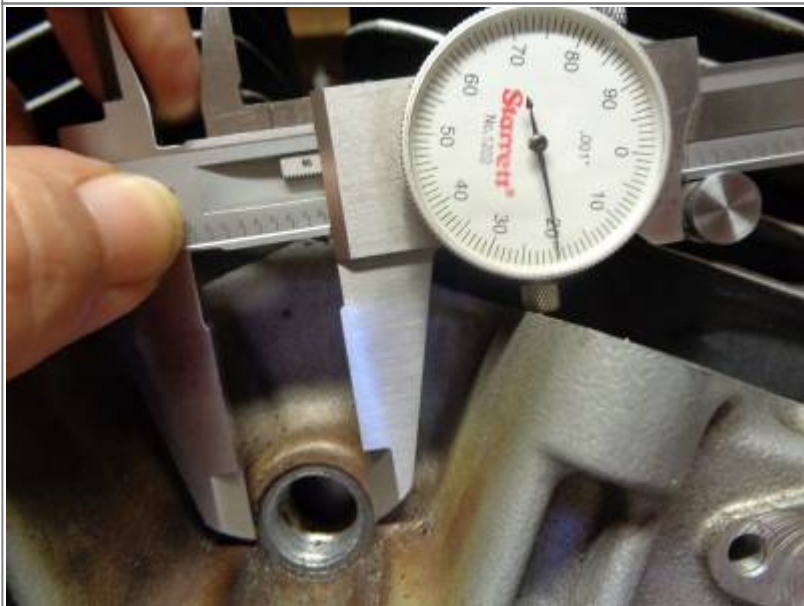
App. diameter of machined outer face ³⁾

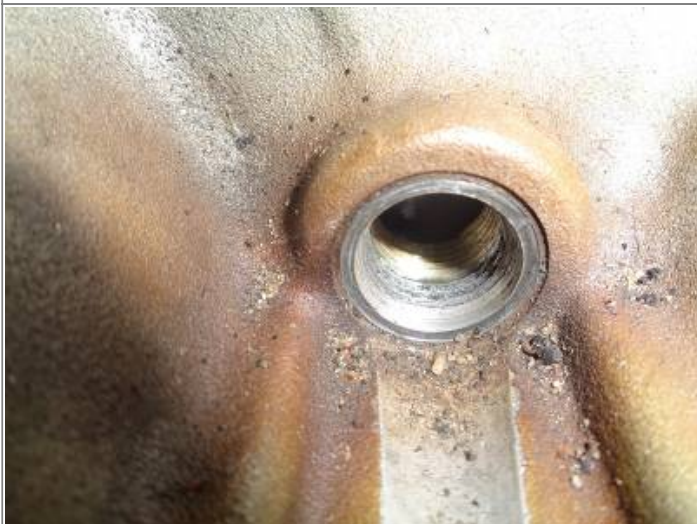
Notice the plug doesn't go all the way into the end of the case threads ⁴⁾

Flywheel sits close to the back of the hole ⁵⁾

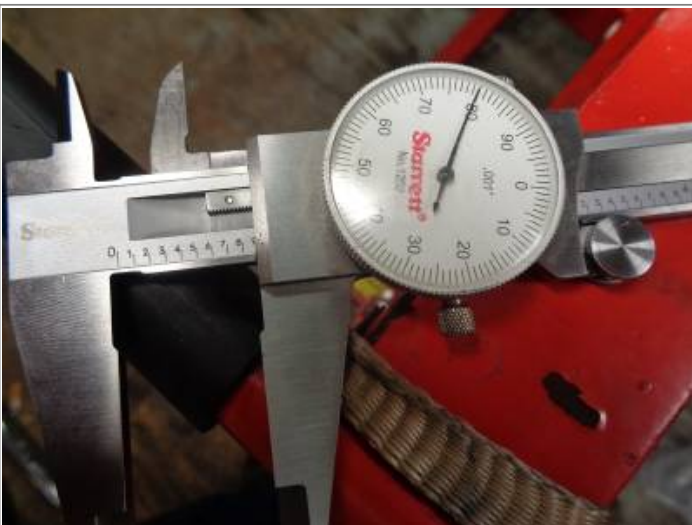
Measured from the case outside surface to the flywheel. ⁶⁾

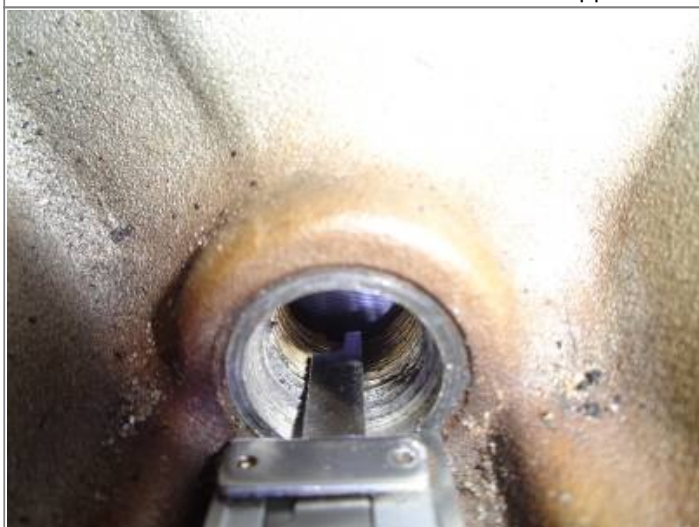
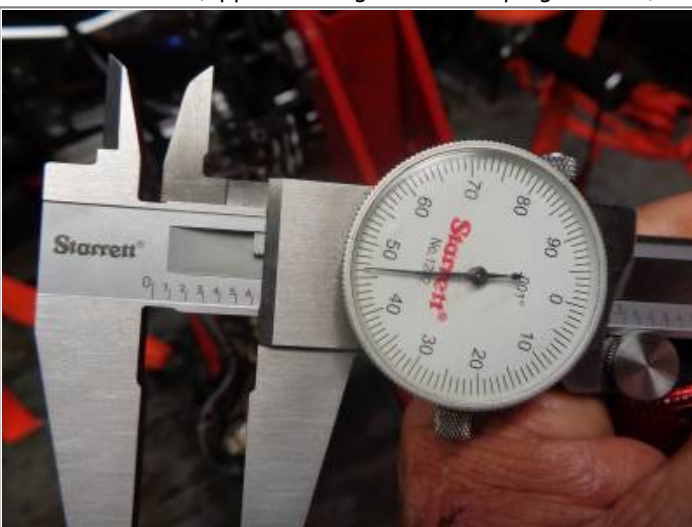
Measured from the case outside surface to the app. end of the case threads (app. 1/4" longer than the plug threads). ⁷⁾
