EVO: Engine Mechanicals - Sub-01A

91-03 Timing Inspection Hole and Plug Pics and App. Dims

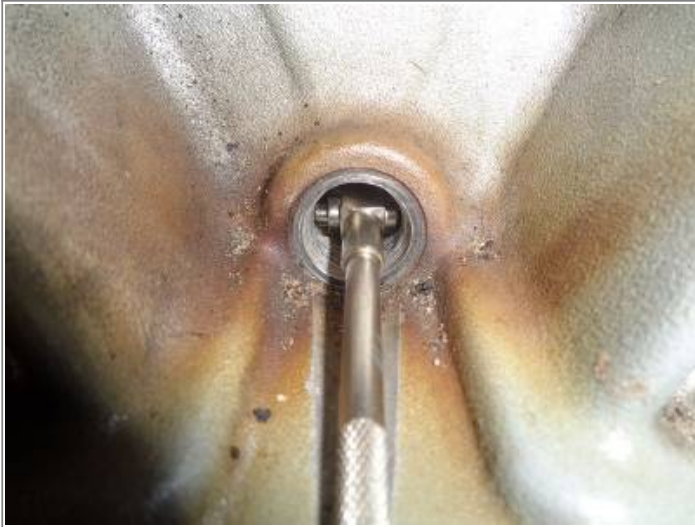
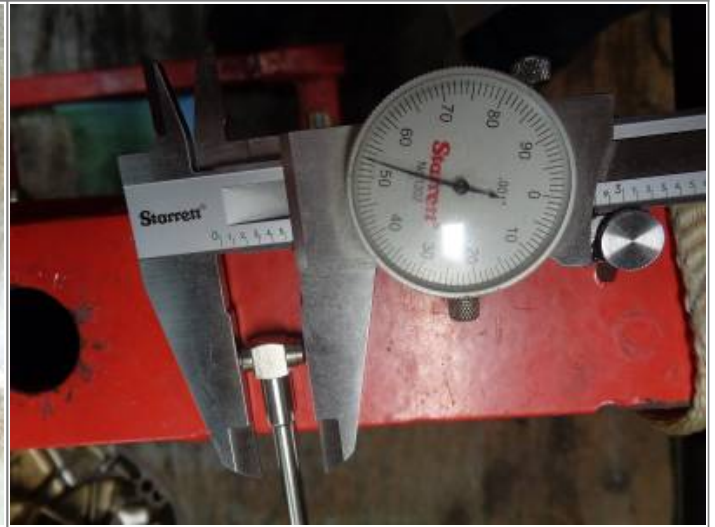
Straight threads in the case. Same drag on bore gauge - front to back. No taper ²⁾

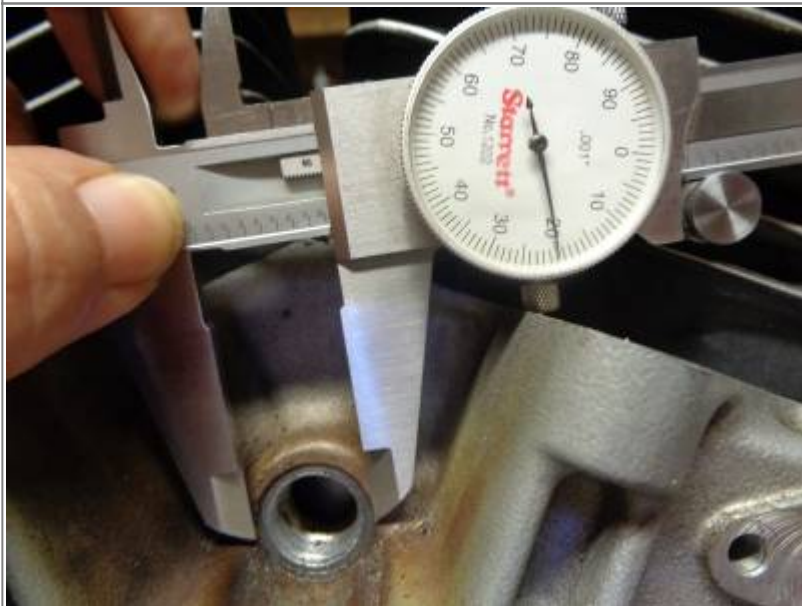
App. diameter of machined outer face ³⁾

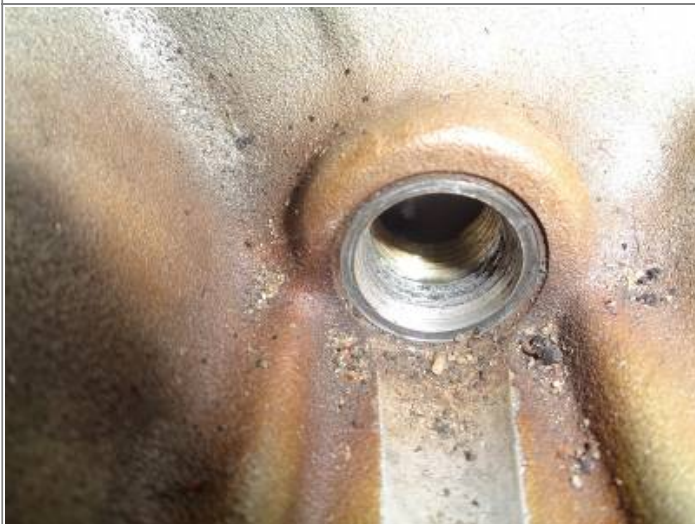
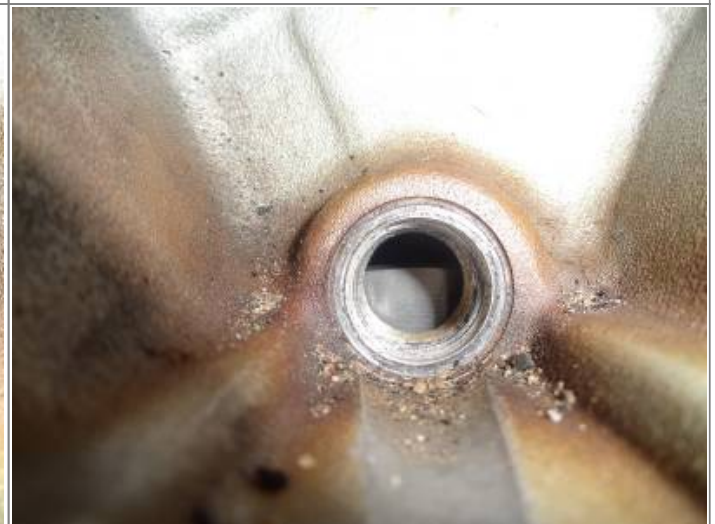
Notice the plug doesn't go all the way into the end of the case threads ⁴⁾

Flywheel sits close to the back of the hole ⁵⁾

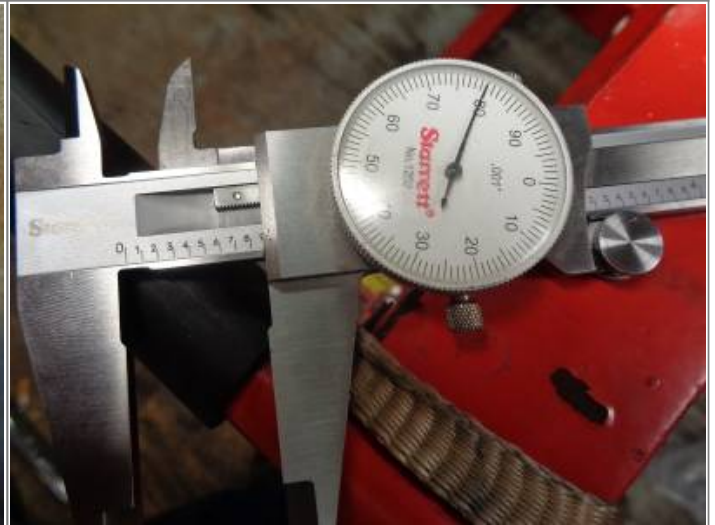
Measured from the case outside surface to the flywheel. ⁶⁾

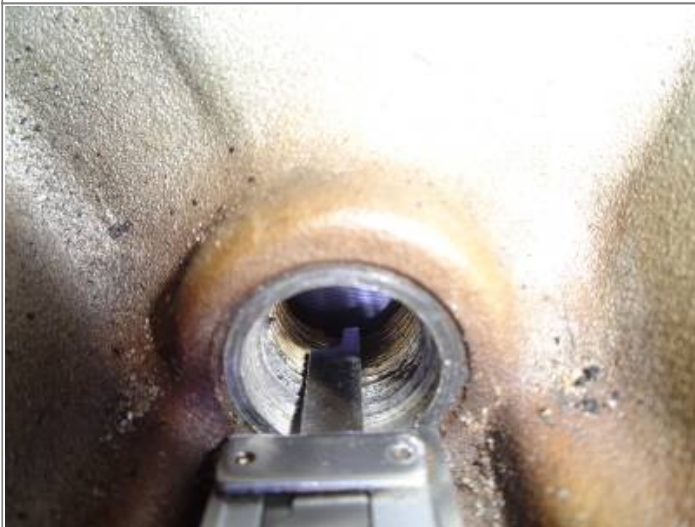
Measured from the case outside surface to the app. end of the case threads (app. 1/4" longer than the plug threads). ⁷⁾
