EVO: Oiling & Lubrication

Primary/Transmission Oiling

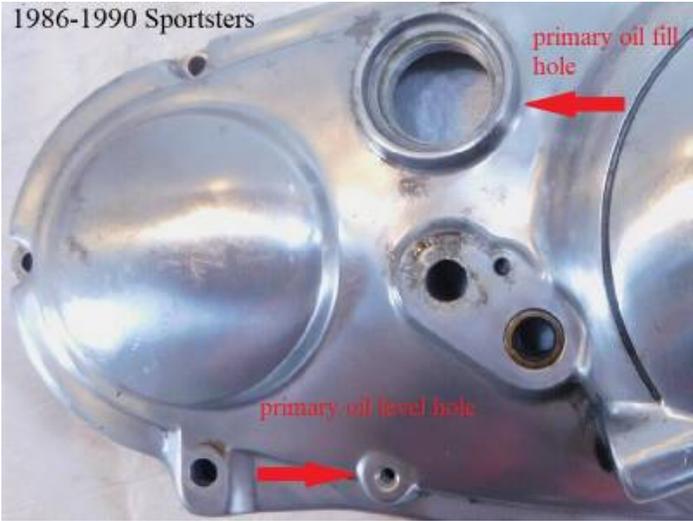
<p>1986-1990 Sportster primary/transmission oil site level and fill holes ¹⁾</p>	<p>1986-1990 primary drain plug ²⁾</p>
<p>1986-1990 Sportsters</p>

- **On the 1986-1990 models**, the oil level screw (stock is Philips-head) is located on the side of the primary cover, forward from the clutch cable mount and below the shifter lever. Oil should seep (not pour) from the hole, bike upright, with the oil level screw removed. If not, proper oil level is achieved by removing the primary chain inspection cover and slowly filling the primary with oil until it pours out the oil level hole. When it's just seeping from that hole, replace the oil level screw and the inspection cover. The Oil Drain Plug is located on the lower/rear of the left-side engine case.

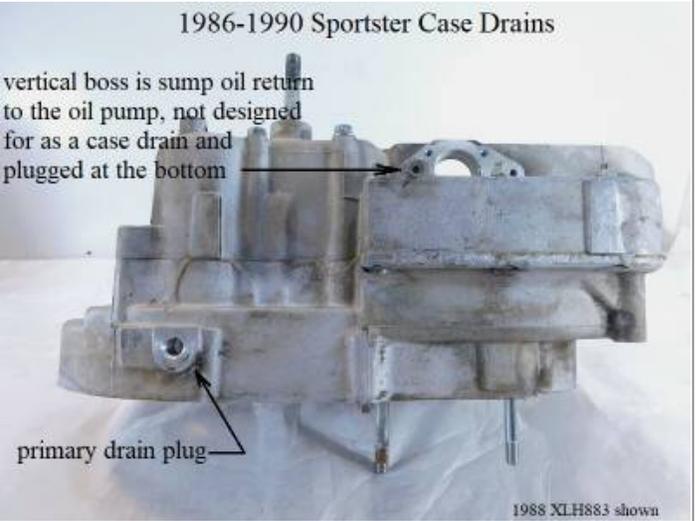
<p>1986-1990 Sportster Case Drains</p>

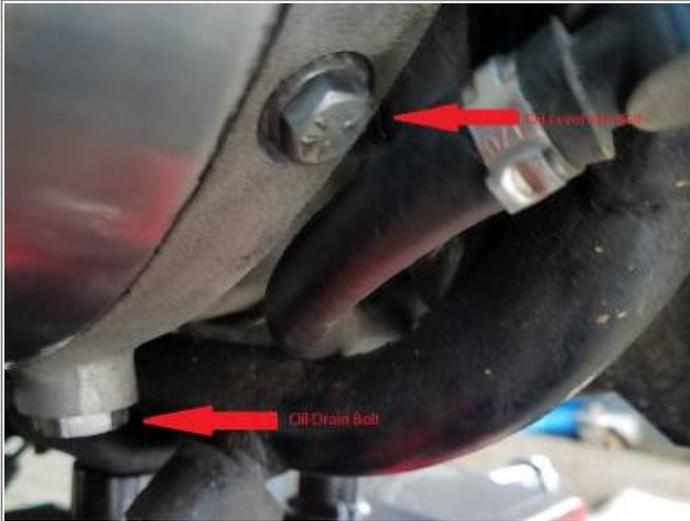
<p>1988 XLH883 shown</p>
<p>1991-1993 Sportster primary/transmission oil drain & oil site level bolts ³⁾</p>	<p>1991-1993 Sportster primary/transmission oil fill hole ⁴⁾</p>

- **On the 1991-1993 models**, the oil level bolt is located at the rear of left engine case, rearward of the oil drain plug. Oil should seep (not pour) from the hole with the oil level screw removed. If not, proper oil level is achieved by removing the primary chain inspection cover and slowly filling the primary with oil until it pours out the oil level hole. When it's just seeping from there, replace the screw and the inspection cover. The Oil Drain Plug is located on the lower/rear of the engine case.

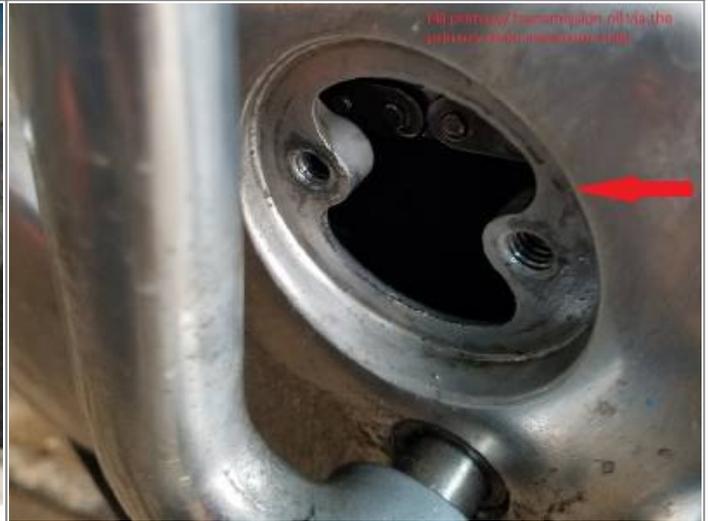
Primary / Transmission oil drain plug on 2001 Sportster ⁵⁾

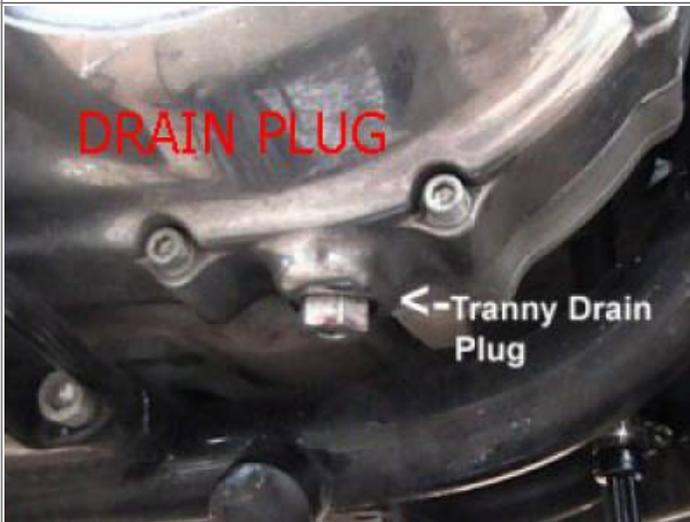
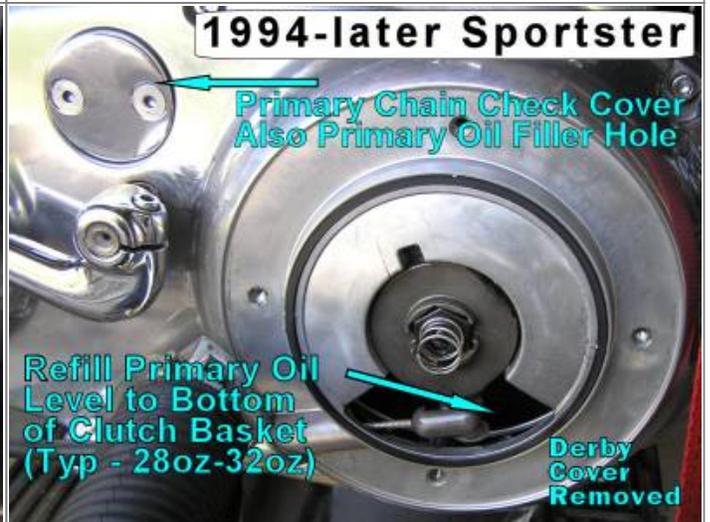
Primary / Transmission fill and check site for a typical 1994-later Sportster (1994 example) ⁶⁾

- Torque Specs:
 - Oil level screw (90-110 in/lbs)
 - Inspection cover screws: (40-60 in/lbs) or (4.5-6.8 Nm)
 - Drain plug (14-21 ft/lbs) or (19-28 Nm)
- **On the 1994-2003 models**, there is no oil level site hole and the clutch inspection cover (Derby Cover) is removed to check primary oil level. The proper level of oil, is when the oil level is just at

the bottom edge of the clutch diaphragm spring. The Oil Drain Plug is located on the lower/rear of the left-side engine case.

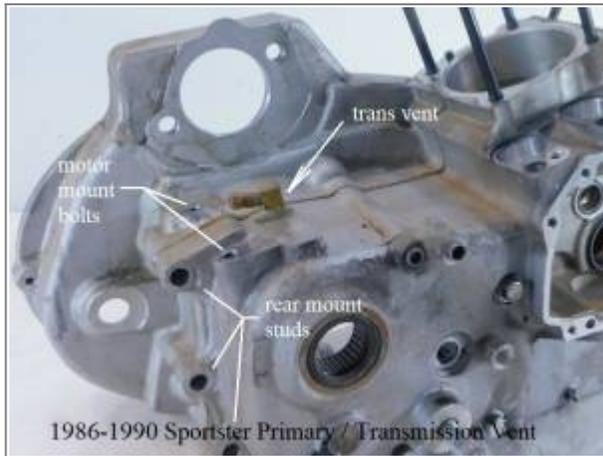
1986-1990 Transmission Vent Fitting ⁷⁾

The fitting (63547-86) for the vent hose is a 1/8"-27 NPT x 1/4" hose barb 75° elbow.

That's to say it's a 90° fitting that has been factory heated and "skewed" to 70°.

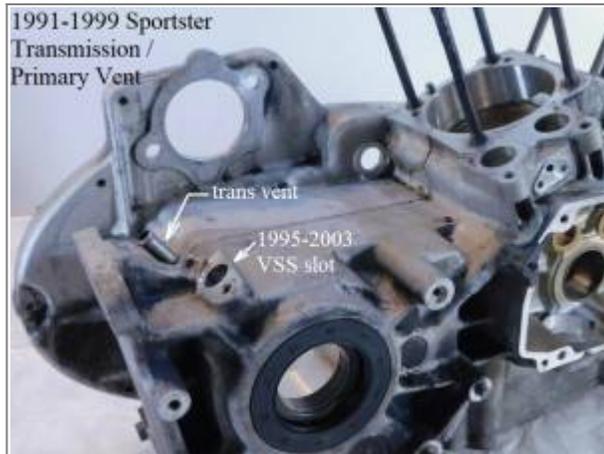
1991-1999 Transmission Vent Fitting ⁸⁾

The fitting (63547-89) for the vent hose is a 3/8" tube pressed into the case with a hose bibb on the outside end.

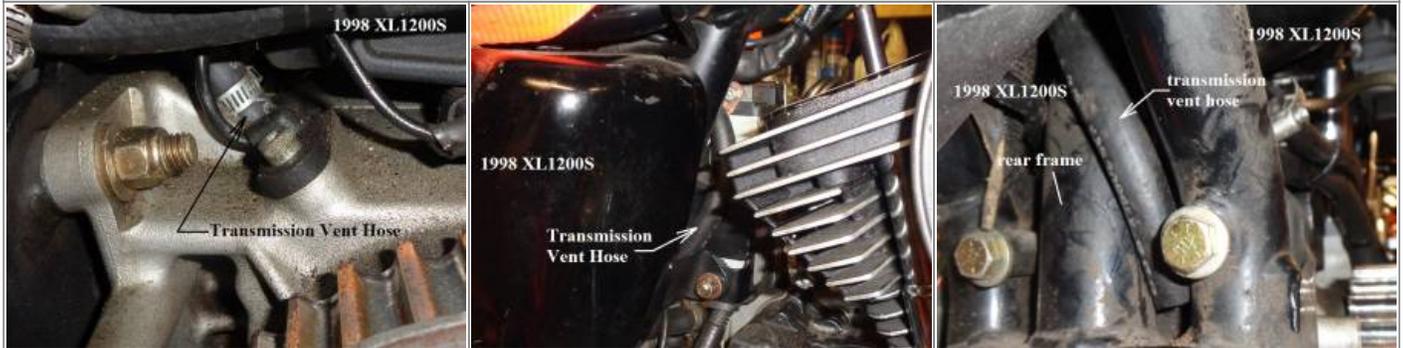
1998 transmission vent hose. ⁹⁾

- The vent hose is raised up high under the seat, behind the battery box with a wide loop down toward the center of the seat downtubes. Make sure that you manage a wide loop that will not eventually close the ID of the hose. The hose is then left hanging low (tied off). Some run the hose end down behind the swingarm. Some run the hose out past the center of the seat tubes, wedging it between the center rear tube and an adjacent L or R outside tube as in the pic below.

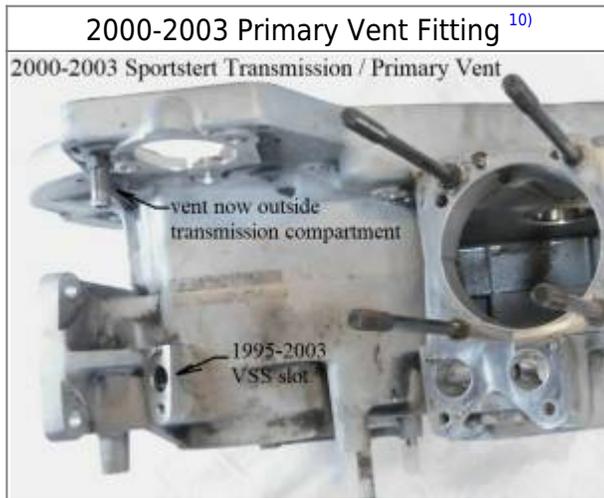
- Route the vent hose up, behind the front battery bracket keeping a long sweep below. Attach the hose to the inboard side of the oil tank with the original T-clip up and then run the hose outboard of the frame tube.
If desired, you can also run the hose down behind the swingarm or pinched between the rear seat post tubes as in 91-99 models above.
That would alleviate the need to tie the hose to the oil tank if your tank doesn't have those provisions.
You also tie the hose to the frame crossmember under the seat.

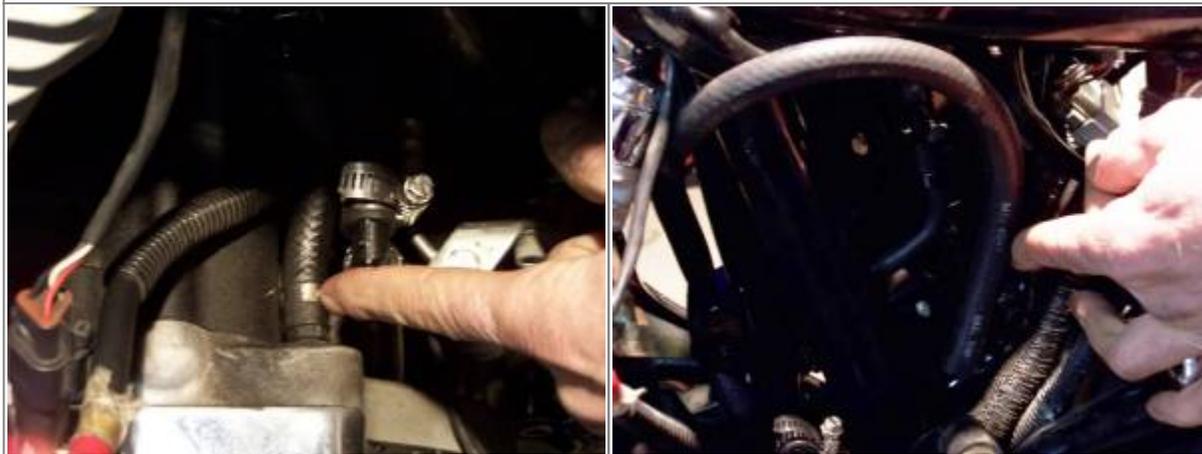
2000 transmission vent hose. ¹¹⁾

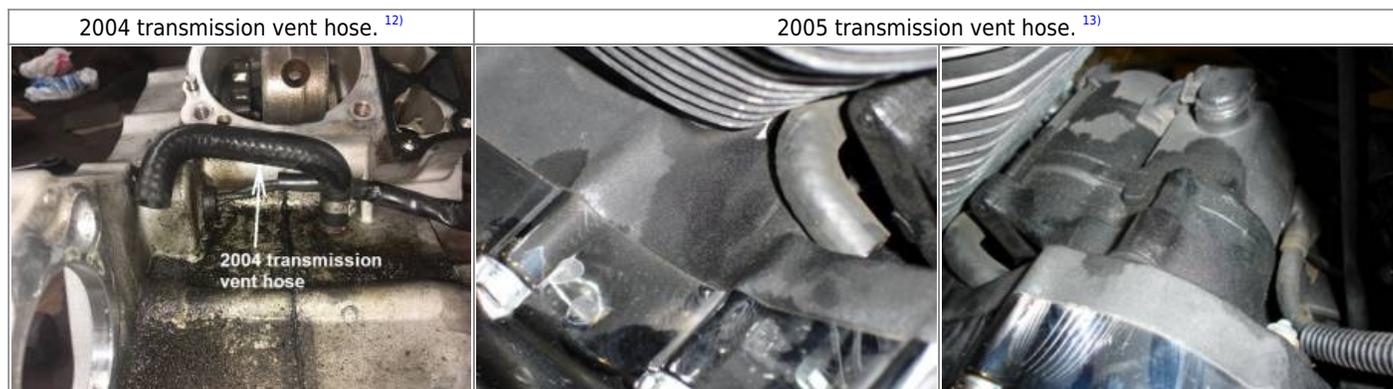
Looking at the first pic below, you can see it is also formed to run at an up angle from the fitting before it turns down at the ending bend of the hose.

It is installed on the fitting with the open end facing the left side of the bike with the open end facing the rear of the bike.

It is designed to run in front of the starter hidden between there and the rear cylinder.

The hose end just peeks out the left side from behind the starter with a 90° bend on the end between the starter and back side of the primary case.
