# IH: Engine Control - Sub-03B

## 1977-1978 Kicker Cover Damage Repair

Article by Hopper of the XLFORUM <sup>1)</sup>

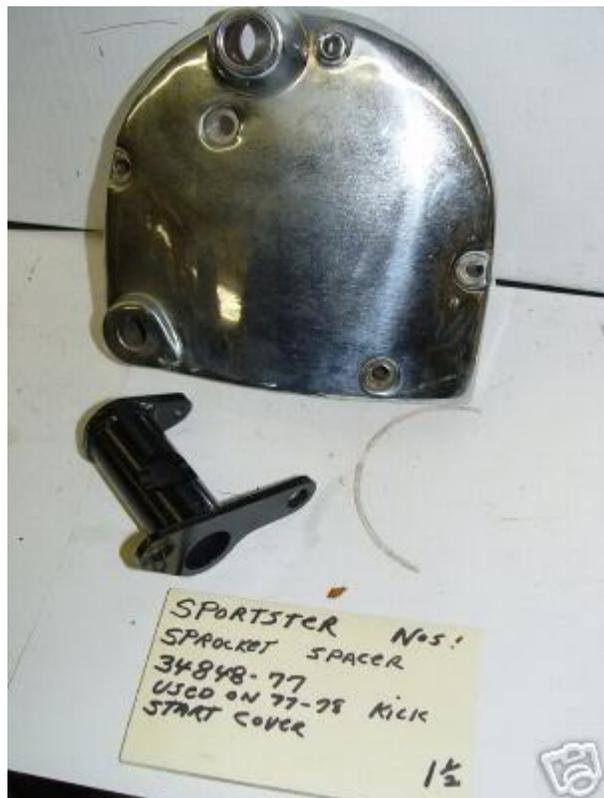
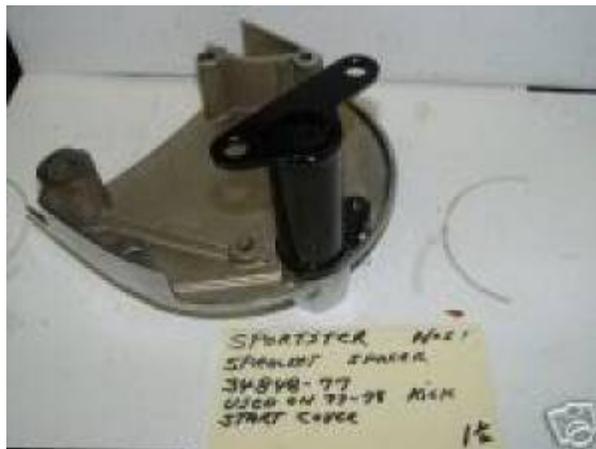
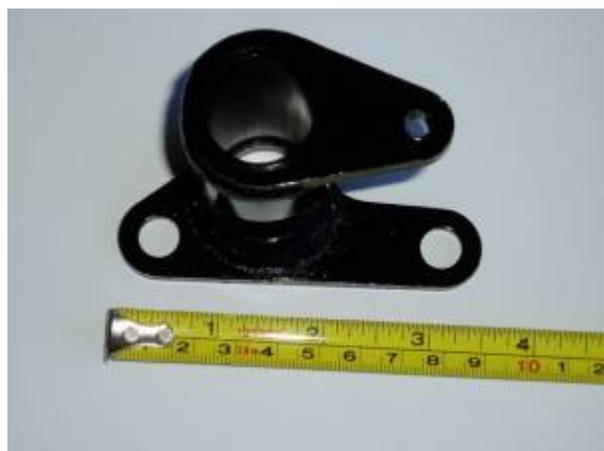
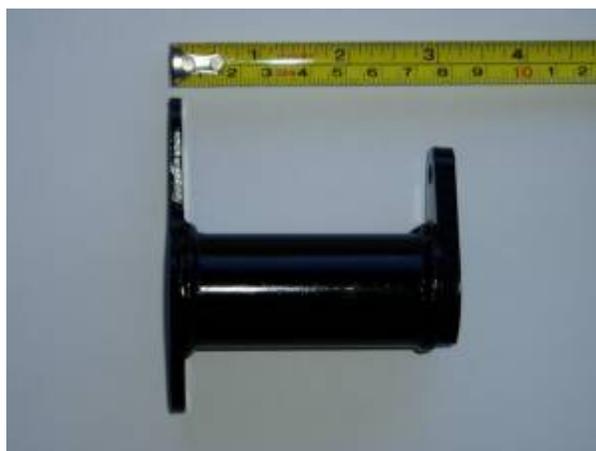
**Pics: The "spacer" as HD calls it.**

This little bracket is the cure for broken sprocket covers and mountings on kickstart 1977-1978 models. It is standard equipment on 1978 kickstart models and was issued by HD as a retro fix kit for early 1977s. HD OEM part number for the spacer is (34848-77).

It would just take two pieces of flat steel strap and a piece of 3/4" water pipe, some drilling and some welding.

It basically bolts to the two rear engine mounting studs and sticks out around the kicker shaft so the cover can bolt to it.

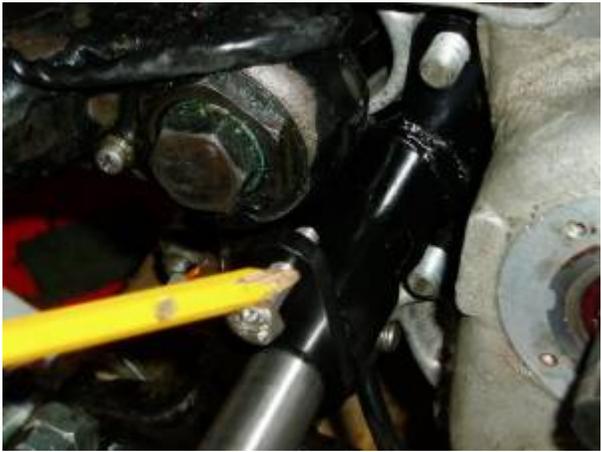
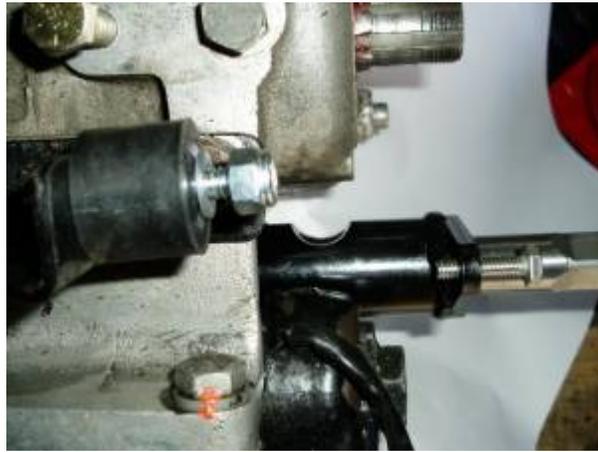
Note the 1/4" bolt, pointed to, goes through the sprocket cover.

Nuts are yet to be put back on the rear engine mount bolts.

Looking straight down from on top, there is a divot ground in the tube where the rubber oil supply line will go.

The bracket itself seems good and solid. The tube is thick walled so will not flex.

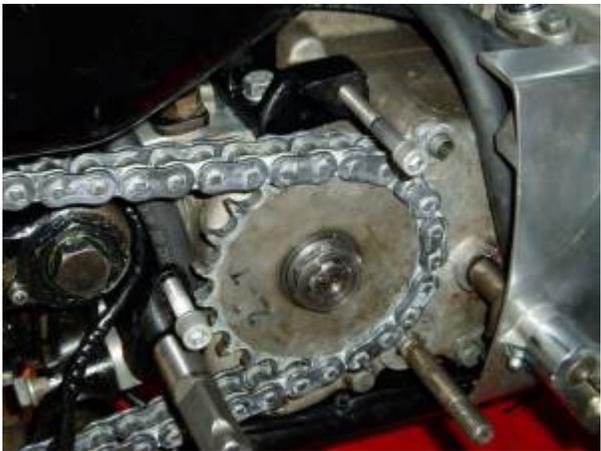
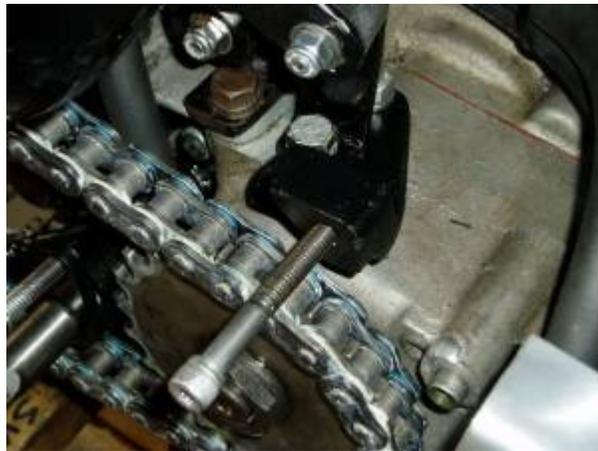
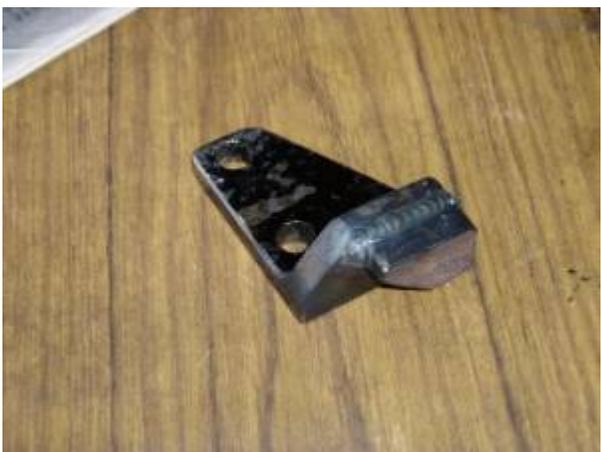
And here is the factory support bracket fix kit in place around the kick starter shaft.

Also my extra support bracket on top of the gearbox casing, ready to bolt the sprocket on when it arrives and then the cover.

Third pic is of the top bracket before I drilled and tip it in position.

Nice welding job by my aircraft welder buddy there.

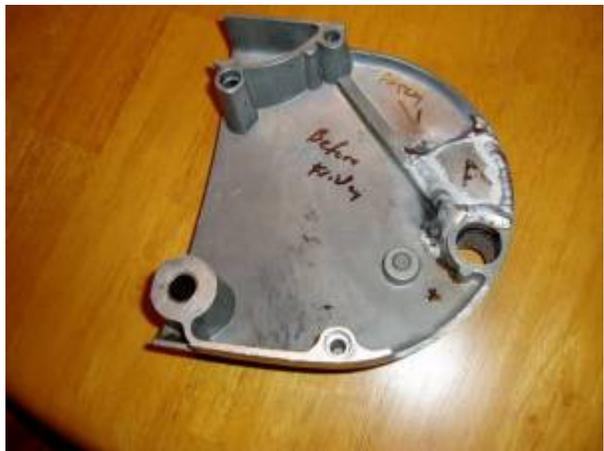
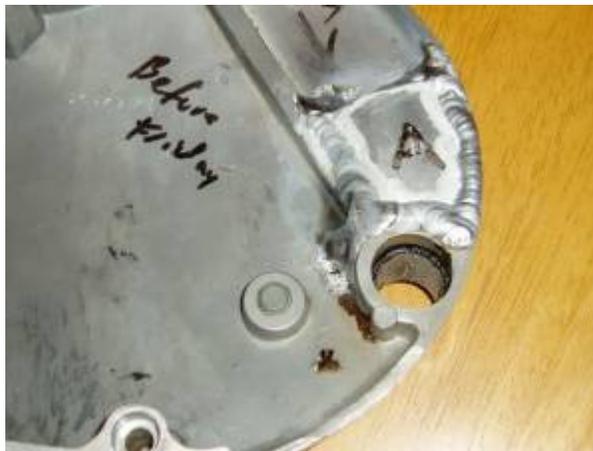
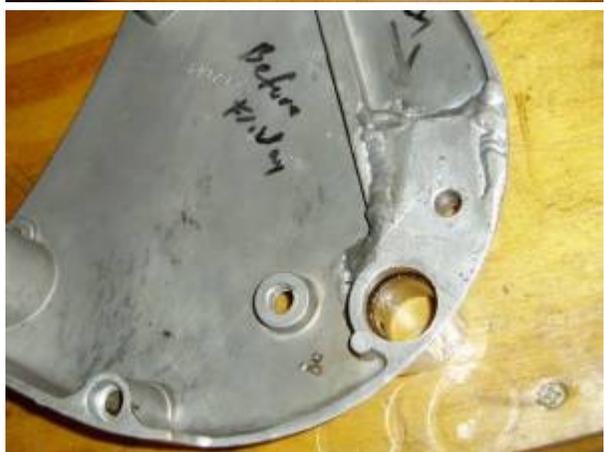
I shaped and had welded a piece of a 3/8" aluminium plate inside the sprocket cover.

And then drilled a hole for the spacer bracket mounting bolt to go through.

Third, pic: the modified sprocket cover, welded, filed down and drilled to suit the factory support bracket spacer.

Covers before mid-77 will need this attachment point. Aftermarket covers for 77-78 will have this standard.

It is easier to just buy an aftermarket 1978 sprocket cover, it already has this in place.

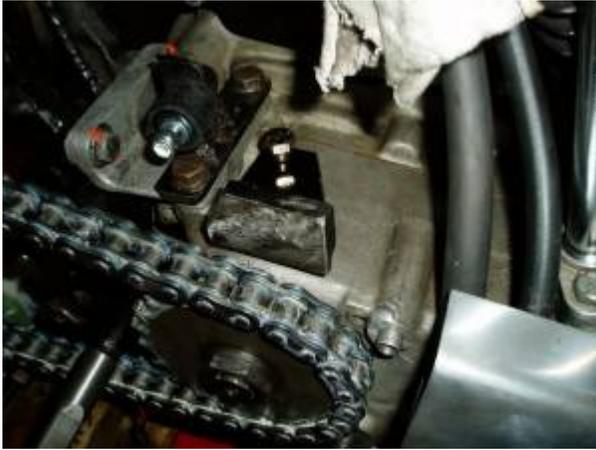
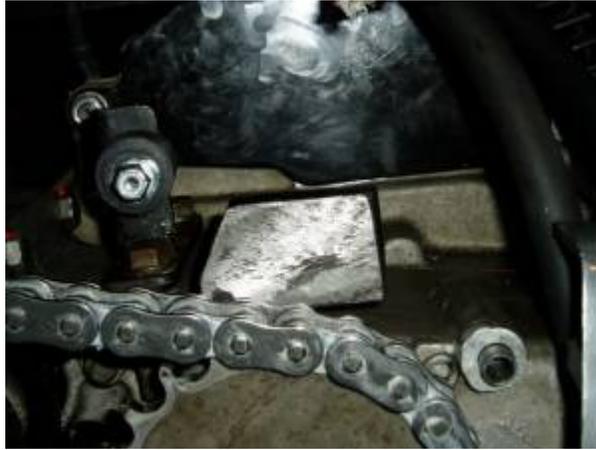
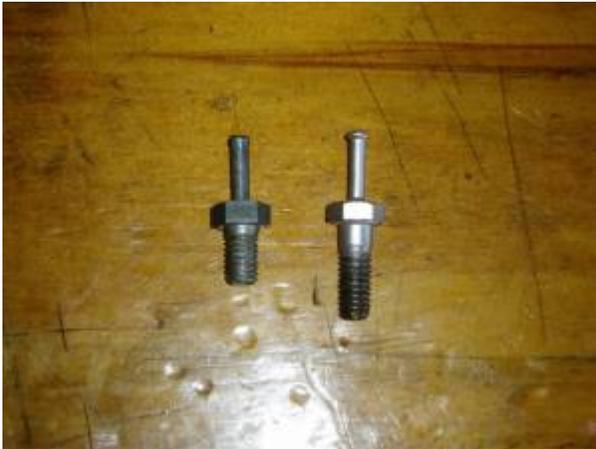
Then I made a big extra angle bracket to go from the bolt holes on top of the gearbox, over to support the top bolt on the sprocket cover.

(which I enlarged to 5/16" to make it stronger)

Make sure it has the bit sticking out at the top so the angle does not hit the chain.

I also had to make an extended gearbox breather fitting to allow for the bracket being fitted underneath it.

It is just a bolt with a hole drilled in it and an old piece of metal brake line silver soldered in.

As well as this, I had my gearbox casing welded up and redrilled the wrecked original dowel holes, but I reckon that with these two brackets, that step might be optional.

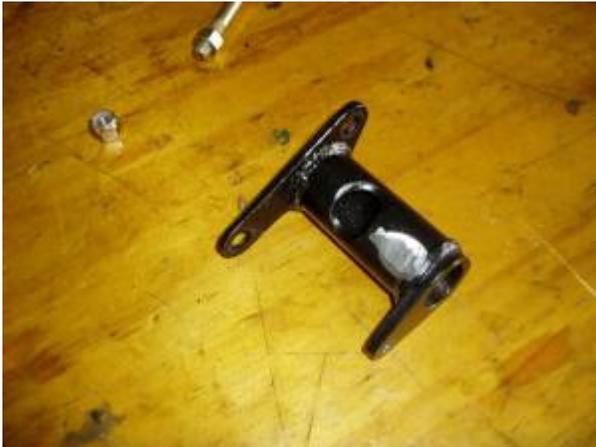
17)

And I did have to grind a little clearance on the factory spacer to allow for the oversize 22-tooth sprocket.

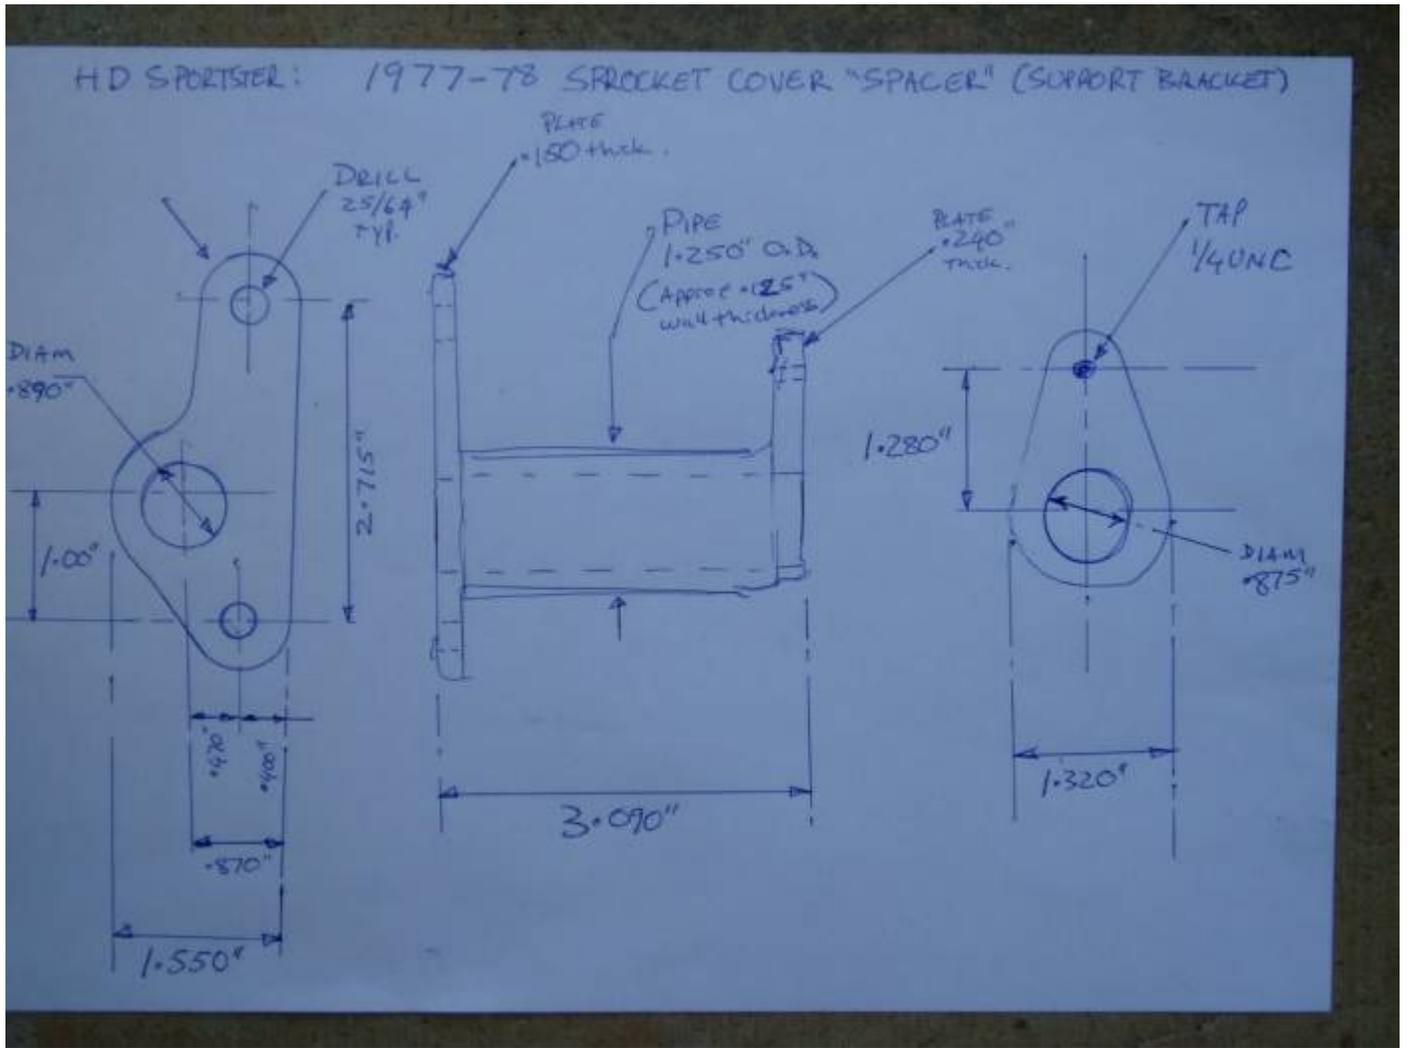
### **Dimensions of the spacer:**

A rough sketch I made by laying the part on paper and drawing around it, then measuring up.
