IH: Engine Mechanicals - Sub-01F

Ironhead Transmission Sprocket Cover Pics

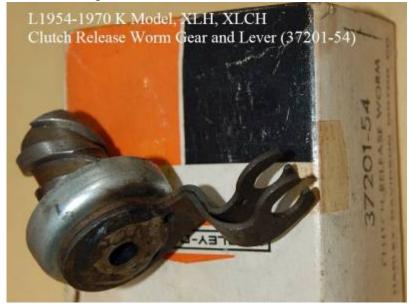
Clutch worm gear (37200-54) was used on 1952-E1954 K Models.

Clutch worm gear (37201-54) was used from L1954-1970 on K Models and Sportsters.

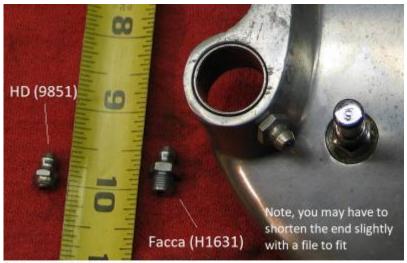
1957-1970 Sportster

The fitting below is a Facca (H1631) straight grease fitting that was slightly shortened with a file.

The extra length/thread on the shank doesn't strip out under pressure from your grease gun.

sprocket cover grease fitting alternative

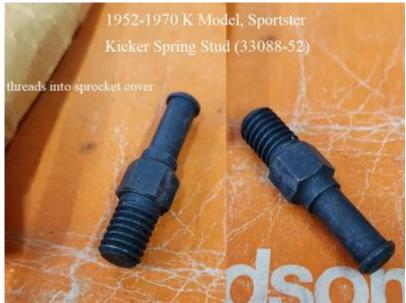
The stud threads into the hole in the sprocket cover to the right of the starter shaft hole. Hd sold several versions of the stud including parkerized, nickel, zinc and chrome.

The first was parkerized, part# (33088-52) for 1952-1970, then 1971-1978 was zinc, part# (33088-71) and 1979 version was chromed (33088-79).

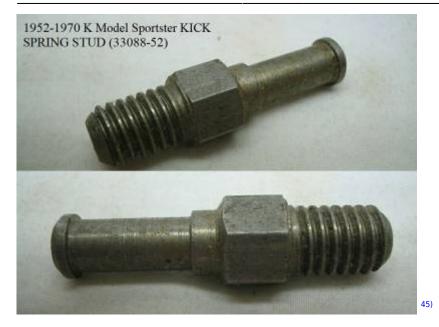
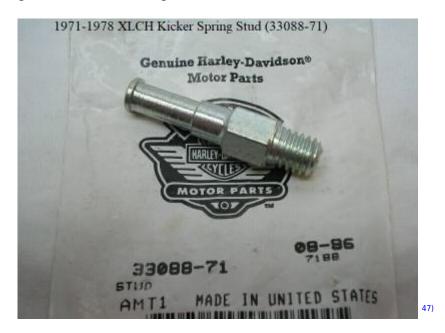
The 1971-1979 stud was lengthened from the earlier version. The area between the spring retention groove and hex is longer. $^{46)}$

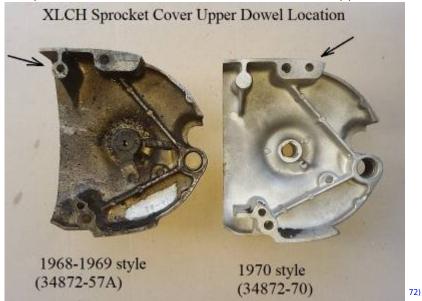
The pic below shows the different location of the upper dowel between the 1969 and 1970 XLCH covers.

This is the first version, uses the same 74-52B casting as the 68-69 version. 73)

First one was factory fitment on some/all 1970 XLCH. It has 1 upper dowel pin hole in the rear of the upper cover attachment bolt.

The second version is machined for 2 upper dowel pin holes, 1 in front and 1 in the rear of the cover attachment bolt;

Rear dowel location is for use with kick only using electric start cases and dry clutch. (ie 70 XLCH). Front dowel location is for use with earlier kickstart only cases.

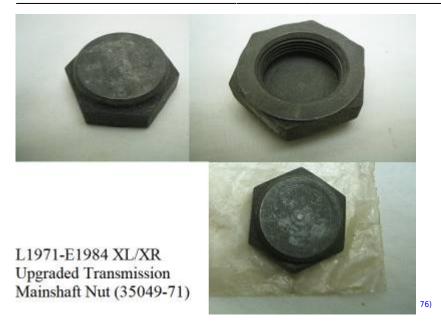
A service replacement mainshaft sprocket nut (35049-71) was developed to prevent transmission oil leakage from the sprocket splines on 1971-E1984 models.

The new sprocket nut encloses the end of the mainshaft and provides a metal to metal seal between the sprocket, lockwasher and nut when tightened to 35-65 ft-lbs.

To use this nut on 1981-E 1984 models, it's necessary to remove a portion of the cover to prevent interference between the nut and the cover.

So you may find some used factory covers that appear to have been hogged out for this purpose. On 1977-1978 models with inner sprocket cover (34893-75), it is necessary to open up the 0.88" opening in the cover to 1.75".

On 1979 models with inner cover (34899-79), a 1.75" diameter hole must be located and drilled as shown in the service bulletin.

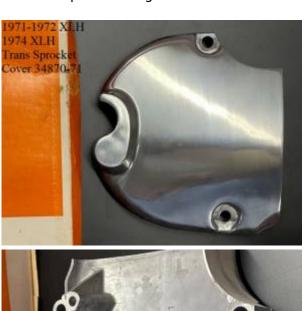
1971-1972 XLH, 1974 XLH Cover

Sprocket Cover (34870-71), polished, without kick starter. Click on a pic to enlarge $^{77)}$

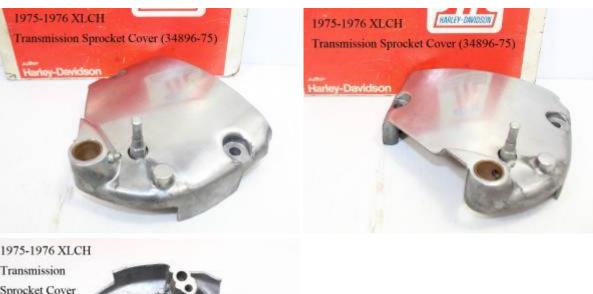
1975-1976 XLCH Cover

Sprocket cover part# (34896-75), polished, with kick starter. Casting number is (34879-71A). Click on a pic to enlarge: 83)

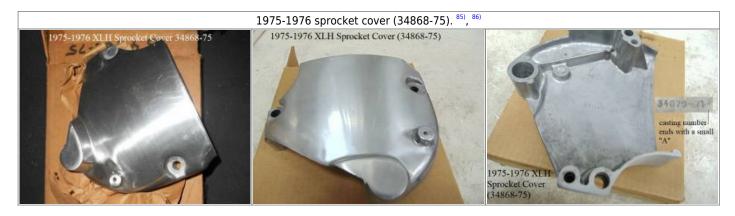
1975-1976 XLH Cover

Sprocket cover part# (34868-75), polished, without kick starter. Casting number is (34879-71A). Click on a pic to enlarge: 84)
