## Diagnosing Oil Consumption

## Valve Seal Updates

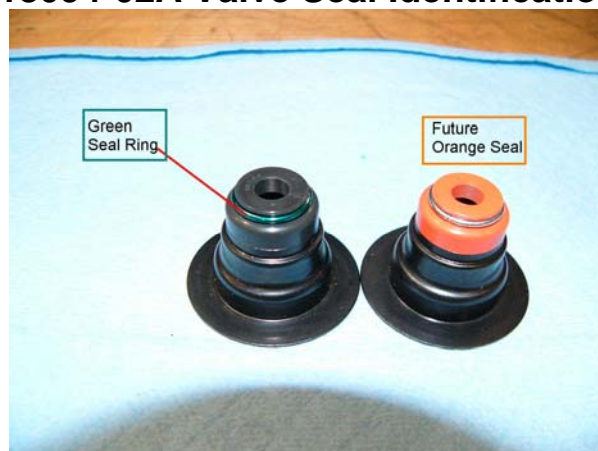
### 18094-02A Valve Seal Identification

- The first batch of this new seal can be identified by a green seal ring as shown below. Towards the end of the month 18094-02A seal kits will change to an orange colored rubber material to improve visual identification of the new parts.

- A new version one-piece valve seal and lower spring seat design (p/n 18094-02A) is being implemented into service parts to improve sealing properties and minimize installation issues.

- Please utilize this new design during any future top end services.
