Dyna Ignition Switch/Fork Lock

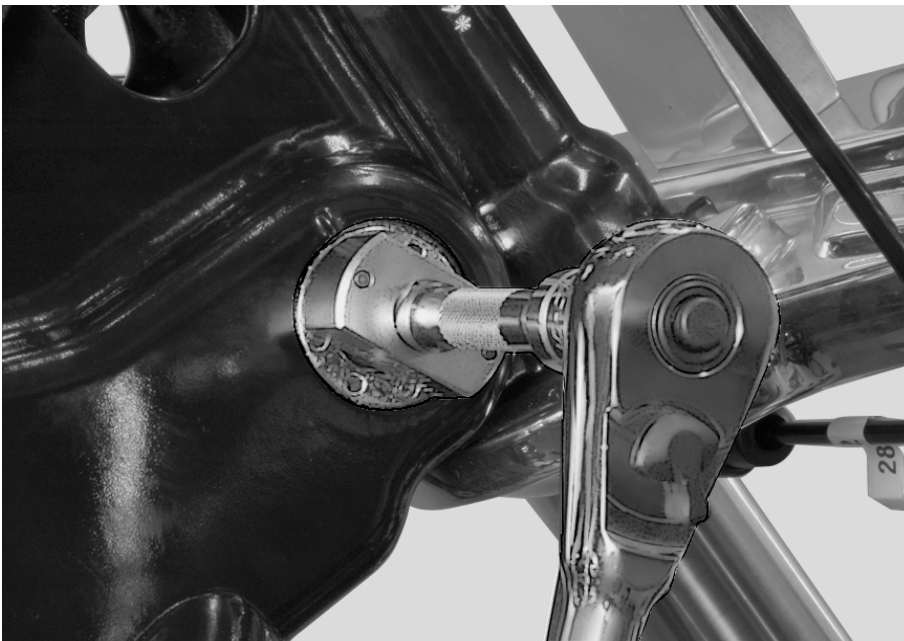
It is recommended that during servicing of any 2006 Dyna that the fork lock operation is inspected. If it is found that the fork lock is not working correctly due to the pin not aligning to the lower tree the lock retaining nut should be removed per the service manual procedure. Reinstall the nut per the Service Manual, make sure the fork lock pin aligns with the slot in the lower triple tree and apply a couple of drops of blue Loctite to the threads of the nut. If this is done it will require a new decal part# 14130-06 be applied on the FXD 35th and Wide Glides or part# 14117-06 decal for the other models. If a repair needs to be done a warranty claim can be filed using labor code 8888 for 0.2hrs in the Event Detail only of the claim.
