2008 Touring Model Accessory Handlebar Installation

TT336 – September 4, 2007 – 2008 Touring Model Accessory Handlebar Installation

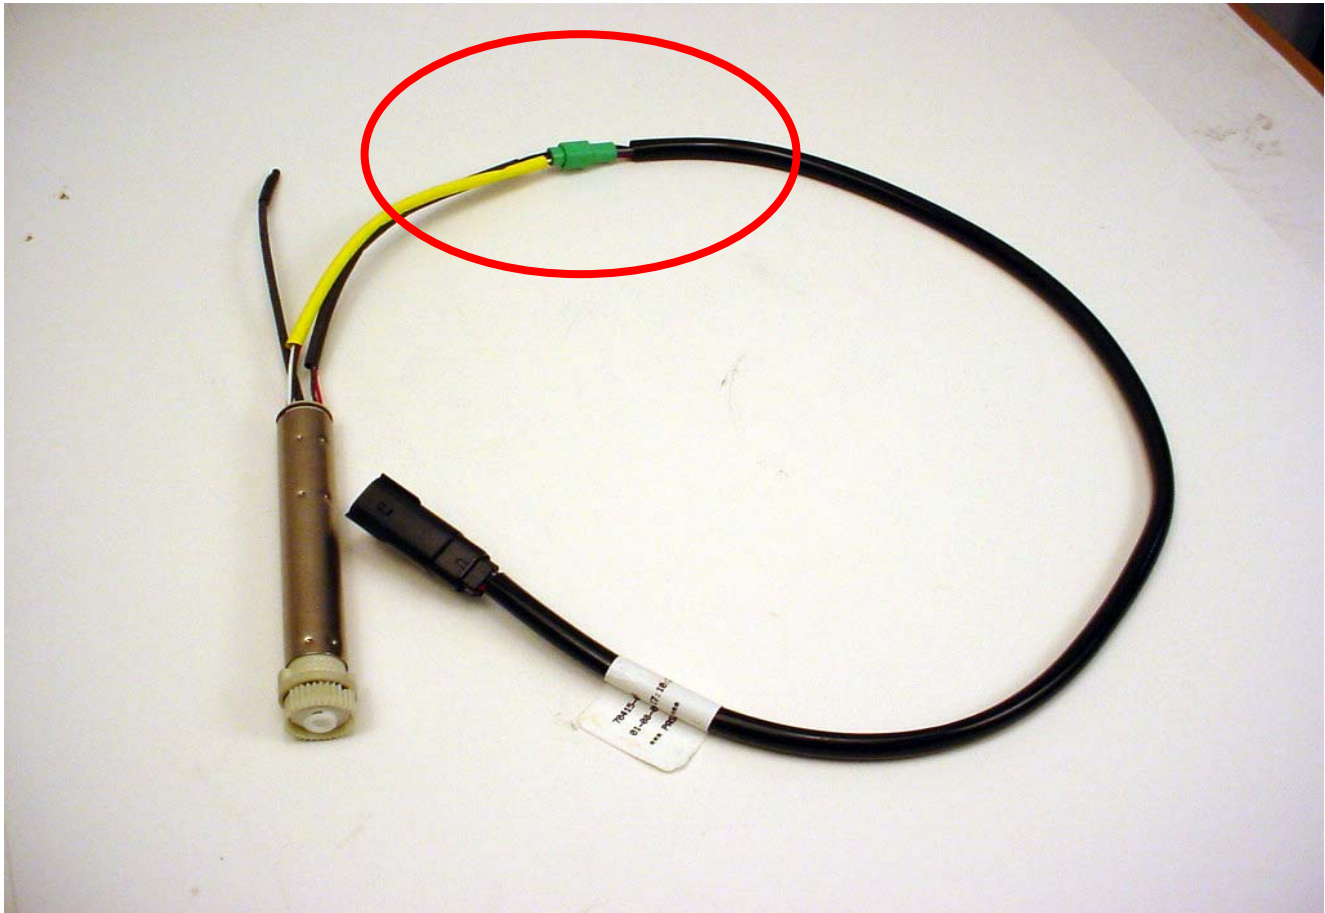
The connector shown below is not serviceable, the TGS or TGS harness would need to be replaced if this connector is damaged. The 32310-08 TGS does not utilize this connector.

TGS part number 32305-08 is used in conjunction with TGS Harness p/n 70415-08 (shown in the picture below). This combination of parts is used on all Touring Models with **externally** wired handlebar switches:

The connectors between these two arrangements are different and not interchangeable, nor serviceable at the dealer level.

We advise against splicing or repairing the TGS or TGS Harness wiring in any way. This type alteration may impact the circuit's integrity or result in drive issues.
