2008 Touring Model Accessory Connector Location

Some early versions of the 2008 Touring Owner's Manuals (part # 99466-08) have the Accessory connector incorrectly pointed out on pages 73 and 74. Refer to the correct picture below.

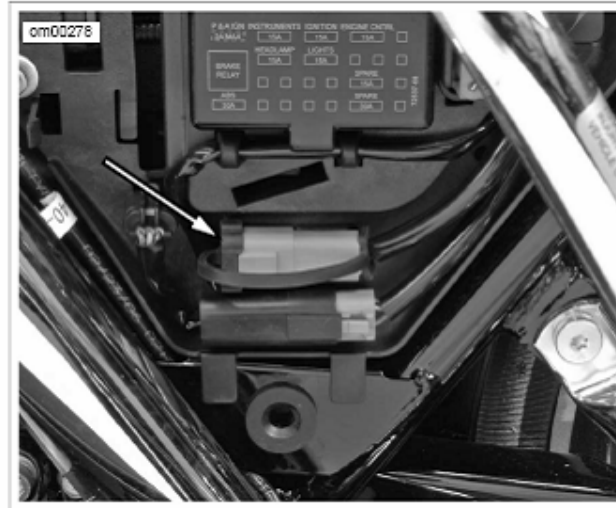
Figure 21. Accessory Connector

In the **INCORRECT** picture the arrow is actually pointing to the GRAY data link which is under the fuse box.

INCORRECT

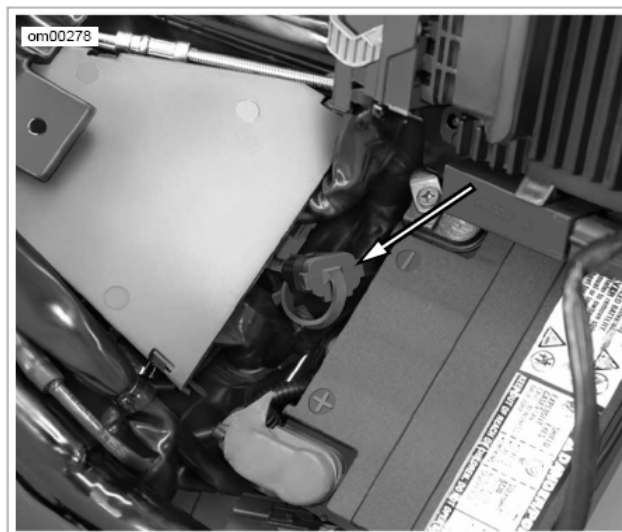
CORRECT

In the **CORRECT** picture the arrow points to the BLACK accessory connector located in front of the battery. This location is the same as previous years.
