Destroyer Replacement Piston Markings

Use caution when servicing top end components on the Destroyer model as some pistons may be marked incorrectly.

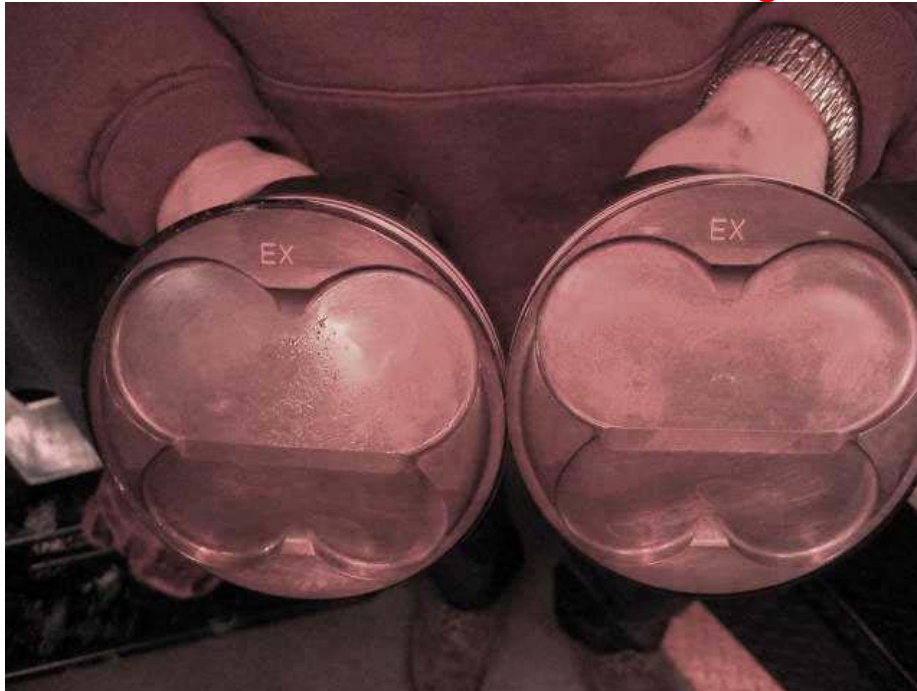
The high compression pistons used in the VRXSE have clearanced areas machined in to allow clearance to the intake and exhaust valves at full lift. Note the piston orientation markings on the pistons in the image. The portion of the piston crown marked “EX” for exhaust is incorrectly marked and obviously on the side of the piston designed to receive the larger diameter intake valves.

Incorrect Piston Orientation Markings

The pistons can be used, just remember when installing pistons that have been incorrectly marked, to position the larger valve reliefs in the piston crown towards the intake side, and the smaller fly-cut areas go towards the exhaust.
