## REF: General-MSR 07

# Diagnosing Catastrophic Engine Failure in Evo Engines

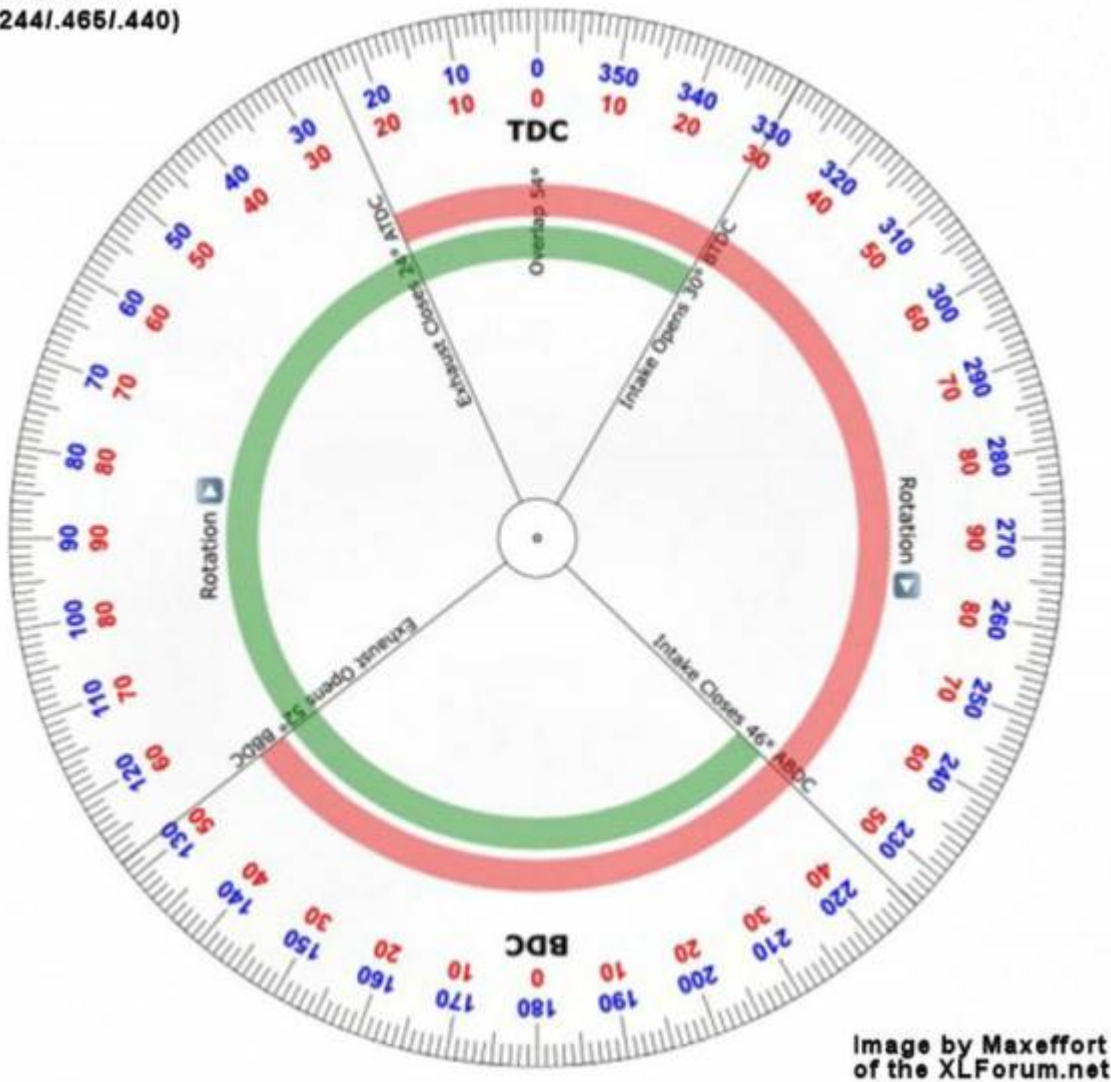
**Andrews N4**  
(240/244/465/440)

is exactly in the middle of each opening and closing times of each valve. You'll see in this drawing that normally, at TDC and BDC, max lift on the cams will not happen at either location.

Now with the pinion gear rotated 90° counterclockwise, the same exact opening and closing times happens in the valve train. Cam timing remained the same respectively but they just happen 90° later than they were originally. A notation was made on the drawing to mark the approximate point of max lift for each valve. There is more to max lift than just the valve opening. But this is for example only to illustrate where the highest lift might occur during TDC. As you can now see, max lift will occur at or near TDC. TDC happens twice per 1 revolution of the cam/valve opening. So in this example, the degree wheel below turns 2 full revs to make 1 full rev of each cam, thus valve train.

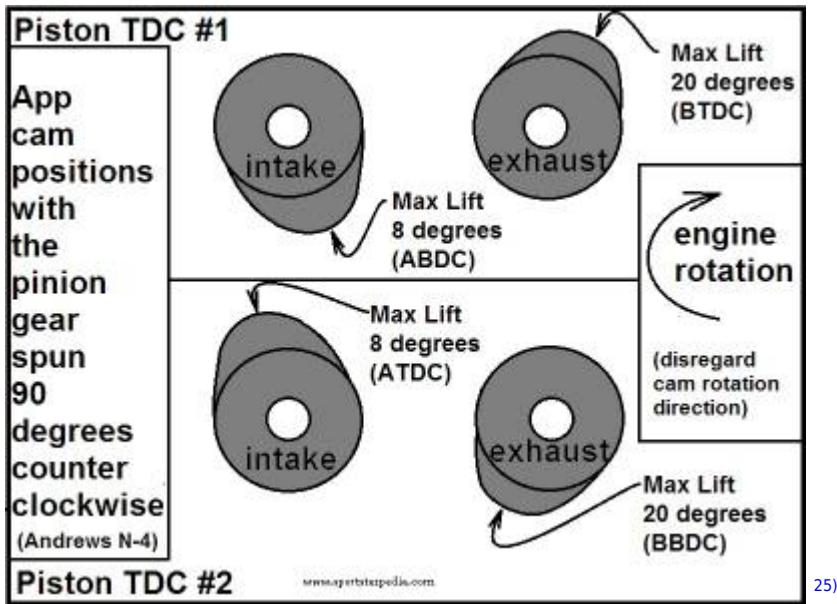
The drawing below is in conjunction with the drawing above to visualize cam lobe positions. Disregard cam rotation direction as the drawing is showing cam lift / valve opening. This is simply to show which direction the cam lobes face in the spun pinion gear scenario.
