## REF: General-MSR 07

# Diagnosing Catastrophic Engine Failure in Evo Engines

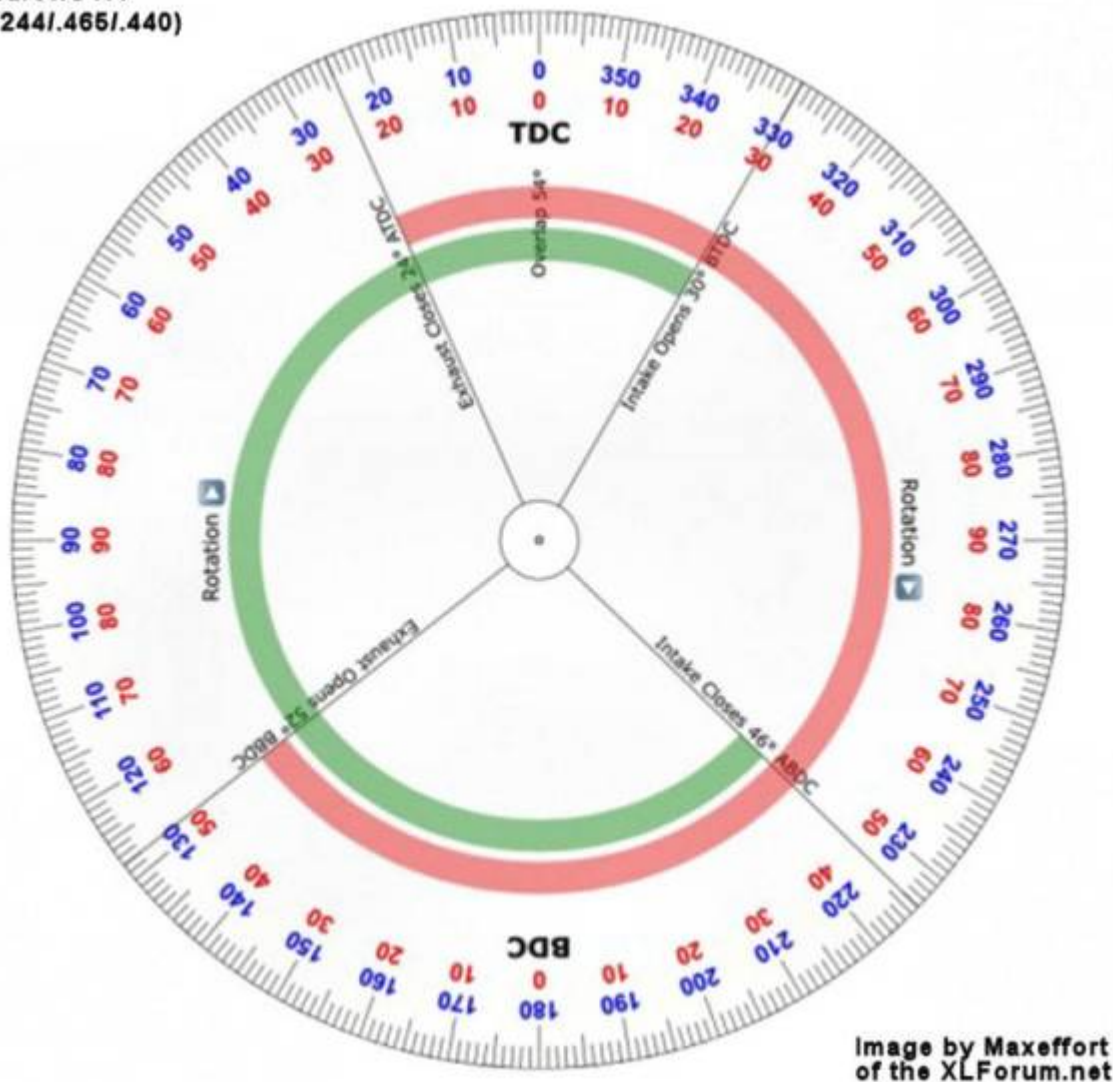
**Andrews N4**  
(240/244/465/440)

You'll see in this drawing that normally, at TDC and BDC, max lift on the cams will not happen at either location.

Now with the pinion gear rotated 90° counterclockwise, the same exact opening and closing times happens in the valve train.

Cam timing remained the same respectively but they just happen 90° later than they were originally. A notation was made on the drawing to mark the approximate point of max lift for each valve.

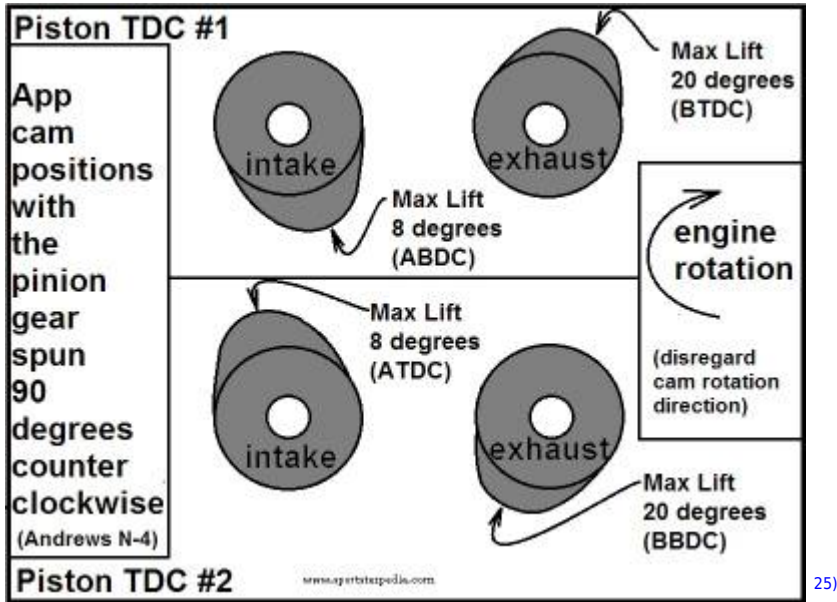
The drawing below is in conjunction with the drawing above to visualize cam lobe positions. Disregard cam rotation direction as the drawing is showing cam lift / valve opening. This is simply to show which direction the cam lobes face in the spun pinion gear scenario.
