TECHNICAL TIPS #27  
OCTOBER 1991

\* SPORTSTER MODELS \*

1992 CYLINDER HEADS & HEAD BOLTS

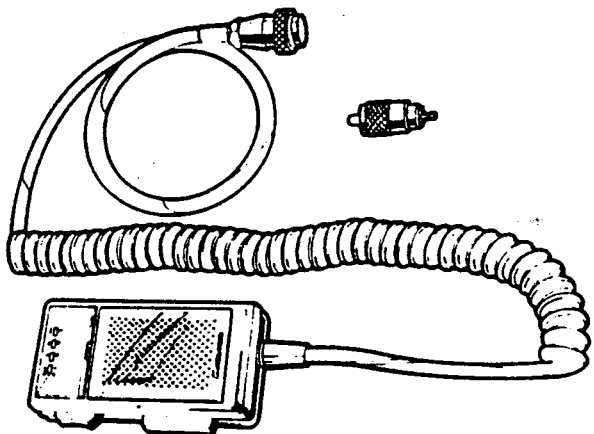
## CB POD/ TRANSCIEVER TEST TOOLS

The 1992 Essential Tool Package included two new tools for quick and accurate diagnosis of CB pod and transceiver failures. Instructions for using these tools are included in the 1991-92 FL Service Manual. Separate instructions were not included with the tools. Our technical staff and

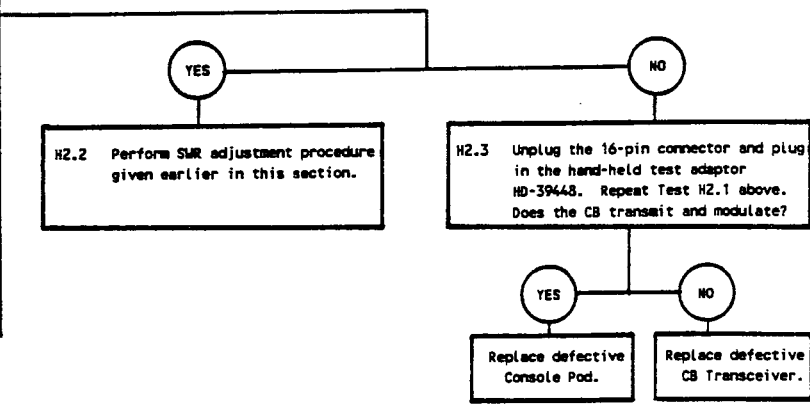
CHART H-2

CB will not transmit

Perform troubleshooting given in Charts F-5 and F-7 before proceeding with H2.1. This will insure that the CB is receiving the command to transmit.

H2.1 Disconnect antenna connector from CB and replace it with a dummy load, that is, the lamp included with tool HD-39448.

To use the load, screw the dummy load onto the antenna jack of the CB. Depress the PTT switch. If the CB is transmitting a carrier wave, the lamp should glow. Speaking into the microphone should cause the lamp to flicker. It should get brighter and dimmer depending on how loud your voice is. A change in lamp brilliance means the CB is modulating. Does the CB transmit and modulate?

The chart shown above is a portion of the troubleshooting procedures illustrating the tool's use. Examine your new Service literature carefully. Troubleshooting familiarity and proper tool usage will increase your efficiency.
