IH: Body Parts - Sub-01G

1973-1976 XLH, XLCH Sportster Frame Pics

1973 XL, XLCH Frame Reinforcement / Tail Lamp Mod

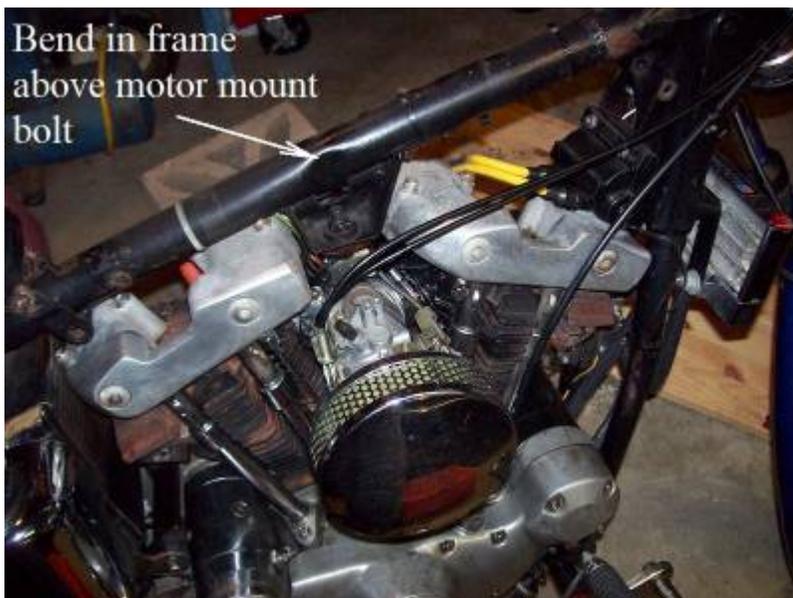
A bend in the frame backbone on the right above the motor mount bolt may be found on L1973-1976 Sportster frames and does appear to be factory induced.

It has been believed to be for easier access to the motor mount bolt but the threaded area around the right side petcock on the gas tank hangs down close to the bend in the frame.

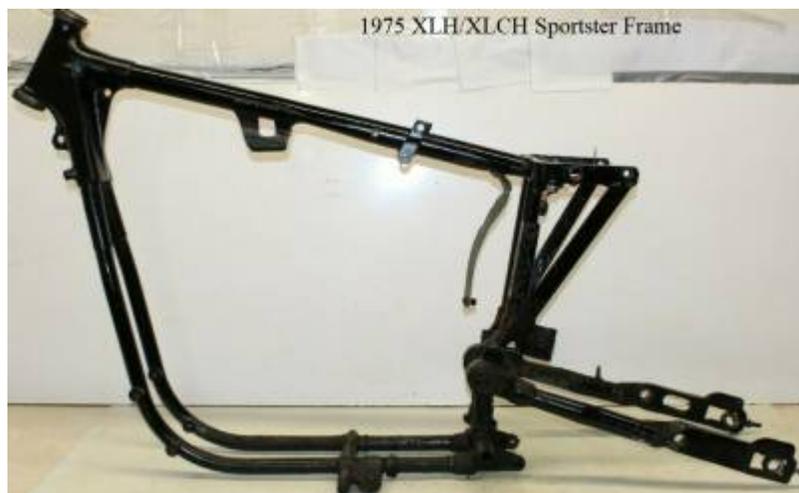
3)

The one frame fits both XLH and XLCH applications.

The left seat post has a "C" channel welded on the lower end for battery tray brackets (threaded holes on upper and lower end, 1 lower for XLH, both for XLCH).

There are 4 squared holes in the middle of the bracket for little plastic expansion nuts (70574-68) used to attach wiring terminals.

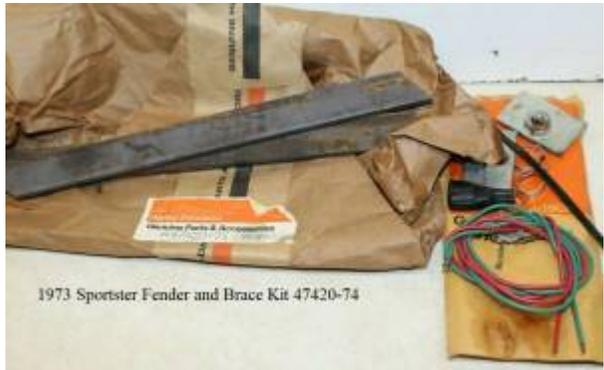
11)

A Frame Brace and Fender Support Kit (47420-74) was issued to make these changes. Below are contents of the kit.

Corrective modification was required to prevent possible breakage at the welded junction of the frame tubes and the rear fender and shock absorber support bracket.

The rear fender support attaching bolts were to be relocated to raise the fender rear end and provide more clearance between the tire and taillight wires.
