IH: Engine Control - Sub-01C

Prestolite Electronic Ignition System

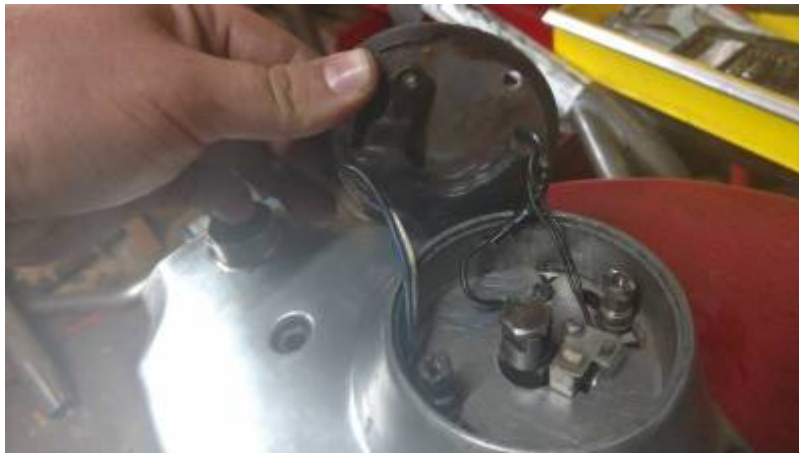
(1979) Upgrade to the breaker point system in which the mechanical points are replaced by a breaker-less electronic ignition on the camshaft. Timer has a rotor with one small lobe and one large lobe and a sensor that sends signal to the control module on the back of the timer inner cover. Rotor is mounted on a mechanical flywheel centrifugal advance like a point cam would be in a breaker point system. The rotor's small lobe fires the front cylinder and the large lobe fires the rear cylinder. ¹⁾1979 Ignition Module Assembly part number 32598-78 ²⁾.

- Make sure the ignition timer air gap is set as close as possible to the lower limit. Use a .004" feeler gauge to set clearance between the sensor and the trigger lobes per the FSM. Check both lobes to be sure they do not touch the sensor body. Review the FSM ignition section for other possible ignition system faults. ⁷⁾
