IH: Engine Mechanicals

Rocker Modifications

Rocker Box

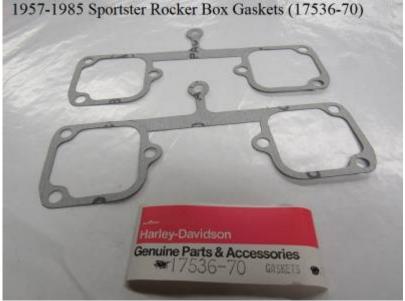
1957-1969 Sportsters did not come factory with rocker box gaskets. Instead, a layer of silver paint was applied between each rocker box and head for sealing. In 1970, a gasket (17536-70) was introduced and retros back to 1957 models. The same gasket is used on each rocker box (2 required).
