TECHNICAL TIPS #23
FEBRUARY 1991

ALL MODELS

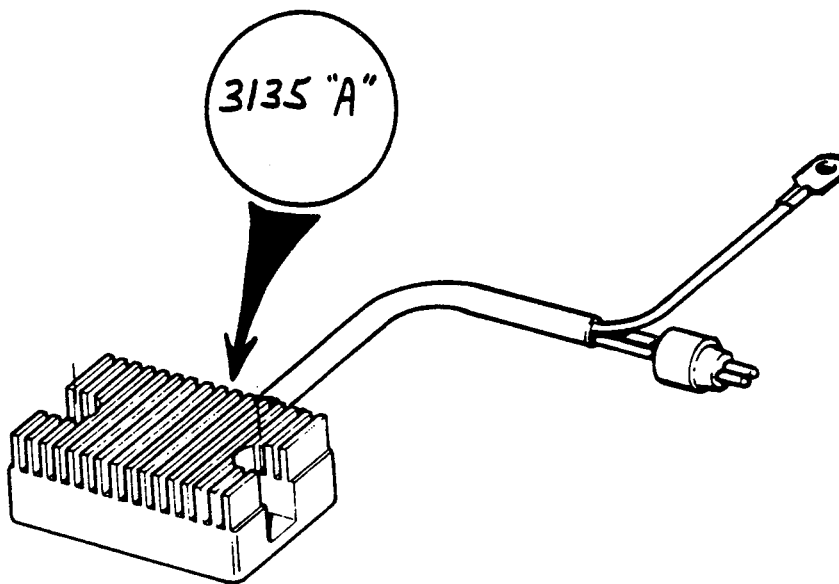
** An internal change has been made to the circuit board of all voltage regulators. This is designed to extend the life of the regulator's SCRs and greatly reduce regulator failures. The new regulators can be identified by the "A" suffix added to the regulator's date code, not part number. (Example: date code 3115 has become 3115A)

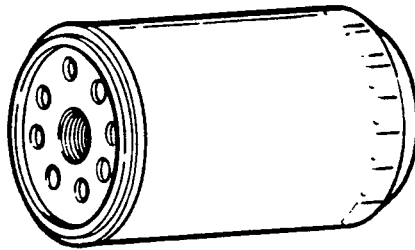
**** We've got a correction to the 1991 Dyna Glide Service Manual. When you're servicing Dyna Glide Sturgis models the oil filter should be tightened 2/3 to 1 full turn after the filter base contacts the mount. Short filters are still tightened 1/4 to 1/2 turn after base contact.**

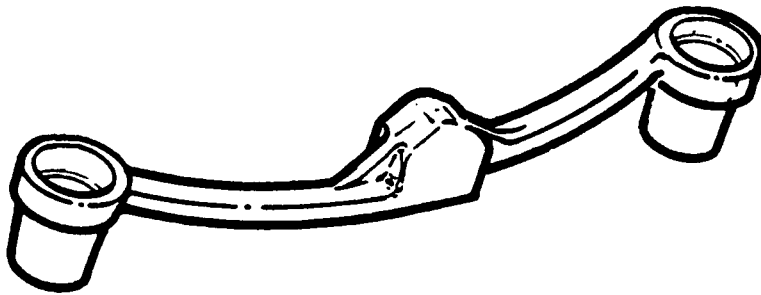
** The 4 speed Sportster transmission cam follower has had a material change. This will reduce wear and increase component life. Order the new part under part number 34063-84B.

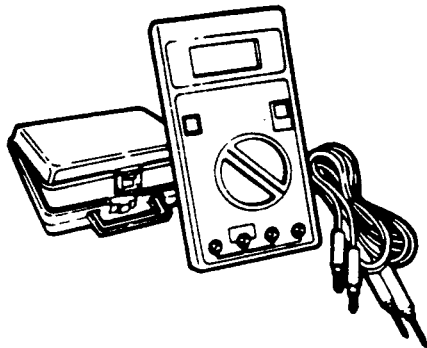
** Kent-Moore Tool has released the FLUKE 23 multimeter, HD-35500-B, as a replacement for the Sanwa meter. American made, the FLUKE meter has been recommended by our Service School instructors. The cost is \$139.00.
