REF: Service Procedures 11C

What Causes the 1991-2003 Shifter Detent Plate to Lean

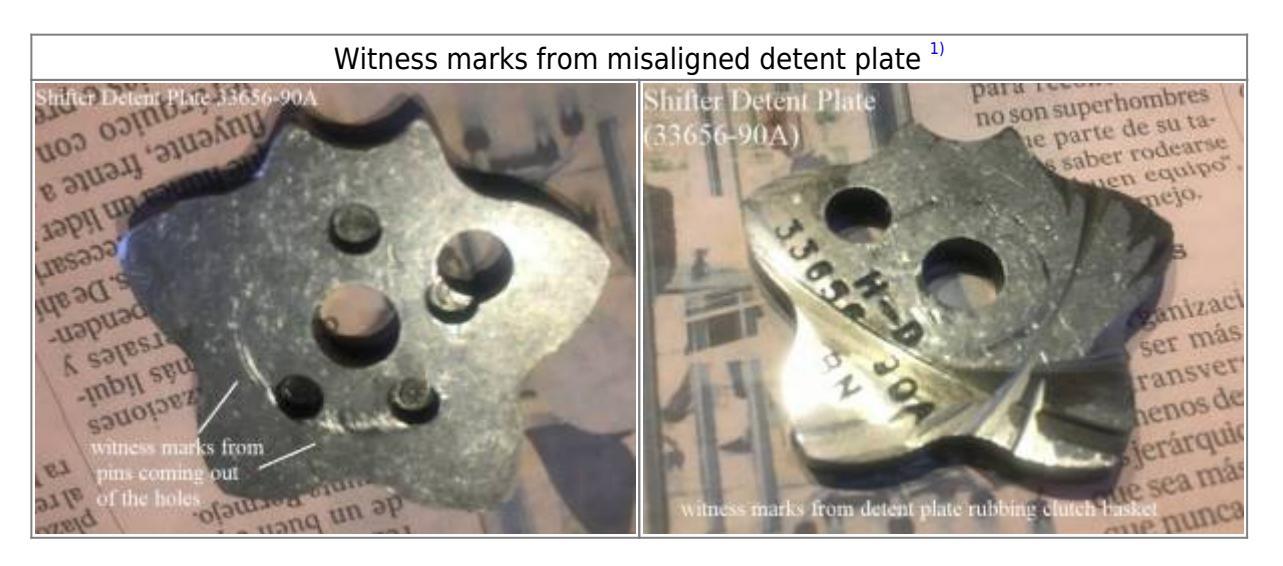
In the rear of the detent plate are 4 holes that slip over the four pressed in pins on the shift drum. The hole spacing in the detent plate matches the pin spacing on the drum.

The pins locate the detent plate (which installs in only one position) and they also posture the detent plate.

It's usually the shift drum pins walking out of their bore that leans the detent plate.

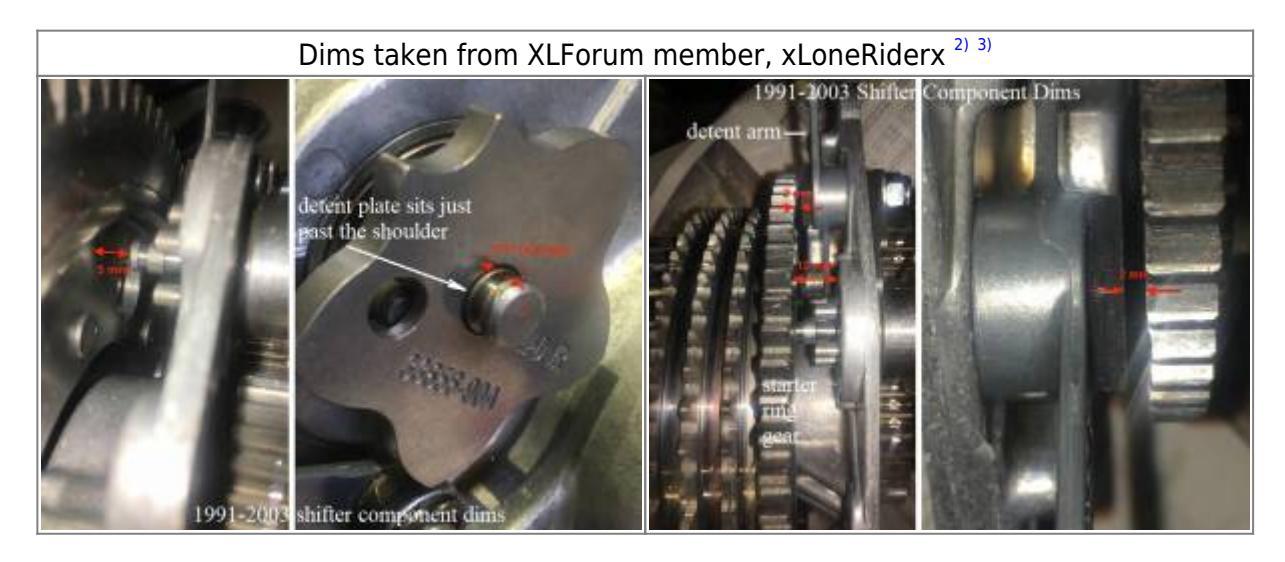
Normally there is a clearance between the detent plate and the clutch basket / starter gear.

And the detent plate roughly sits vertical to the starter ring gear.

The detent plates' vertical position is established by the length of the pins on the end of the shift drum. They should all be "home" and protruding the same length out of the drum (installed height .326" - .334").

However, since the space is so small between the plate and the clutch basket, a skewed detent plate can make contact.

The designed "slop", adverse conditions and wear can easily make the detent plate "kiss" the back of the clutch basket.

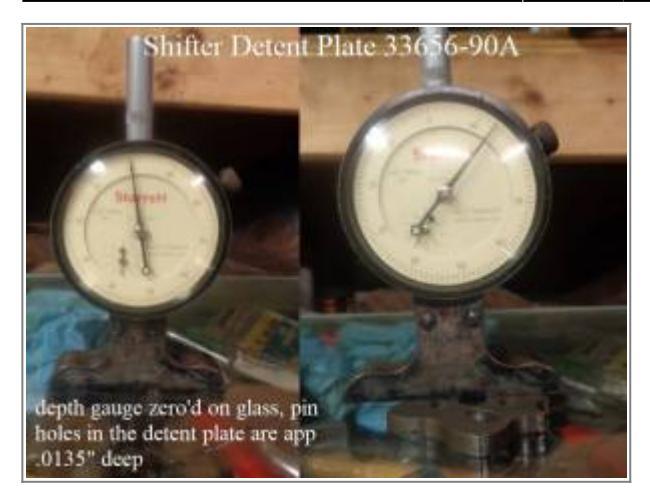
Detent plate pin hole depths 4)

With the shift drum being the strongest point, the load transfers to the clip which flexes outward. This "angle" pushing the detent plate can scar up the holes in the back of the it where the pins go in. The retainer clip allows the detent to move far enough off the pins to slap the holes when the plate returns.

You may have noticed marring around the those holes (which are not very deep to begin with). Depending on soft or hard shifting, shifter assembly wear, angle of the bike at the time, heat and vibration, that load can be more or less.

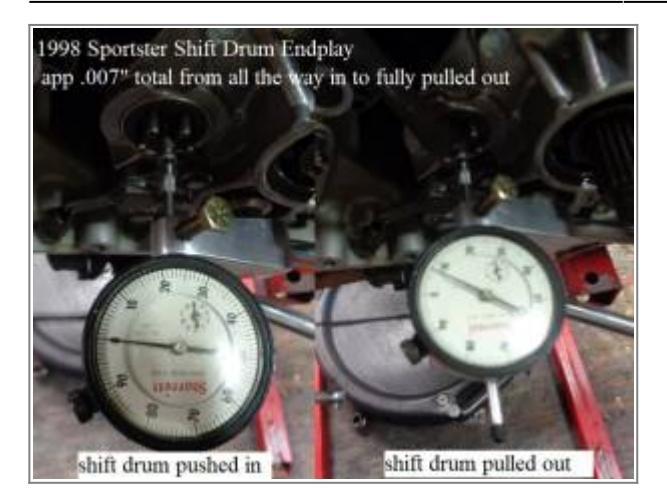
Shift drum end play ⁵⁾

The shift drum has end play as well.

The detent plate installs on the end of the shift drum.

With the drum itself able to shift axially (app .007"), the distance between the detent plate and the clutch basket will be variable within that range.

So a leaning plate may have a touch / not touch situation if the space falls within that end play.

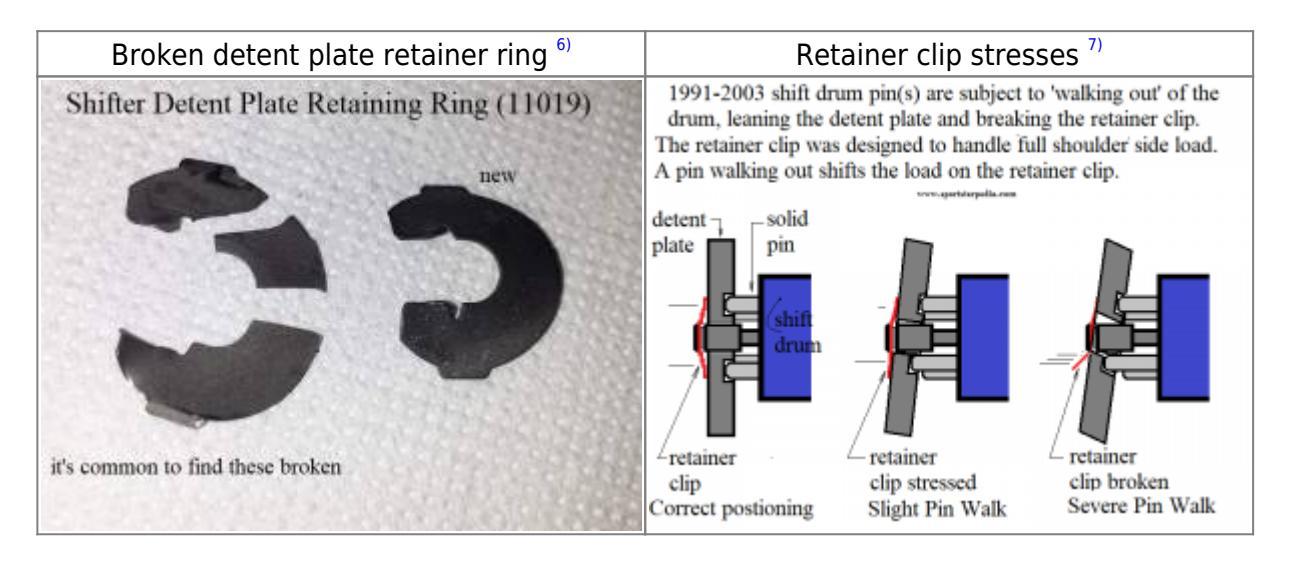
In this instance, the flex clip is being pushed backwards in circumference (like turning a sock inside out). And this will cause the clip to break sending it into the primary to chew and get chewed by tranny gears. The flex clip is made from spring steel and is meant to soften and return axial full body force (as in the detent plate pushing against it in a vertical position)

However, it is very brittle with forces trying to cup opposite ends and push them in reverse while holding the center still.

Likewise, if the detent plate is forced too far out on one side, that could also break the clip. In reality, there is very little clearance between the end of the shift drum and the starter gear.
