# **EVO: Engine Mechanicals - Sub-09A**

# Sequence of Installing Rigid Evo XL Motor Mounts

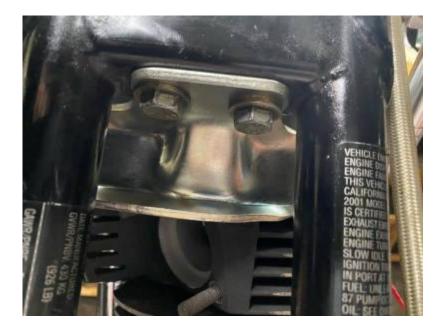
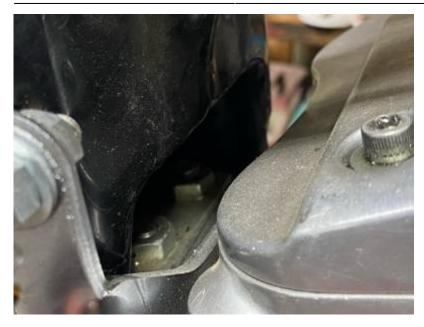
Here is how the upper front mount looks as installed.

The washers in the 1st pic aren't OEM matches but as you can see in the 2nd pic, that's Ok. 3)

- Factory bolts and washers: 4)
  - Bolts (4716W) 3/8"-16 x 1-1/4" Hex Head Grade 5
  - Washers: (6701) 3/8" x 13/16" x 1/16"

It is not suggested to leave it off. It adds rigidity to the entire engine/frame structure (and reduces vibration). 1)
  - Tighten the bracket to the head before you tighten the bracket to the frame to keep from introducing any additional stress. <sup>2)</sup>
- 4. Install the top center mount.

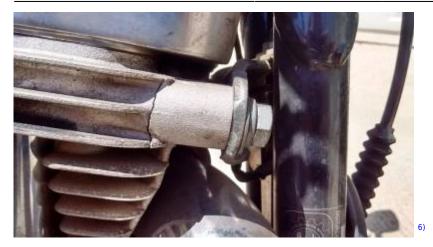
#### Cracked head at the front mount threads

Unfortunately, this is not an uncommon problem. It was especially a problem on Buells, which don't have a frame under the motor and therefore those two bolts were supporting the entire weight of the engine. But even on solid mount Sportsters, these cracks happen sometimes. The top end of the motor grows with heat and the frame doesn't grow near as much, so this spot gets progressively more stressed. Add in a little vibration and you can see the result.

The Motor Company pulled that bolt inboard on the Buell XB's in 2003 to get some more material around it and make it stronger. Then they did the same with the rubber mount Sportsters in 2004. So all the new heads have that bolt hole relocated inboard a little.

I've seen people cause this failure themselves, too, by using a bolt that's too long for the hole. Once that bolt bottoms in the hole, continuing to tighten it just pushes the threaded portion away and causes the failure.

As far as fixing goes, I've seen it hold up after welding, and I've seen it just crack again. So that's an iffy repair. The head needs to come off regardless and that vintage heads are generally pretty darn common and not expensive in the used market, so I personally would just replace it. But that's just me.
