EVO: Oiling & Lubrication

Oil Leaks

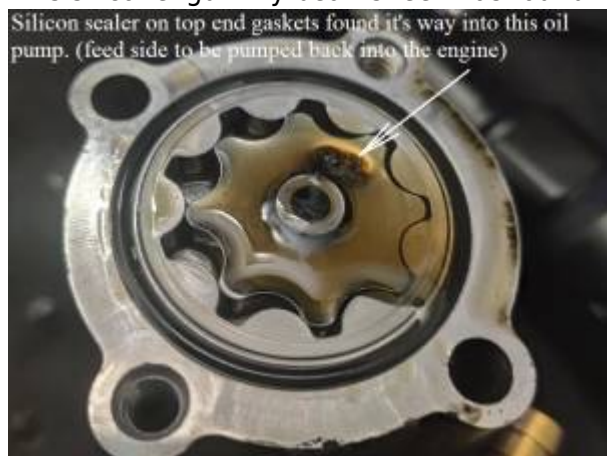
2)

In an instance where used silicone was used to seal the gaskets, pieces of silicone (or sheets) could be sucked in, stretched and broke off into the engine.

This silicone 'gummy bear' sheet was found in the oil pump.

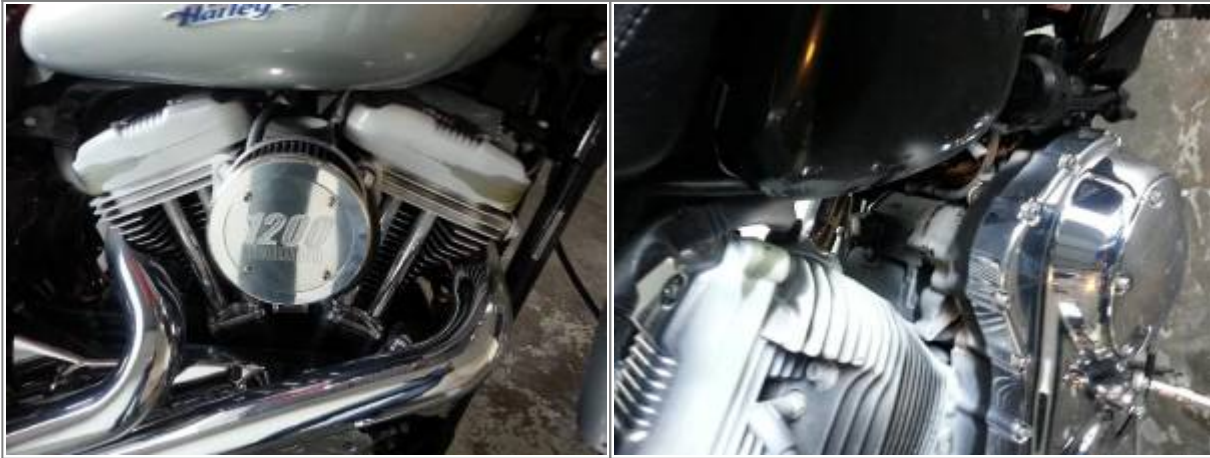
Rocker boxes sprayed with powder antiperspirant to detected oil leaks. ⁸⁾

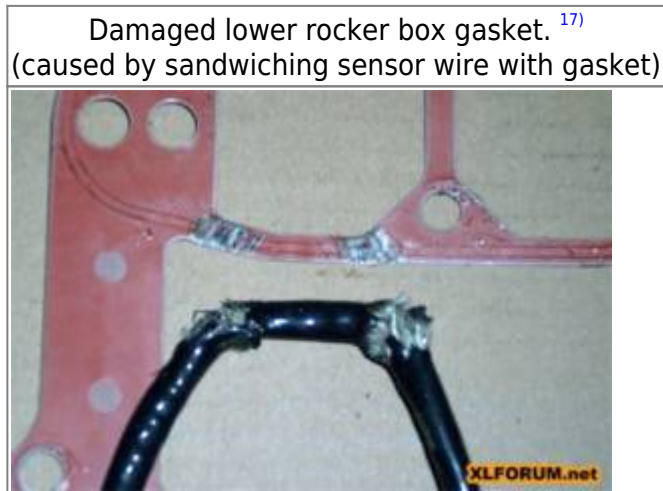
The fiber will still seal until the whole OD is curled up or the thickness gets small enough to loosen the torque on the bolt.

This may be one example of how rocker box bolts get loose by themselves.

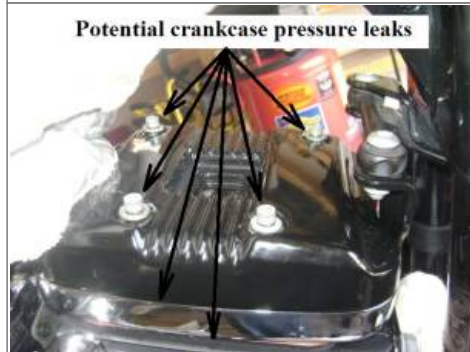
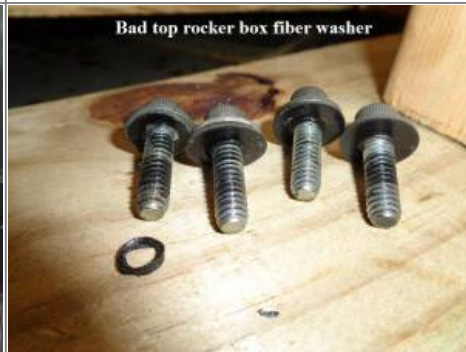
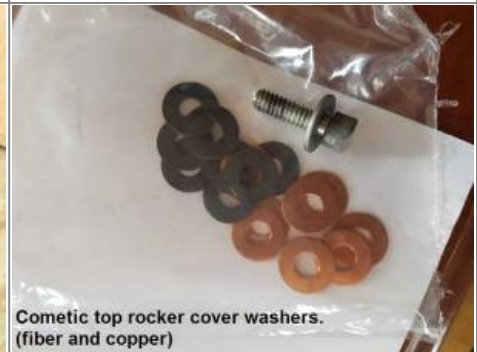
Potential oil leak areas of rocker boxes. ¹⁸⁾ Fiber washers will crush in the center and leak around threads due to excess vacuum. ¹⁹⁾ Replace the washers with new OEM ones. Or consider swapping to copper washers. CHECK BREATHER VALVES ALSO. ²⁰⁾

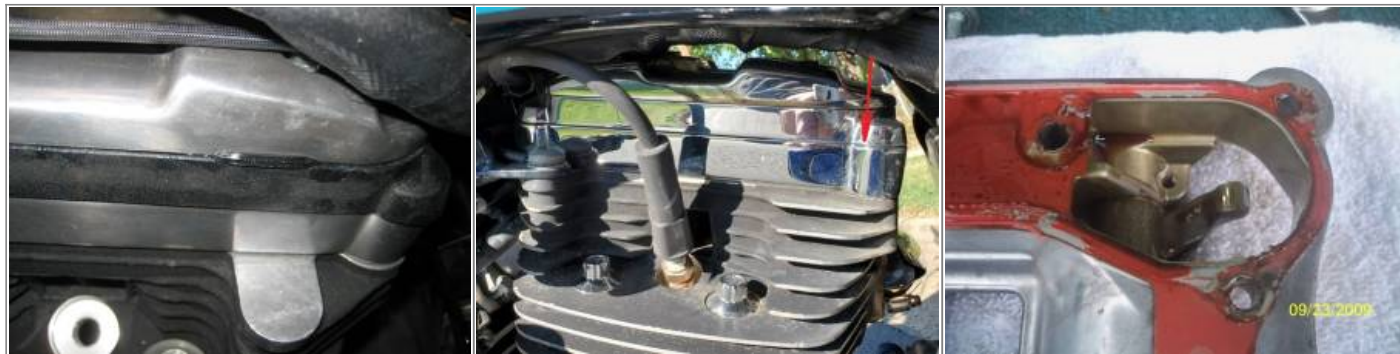
Leak with pinched gasket. ²¹⁾
(can cause crankcase pressure problems)

Leak with non pinched gasket. ²²⁾
(can be caused by crankcase pressure problems)

Worn / leaking HD lower gasket. ²³⁾
(can be caused by improper torque)

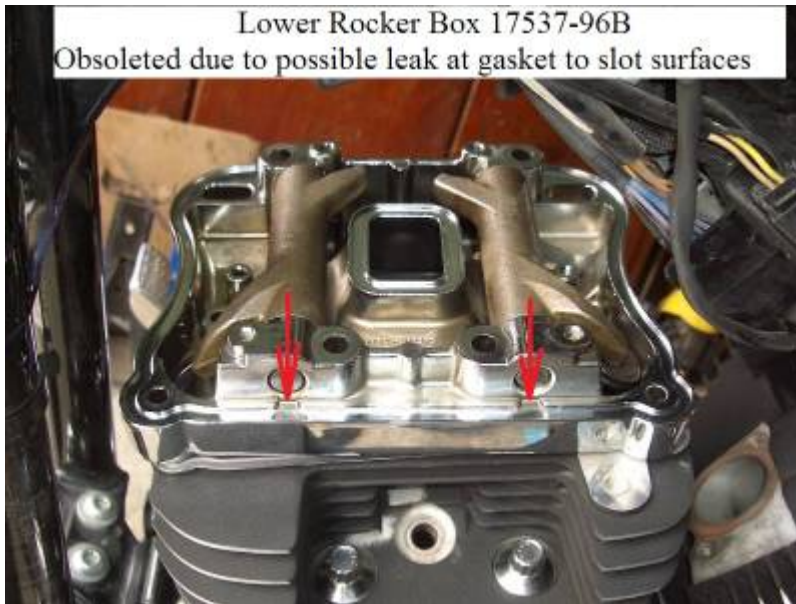
25)

- **Examine the inner rocker box gasket channel. If it has wide or narrow slots made into the gasket channel, it is the old design known for leaks.**
 - Part number (17537-96A) has wide slots.
 - Part number (17537-96B) has narrow slots.
 - The newer lower box (17537-96C), introduced 9-12-2005, does not have any slots there.
- **Replace the rocker cover gasket with the new style gasket (17353-89B).**

The new style gasket has square edges, whereas the old style gasket has rounded edges. The new replacement rocker box gaskets are different from the originals and have a Teflon or rubberized surface on both top & bottom faces. ²⁴⁾

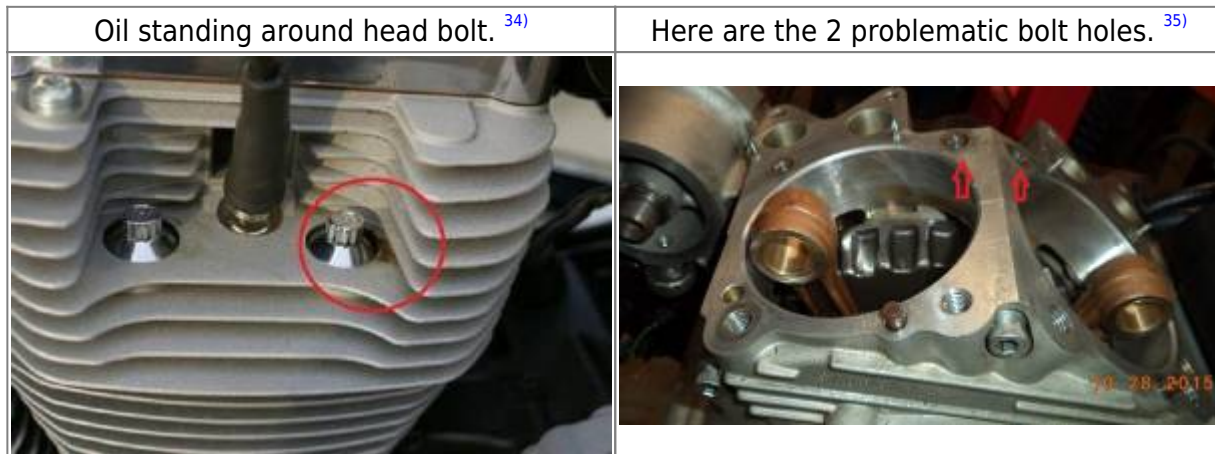
- Officially, a leaking head gasket should be replaced.
- **DO NOT try to simply tighten the head or rocker bolts that may be loose.** You will distort the cylinder head
Cylinder head fasteners should never be re-torqued on any Evolution engine. ³³⁾ All multiple bolt fasteners are required to be torqued in a cross pattern.
Likewise, simply tightening only the bolts that are loose will change the clamp load on the ones that are tight and not touched.
If you feel it's simply a loose bolt, loosen all the bolts on the rocker box / head / etc.
Then torque them back using the correct specs and tightening sequence.
- If one or both of the two center cylinder studs on the right side of the engine are loosening, backing out or stripped;
The fix is usually a helicoil or other thread repair insert into the case. See [Cylinder / Head Bolt Issues and Repair](#) in the Sportsterpedia.

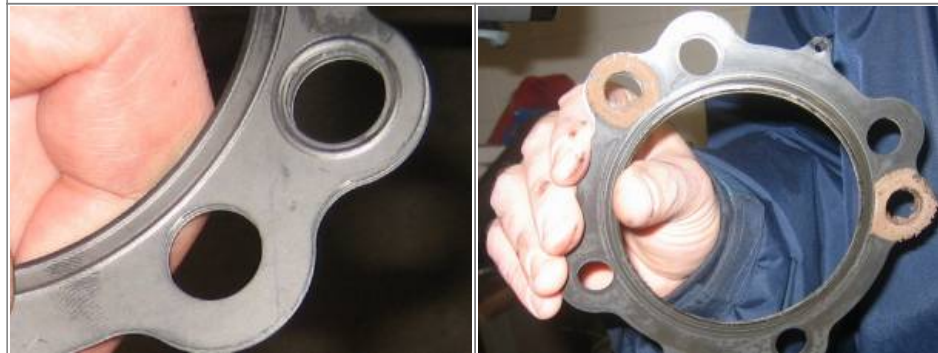
Deteriorated O-rings used with MLS gaskets. The MLS gasket is tight around the dowel and has a raised area to seal the dowel. No need for an O-ring. ³⁶⁾

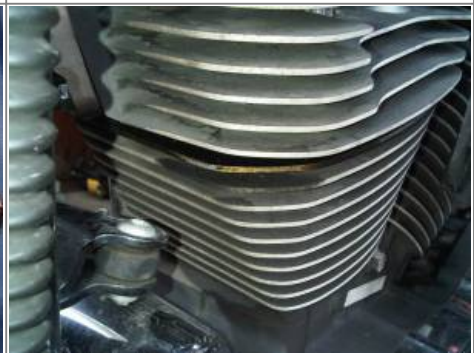
Head gasket leak. ³⁷⁾

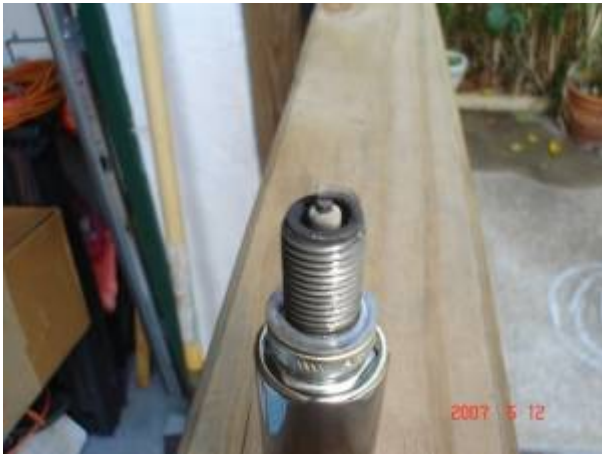
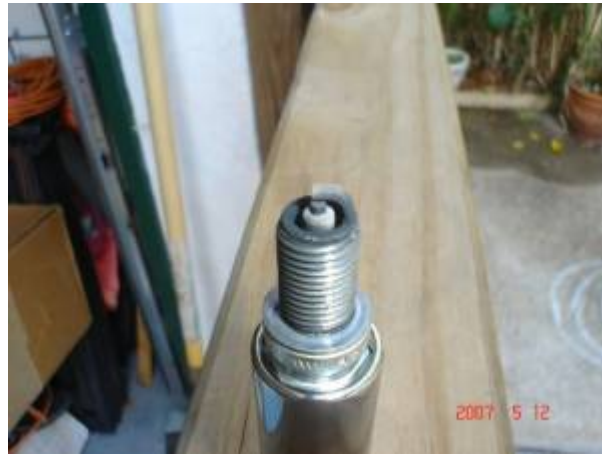
Check the spark plugs for oil fouling.

Worn rings or an imbalance in crankcase pressure can send oil up into the combustion chamber and foul the plugs.
Check the plugs for wet oil saturation.

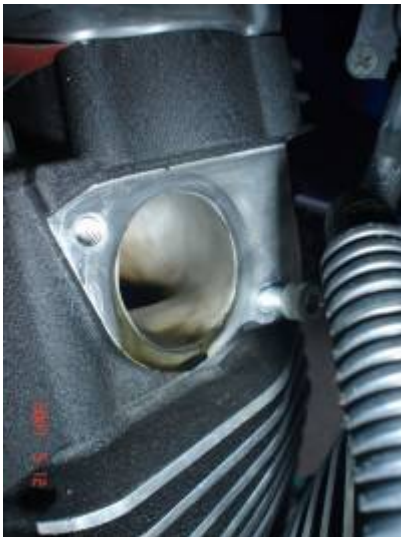
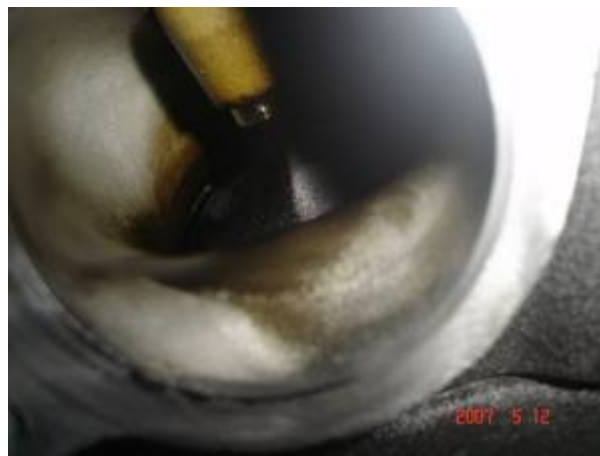
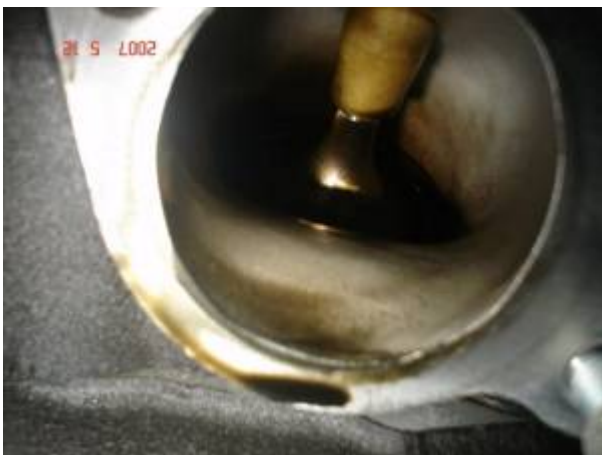
Check intake and exhaust ports in the heads.

You can pull your exhaust pipes and intake manifold and look at the valves to see if the oil is leaking past the valve stem seals. ⁴⁰⁾

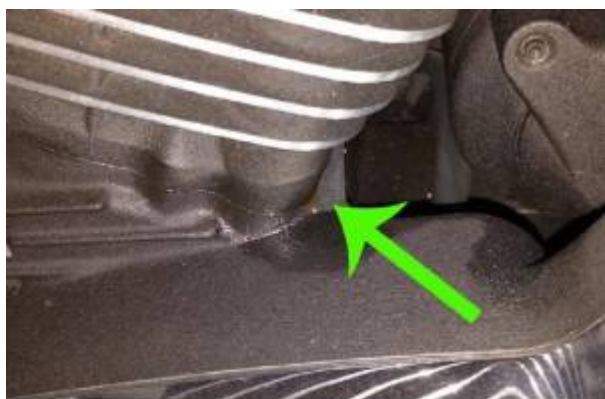
⁴⁶⁾

Cylinder base gasket weeping

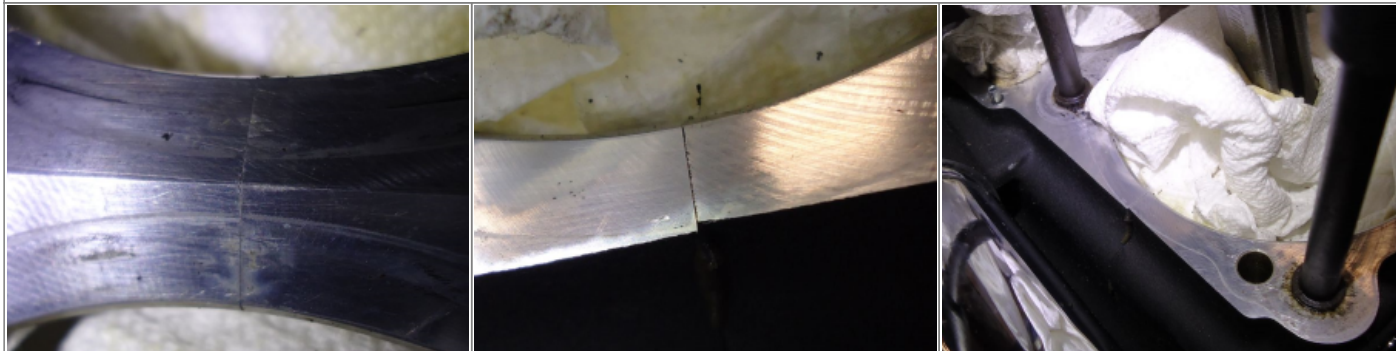
Case seam mismatched under cylinders causing a leak. ⁴⁹⁾

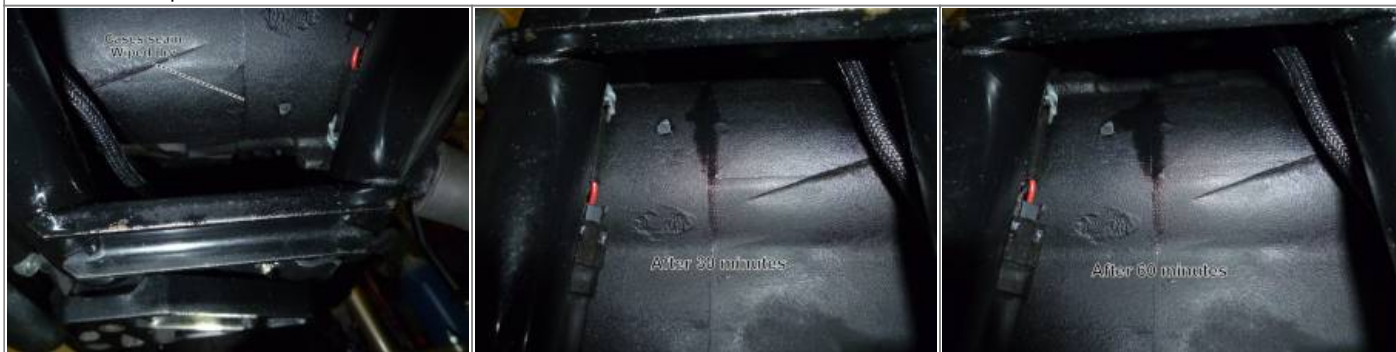
This seemingly case seam leak turned out to be a leak at the point where the stator wire grommet comes through the primary case. The oil would pool up on top of the transmission during riding and when parked would run down the back and onto the ground. Every morning, after riding, there would be a 6" oil pool under the bike. These pics are underneath from the rear at the transmission. ⁵⁰⁾

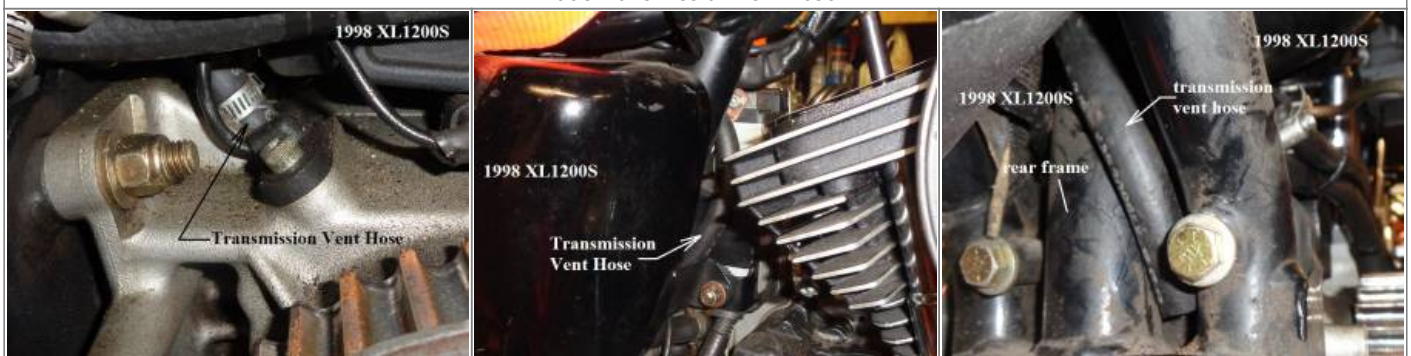
1998 transmission vent hose. ⁶⁵⁾

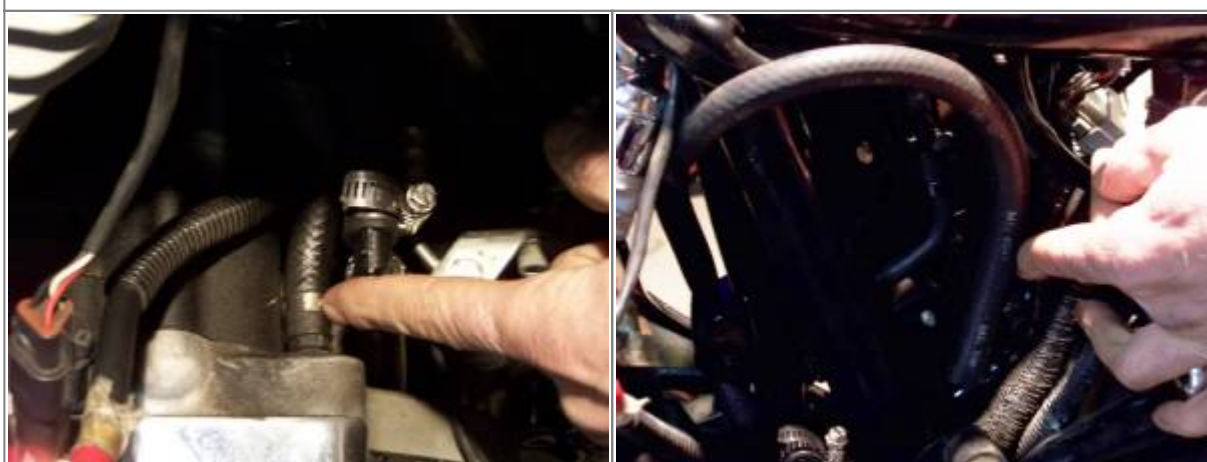
2000 transmission vent hose. ⁶⁶⁾

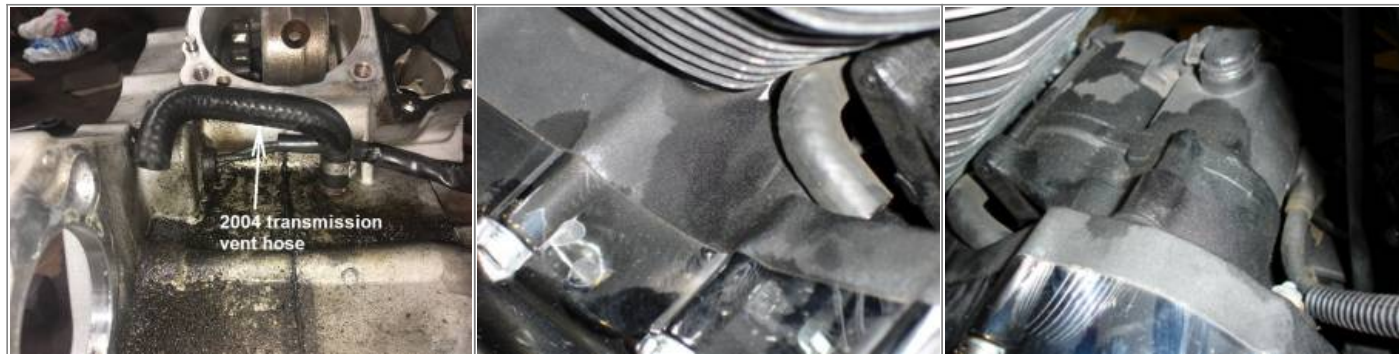
2004 transmission vent hose. ⁶⁷⁾

2005 transmission vent hose. ⁶⁸⁾

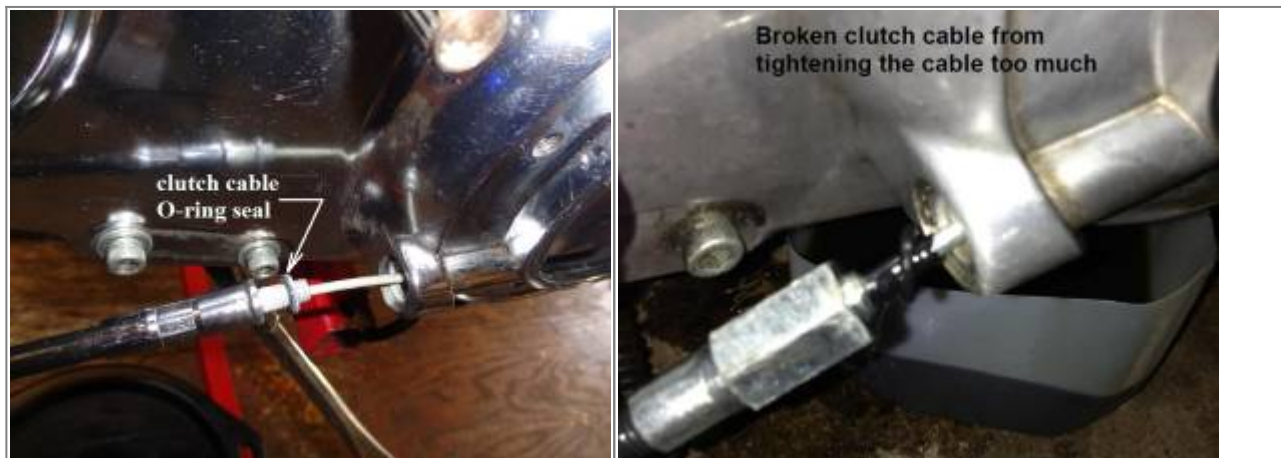
Clutch cable and O-ring on a 98 S model. ⁷⁴⁾ Pipe dope on the threads.	Broken cable threads from tightening too much. ⁷⁵⁾
--------------------------------------------------------------------------------------	---------------------------------------------------------------

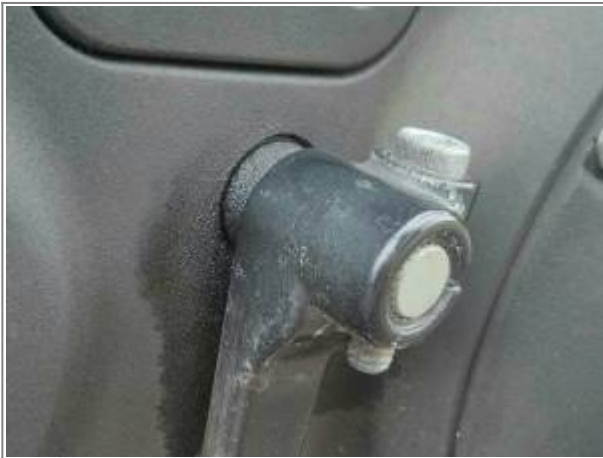
Leaky shifter shaft seal on 09 Sportster. ⁷⁷⁾

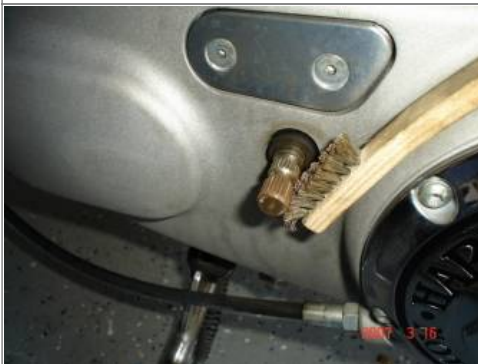
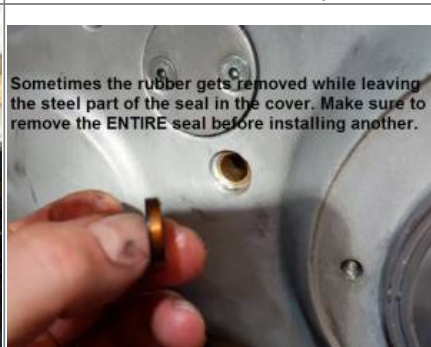
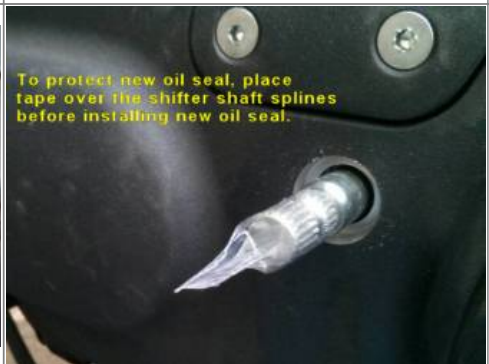
Clean all surface rust on shaft. ⁷⁸⁾	Make sure you remove the entire seal. ⁷⁹⁾ Or that the entire seal assembly is there.	Tape over shaft to keep from tearing new seal. ⁸⁰⁾
-------------------------------------------------	----------------------------------------------------------------------------------------------------	---------------------------------------------------------------

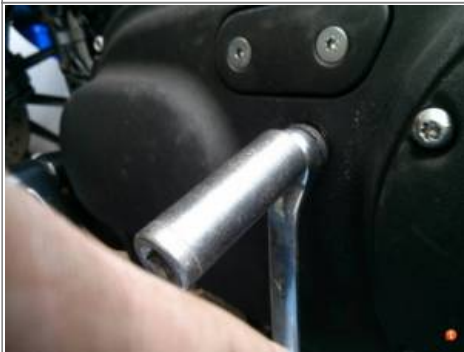
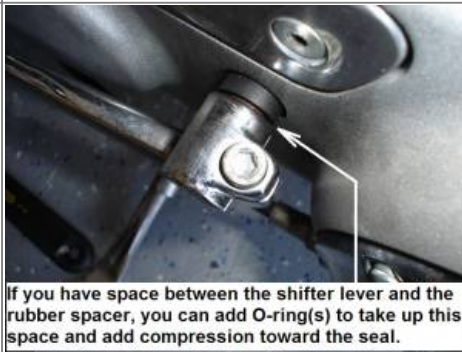
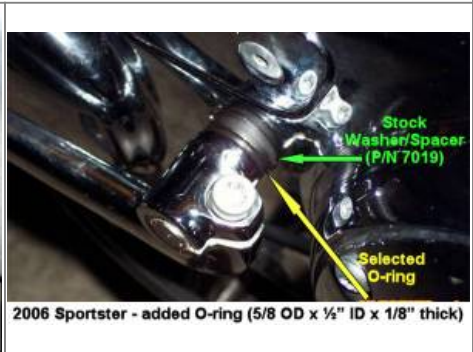
You can push against old seal with a wrench and deep socket to lock in new seal. ⁸¹⁾

If you have an empty space between the shift lever and the rubber bushing, you can install an O-ring on outside of spacer to increase compression on the shaft seal. ⁸²⁾

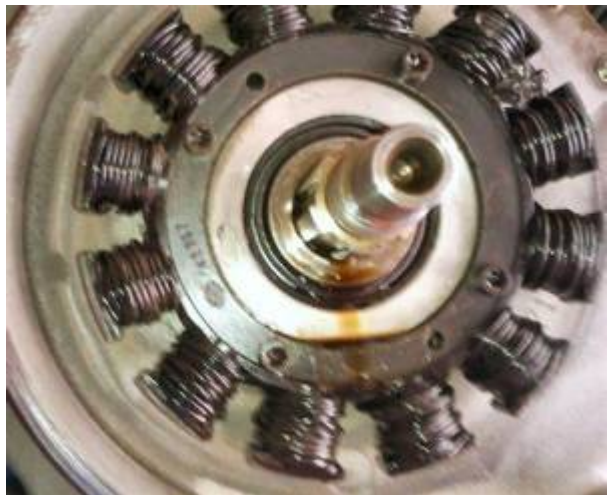
88)

The leak is most likely not coming from between the spacer and the seal but rather between the spacer and the sprocket shaft (which would now be removed).

Once the rotor/sprocket is bolted back up, it should effectively stop the leak. Oil slowly draining down into the crankcase from the oil tank is not that unusual.

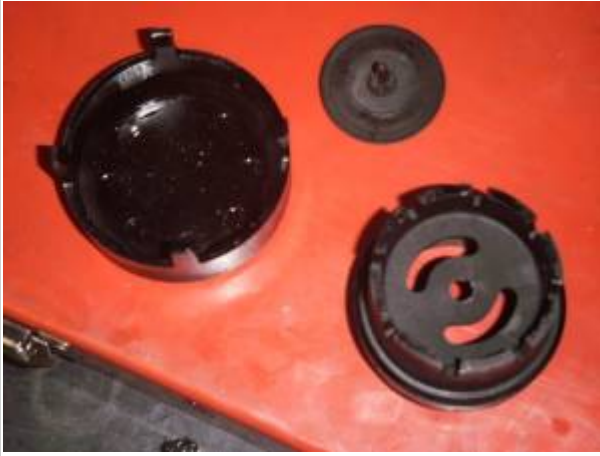
<p>L82-90 cap, tube and umbrella ⁹¹⁾</p>

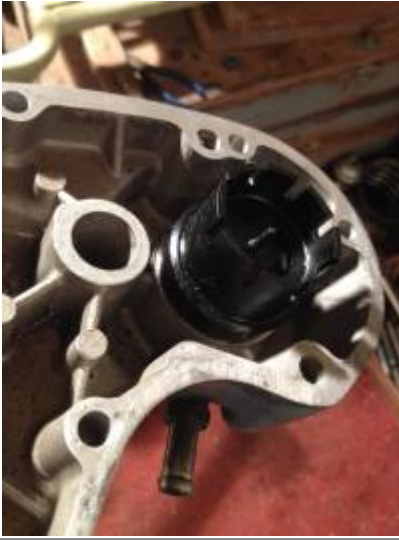
<p>Breather baffle tube installed ⁹²⁾</p>

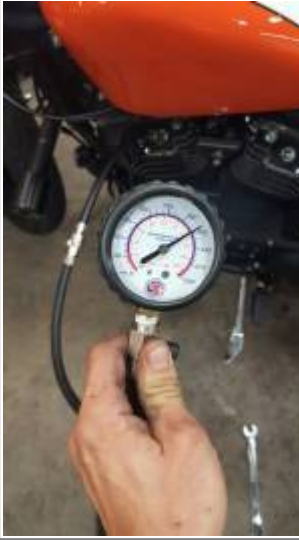
<p>Compression test. ⁹³⁾</p>

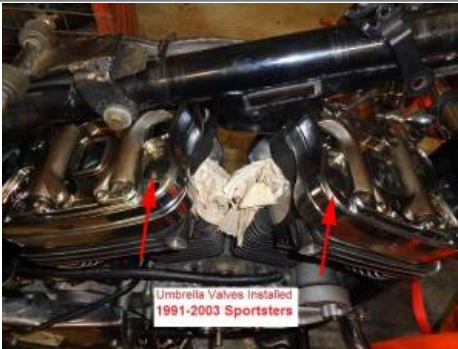
<p>91-03 breather valves ⁹⁴⁾</p>

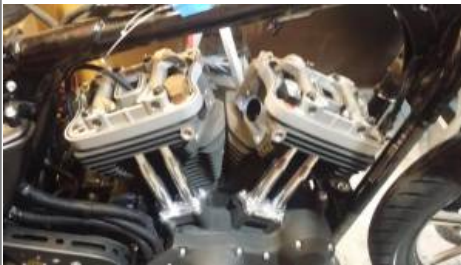
<p>04-up breather valves ⁹⁵⁾</p>

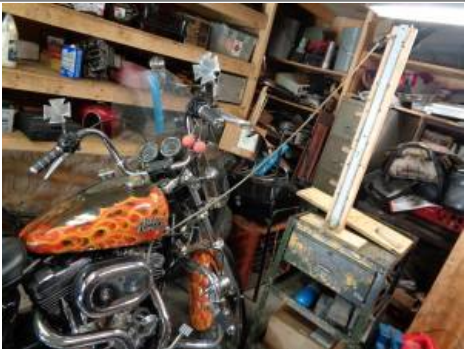
<p>Homemade manometer using a ruler as a scale. ⁹⁶⁾</p>
