IH: Engine Mechanicals - Sub-01F

Ironhead Transmission Sprocket Cover Pics

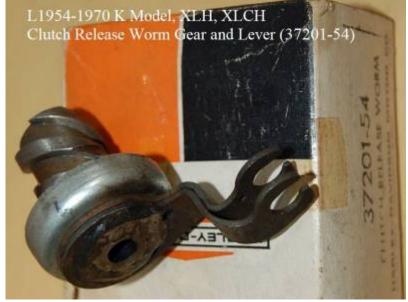
Clutch worm gear (37200-54) was used on 1952-E1954 K Models.

Clutch worm gear (37201-54) was used from L1954-1970 on K Models and Sportsters.

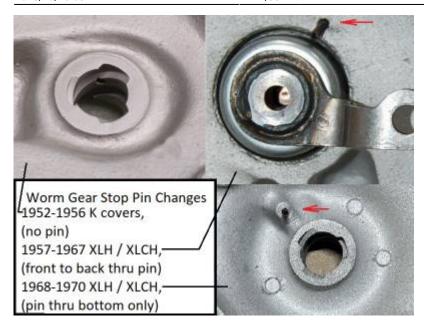
The stop pin (roll pin) is in the cover (underside). Look closely at these as they have a tendency to shear off flush with the cover.

1957-1967 covers were drilled through at the roll pin and you could drive it out from the outside. 40)

1968-1970 covers have a boss added to the underside in a wider girth around the worm gear.

The hole for the roll pin is drilled from the underside, through the boss, but not all the way through to the outside of the cover.

This makes removing a broken off roll pin harder.

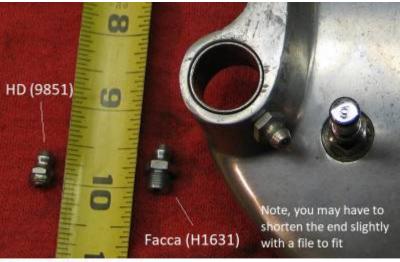
The fitting below is a Facca (H1631) straight grease fitting that was slightly shortened with a file.

The extra length/thread on the shank doesn't strip out under pressure from your grease gun.

1957-1970 Sportster sprocket cover grease fitting alternative

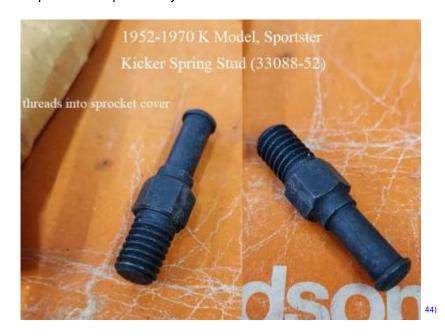
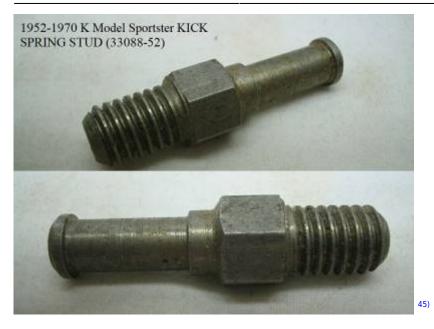
Kick Starter Spring Stud

The stud threads into the hole in the sprocket cover to the right of the starter shaft hole. Hd sold several versions of the stud including parkerized, nickel, zinc and chrome. The first was parkerized, part# (33088-52) for 1952-1970, then 1971-1978 was zinc, part# (33088-71) and 1979 version was chromed (33088-79). Replacement parts all years were mixed materials.

The 1971-1979 stud was lengthened from the earlier version. The area between the spring retention groove and hex is longer. $^{46)}$

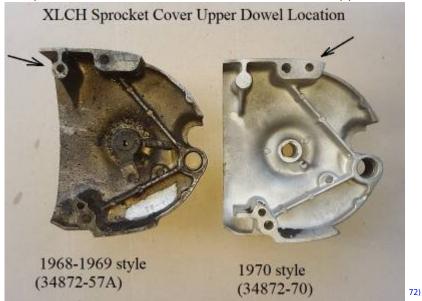
The pic below shows the different location of the upper dowel between the 1969 and 1970 XLCH covers.

This is the first version, uses the same 74-52B casting as the 68-69 version. 73)

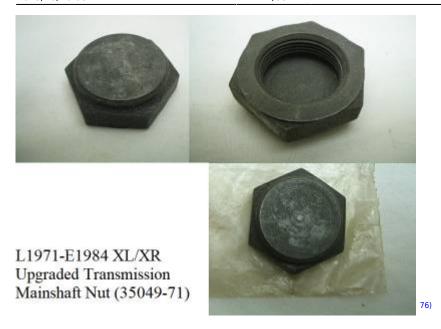
The new sprocket nut encloses the end of the mainshaft and provides a metal to metal seal between the sprocket, lockwasher and nut when tightened to 35-65 ft-lbs.

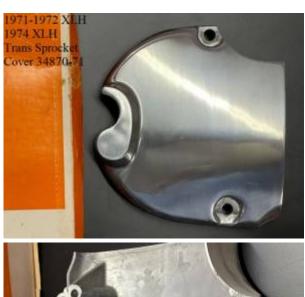
1971-1972 XLH, 1974 XLH Cover

Sprocket Cover (34870-71), polished, without kick starter. Click on a pic to enlarge $^{77)}$

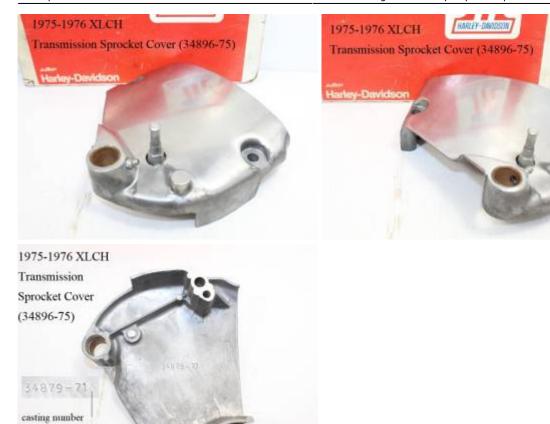
1975-1976 XLCH Cover

Sprocket cover part# (34896-75), polished, with kick starter. Casting number is (34879-71A). Click on a pic to enlarge: $^{83)}$

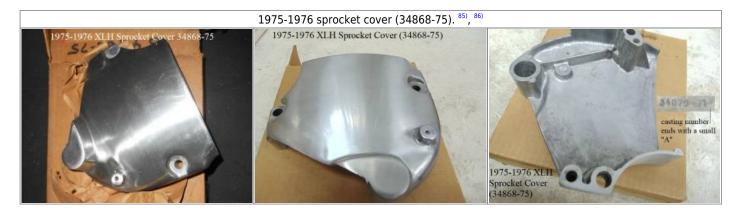
1975-1976 XLH Cover

ends in small "A"

Sprocket cover part# (34868-75), polished, without kick starter. Casting number is (34879-71A). Click on a pic to enlarge: 84)
