SERVICE BULLETIN

M-877

MAIN DRIVE GEAR OIL SEAL

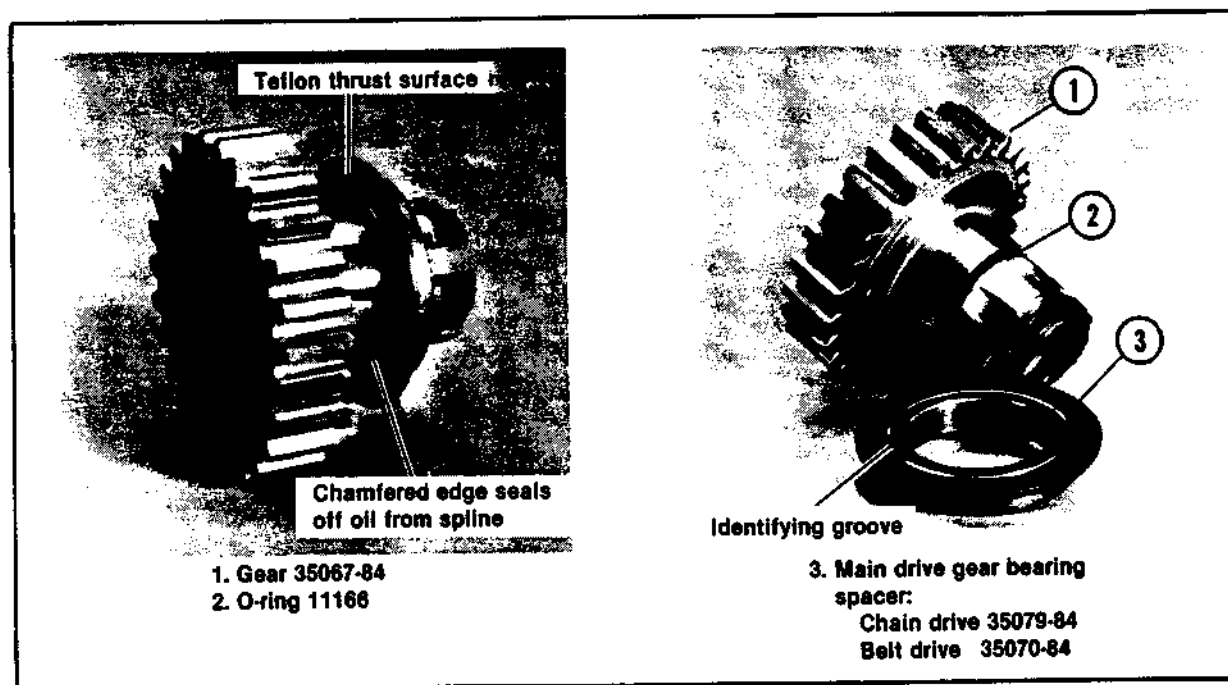
See Figure 1. The main drive gear on production vehicles are now being machined with a deeper groove, adjacent to the bearing shoulder, to accommodate

mounting a deep section o-ring. The bore of the spacer at the thrust bearing side will be chamfered slightly for improved contact surface with the o-ring. All spacers that have the chamfered bore will be identified by a shallow groove machined in the Teflon surface. Transmissions for chain drive and belt drive are each equipped with a spacer of different width for alignment purposes.

Figure 1. Main Drive Gear Arrangement
