EVO: Primary Drive & Clutch

Primary Drive Design

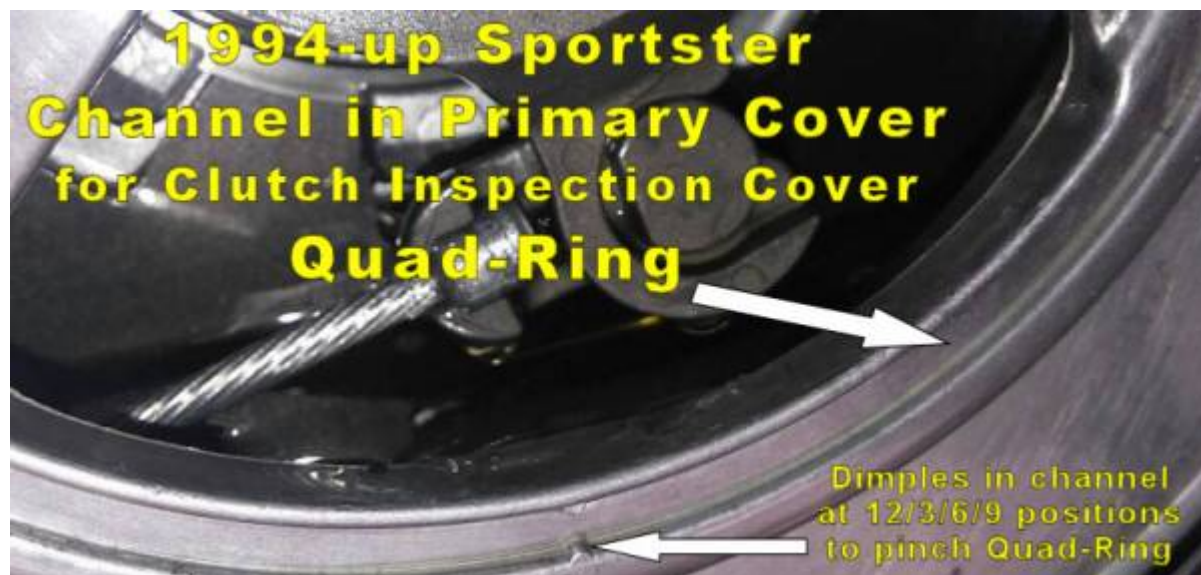
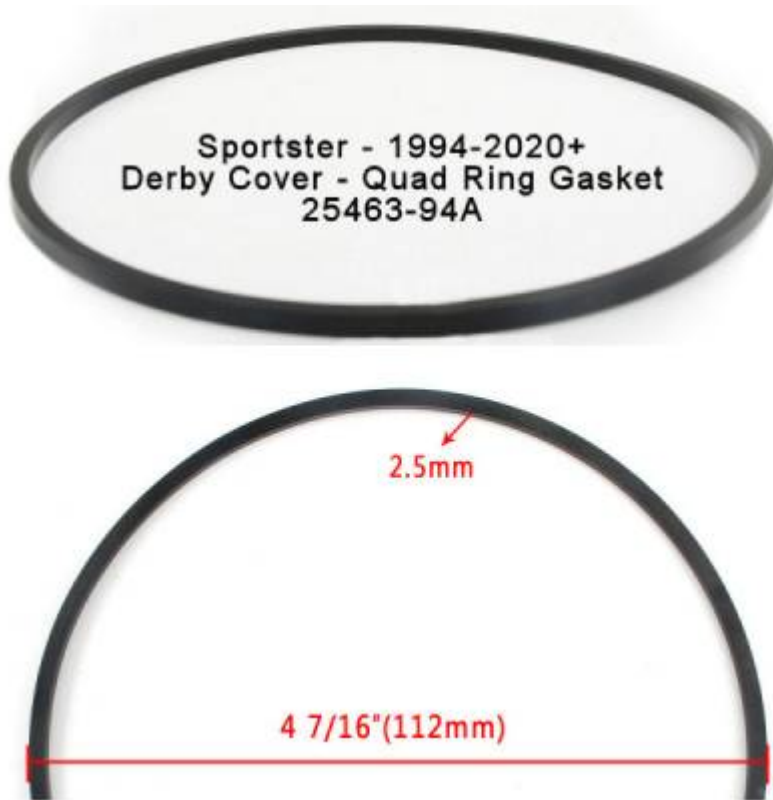
Quad-Ring - Clutch Inspection Cover

From 1994-later the Clutch Inspection Cover (AKA: Derby Cover) has had a sealing ring, often referred to as the Quad-Ring. It is circular, but its cross-section profile is not round like an o-ring, but rather four-sided flat. The quad-ring P/N is 25463-94A. See discussion at <https://www.xlforum.net/forum/sportster-motorcycle-forum/sportster-motorcycle-drivetrain/sportster-motorcycle-transmission-clutch-primary-secondary-drive/183554-clutch-cover-gasket?t=1974683>

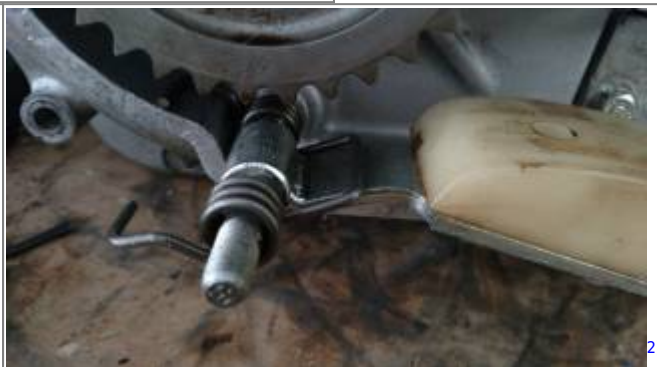
1986-90 Primary Chain Tensioner Parts

39973-86 - Steel Carrier Plate
 40018-86 - Pivot Stud
 40019-86 - Spring for Tension
 39966-80 - Pad against Chain
 3250 ——— Threaded Stud - for Adjustment

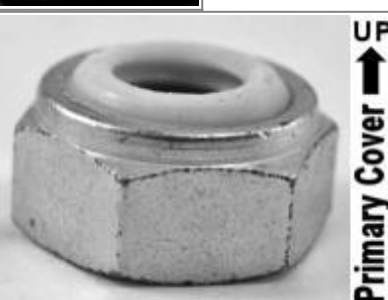
1991-later Sportsters
Primary Chain Adjuster Nut
P/N 7804

This nut has a special extended nylon face⁴⁾ which seals against the Primary Cover

TO PREVENT LEAKS
Avoid Common Nylon-insert Nuts

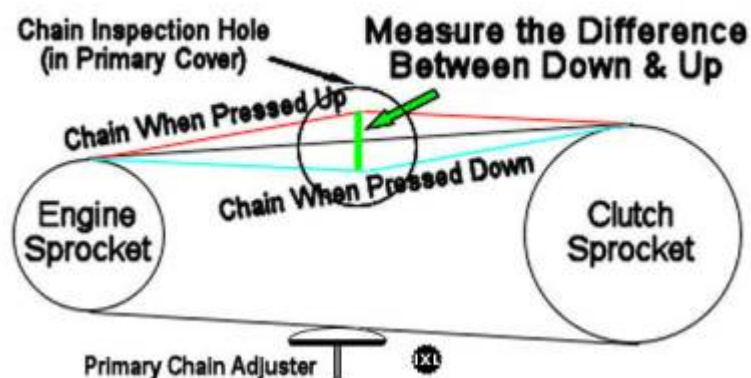
Before adjusting, rotate sprockets to find the tightest Primary Chain tension point.

- Place the bike on a lift
- Remove the Primary Chain inspection cover
- Remove the spark plugs
- Put the bike in 5th gear
- Rotate the rear tire to cause the Primary Chain to rotate past the inspection hole

Rotate the chain fully around its length to find the spot that has the tightest tension. This is the point at which you must set the minimum play (or looseness). The initial primary chain vertical free play may be slightly tight from the factory since they use precision measurements.

On a cold engine (left overnight), the overall movement of the chain from pressed down to pressed up must be 3/8" to 1/2". On a hot engine, the recommendation is 1/4" to 3/8". By finding & using the tightest tension point and using the looser specification, you will avoid overtightening, which might otherwise occur. An overtightened primary chain will cause whining and excessive wear of the sprocket bearings ([SEE HERE](#)).

Vertical Play in Upper Primary Chain			Although the 1986-1990 models have a rotational mount for the primary chain shoe and the 1991-later models use a fixed T-mount, the tension adjustment for all models accomplishes the same goal and is performed in the same way.
All Years	Cold Adj	Hot Adj	
		3/8" to 1/2"	1/4" to 3/8"

The adjustment of the chain tension is made using the Primary Chain Adjuster, mounted to the bottom of the Primary Cover. The adjuster mounting bolt extends through the Primary Cover to allow adjusting the tension without removing the cover. The adjuster bolt has a lock nut to keep the adjustment from changing. The adjuster has a nylon shoe atop it that rides against the loose side of the primary chain to take up excess slack. By loose side is meant the bottom path of the chain because the upper chain path is the one that transmits power to the clutch/transmission when accelerating. When decelerating in gear, the bottom side chain path is tight against the shoe because the engine is braking the bike motion thru the clutch/transmission.

To make the adjustment, hold the bolt steady and loosen the lock nut. Turn the bolt clockwise (viewed from below) to reduce (or tighten) the amount of chain free play or CCW to increase the free play. Once the adjustment is correct, hold the bolt steady & tighten the lock nut.

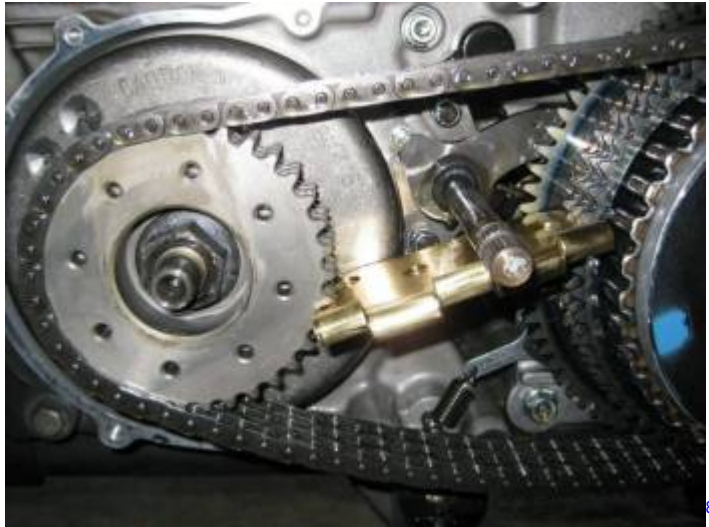
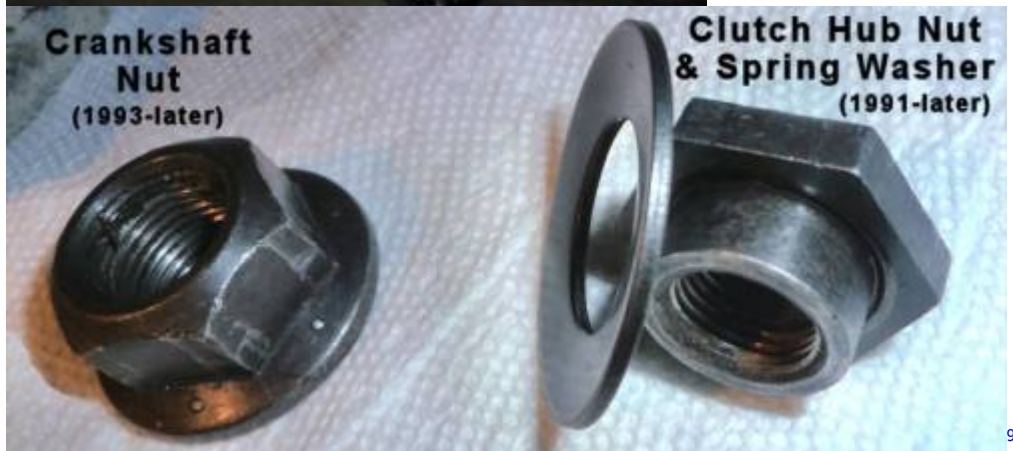
When loosening or tightening these nuts, you will need to **lock the hub & sprocket** - Do not wedge the chain.

Buy a primary locking tool (bar) or use a closed 4" BRASS hinge as a wedge between the sprockets. (Place the wedge so as not to put pressure on the shifter shaft)

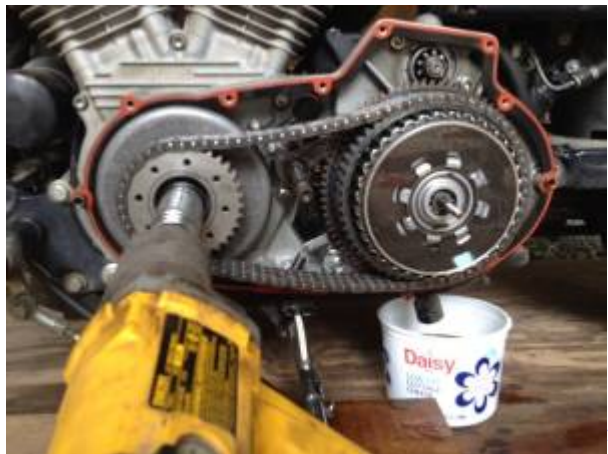
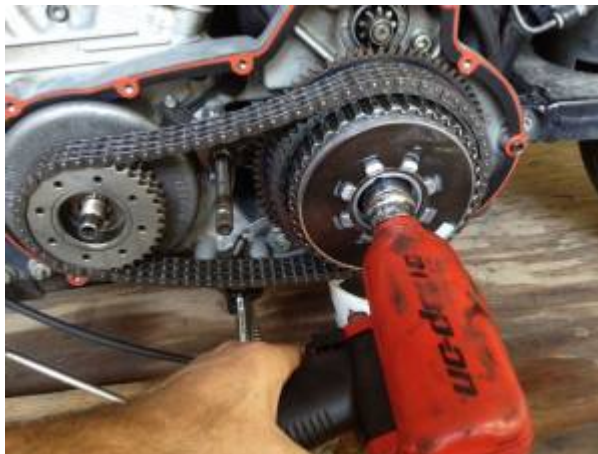
A reversible impact wrench has been used successfully to remove both the engine sprocket and the

clutch basket nut.

Whichever way you remove them, use regular six-sided sockets.

They are less likely to slip and round off the edges of the nuts. Impact-type sockets are likely too thick to fit.

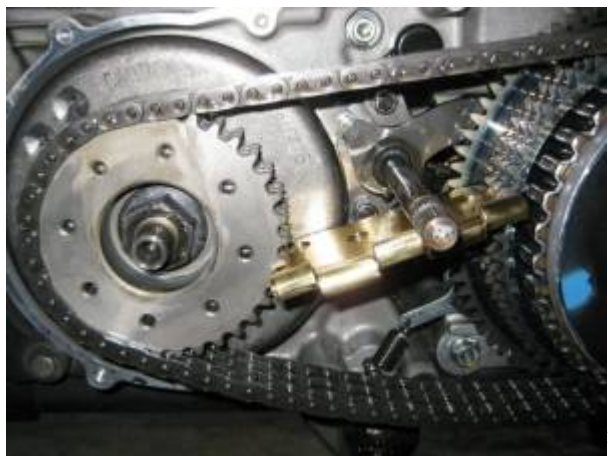
A closed 4" BRASS hinge also works well to lock the sprockets and then you can use a pull bar and sockets / socket wrench.

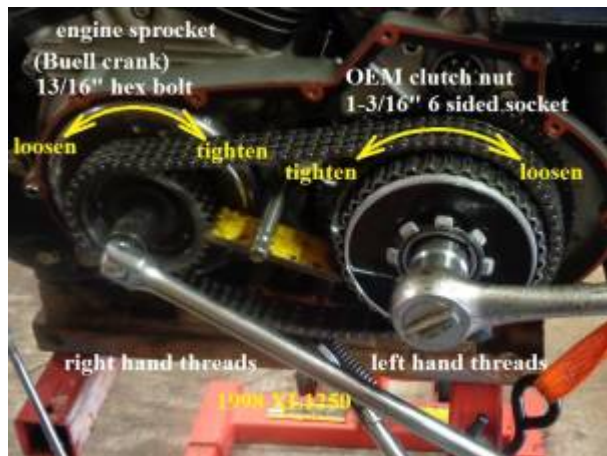
13)

The engine sprocket and clutch hub should be removed as one unit.

Both have to come out together to some point since the chain will tighten and neither will budge at that point.

Once they are both moved out far enough, you may be able to get one or the other to come off without the other.

Once the sprocket and clutch basket is removed, you can gain access to the mounting screws for the stator.
