IH: Carburetor, Intake Manifold & Exhaust - Sub-01G

Tillotson Carb Functions, Adjustments, Tuning

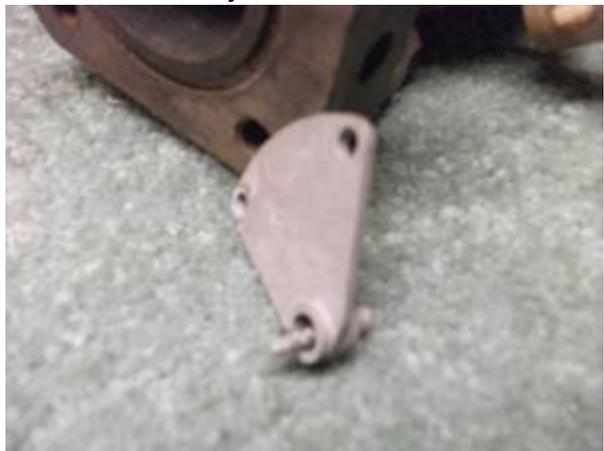
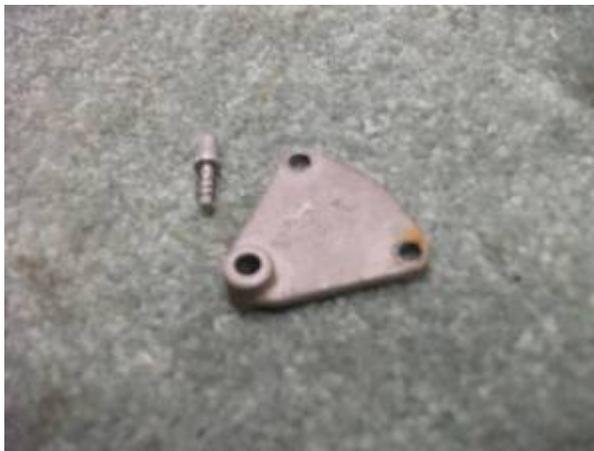
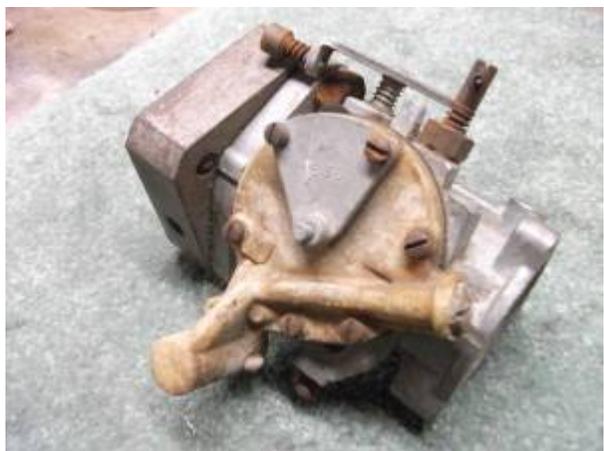
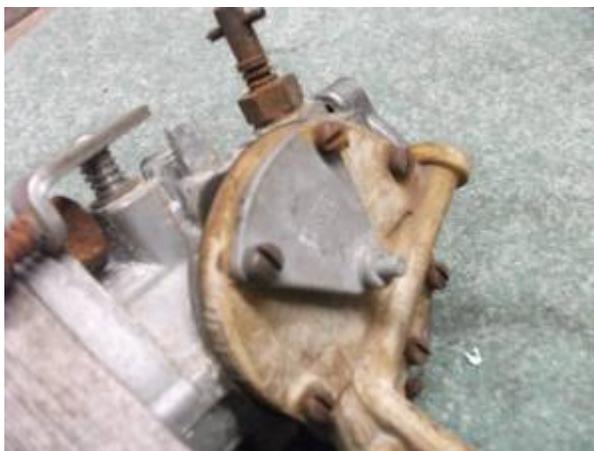
There is an old trick of using a paperclip to depress the diaphragm through a small hole in the diaphragm cover on the bottom of the carb. Starting will improve significantly. Using the paperclip method can be cumbersome with the fuel line, original air cleaner, circuit breaker and tach cable in the way.

This was made by S&D installed on a HD2D model.

A tickler is any device that is inserted into the bottom hole to 'massage' a little extra gas from the diaphragm.

By 'tickling' the diaphragm via paperclip or spring type pin, you are allowing fuel to enter the accelerator galley via gravity.

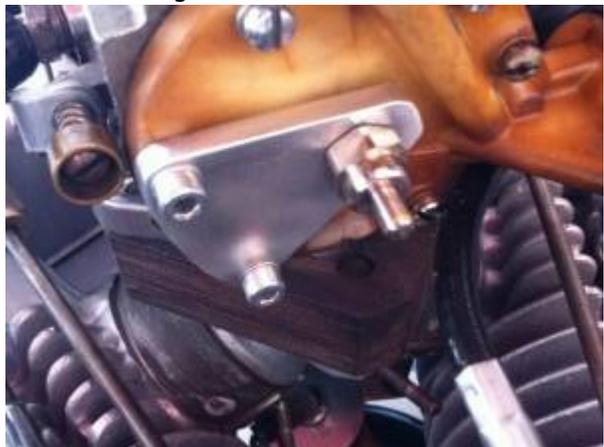
Since vintage ticklers are now pretty much unobtainable, the one below was homemade. This is an original Tillotson on a 1969 XLH.

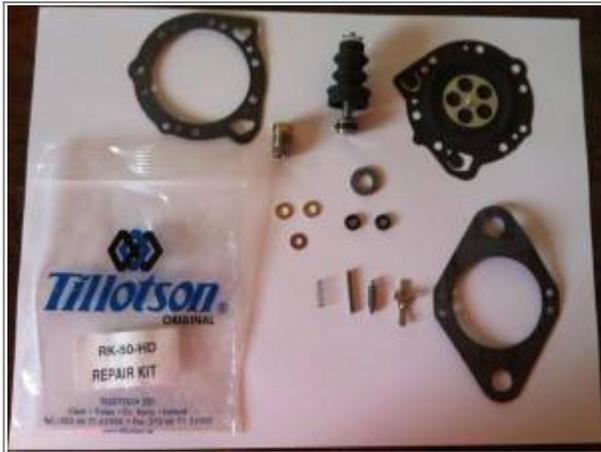
Tillotson Carburetor repair/ refresh kit¹⁹⁾
