# IH: Carburetor, Intake Manifold & Exhaust - Sub-01G

## Tillotson Carb Functions, Adjustments, Tuning

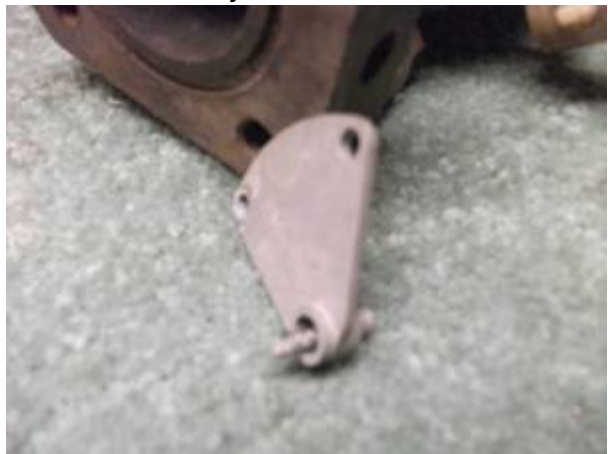
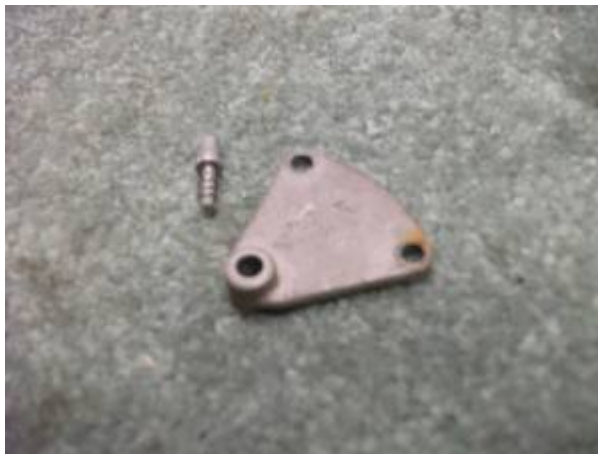
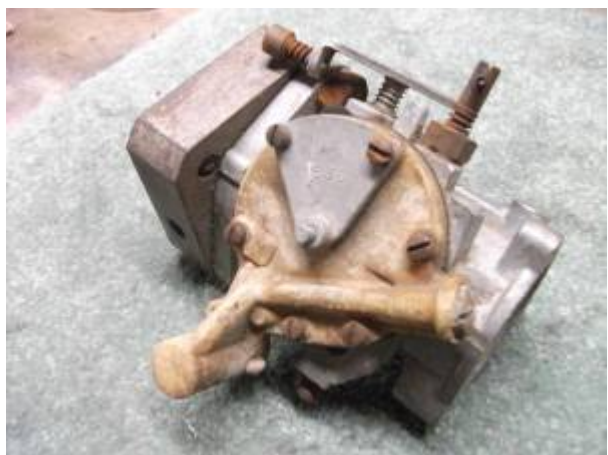
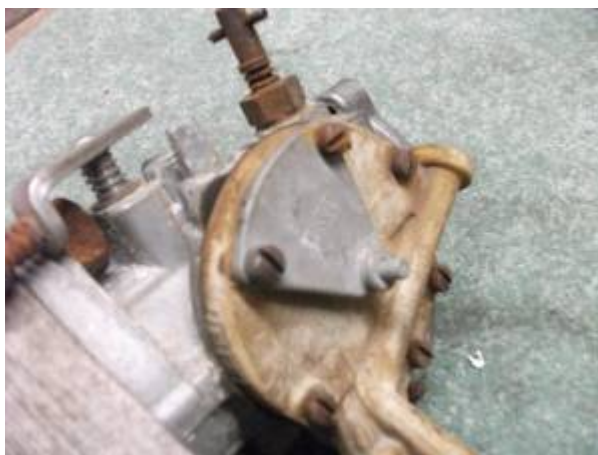
This was made by S&D installed on a HD2D model.

A tickler is any device that is inserted into the bottom hole to 'massage' a little extra gas from the diaphragm.

There is an old trick of using a paperclip to depress the diaphragm through a small hole in the diaphragm cover on the bottom of the carb.  
Starting will improve significantly.  
Using the paperclip method can be cumbersome with the fuel line, original air cleaner, circuit breaker and tach cable in the way.

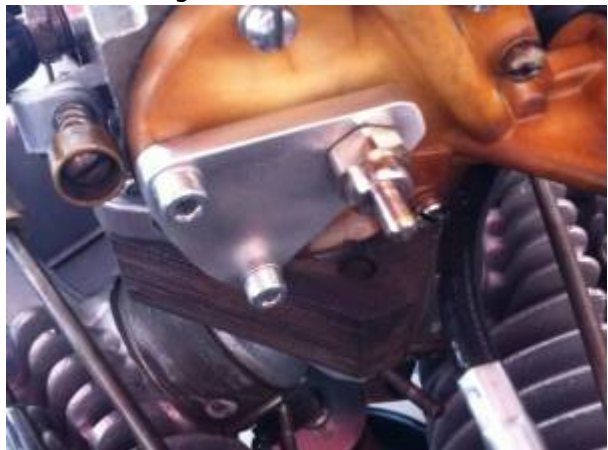
Since vintage ticklers are now pretty much unobtainable, the one below was homemade.  
This is an original Tillotson on a 1969 XLH.
