IH: Electrical System

FUSES, RELAYS, CHARGING SYSTEM

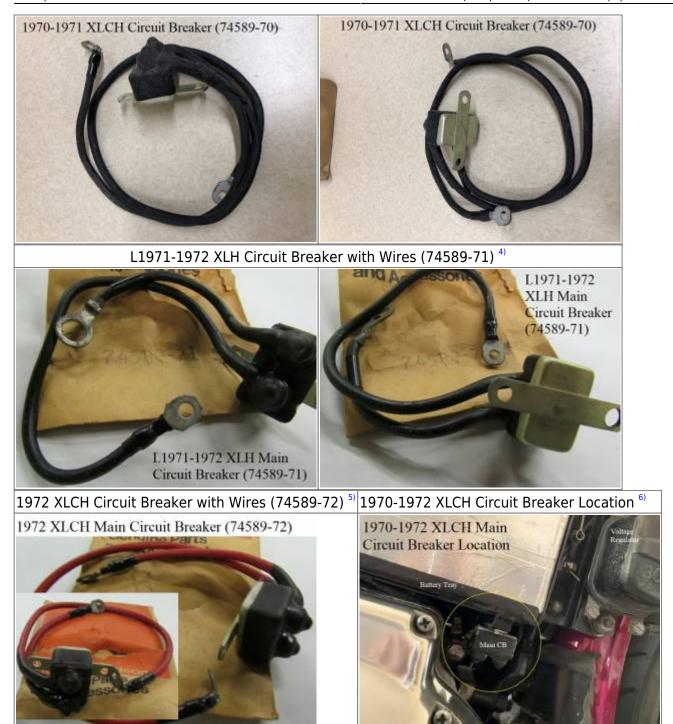
Pics of 1967-1972 Circuit Breakers

The Circuit Breakers (CB) used on Sportsters are of the self-resetting type. Once they break contact, they will automatically reset after a period of time. These breakers function based on a bi-metallic strip that is heated by current flowing through the strip. More current will cause more heat.

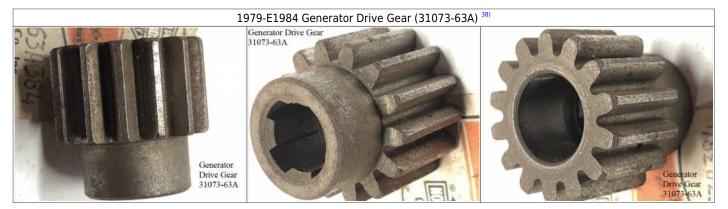
- 1979-1981 Sportsters used 14T gear (31073-63A) with the 1-5/8" slinger washer (31067-63).
- **1982-E1984 Sportsters** used the same 14T gear (31073-63A) with a 1-3/4" slinger washer (31066-82) to accommodate the larger crankcase breather valve.
