IH: Engine Control - Sub-03A	
1968 Kicker Cover Roll Pin Repair

1968 Kicker Cover Roll Pin Repair

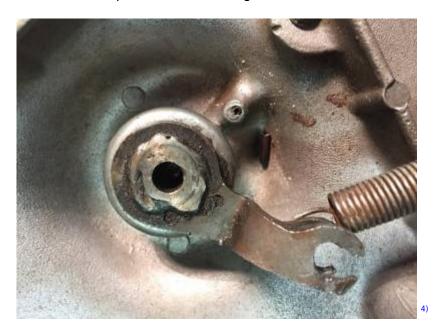
The little roll pin sticking out of the inside of the kicker cover acts as a stop pin. The release should rest on the pin when the clutch lever is fully extended and the adjustment of the release rod is slack. ¹⁾ Sometimes they will snap off. This could be due to it being a pretty wimpy size pin, and possibly bad clutch adjustment followed by abuse. ²⁾

Up to '67, the hole was drilled all the way through where you could drive the old pin out from below. However, the sprocket cover changed in '68. ³⁾

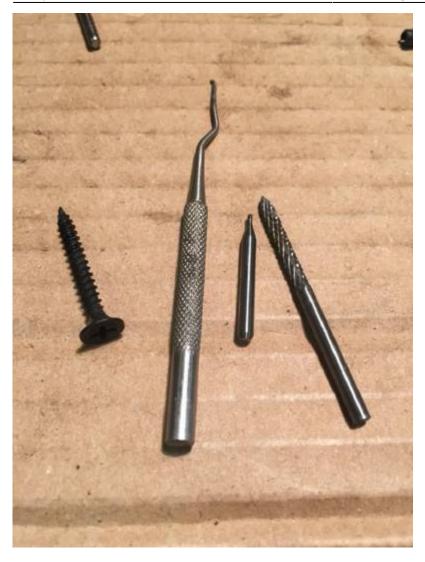
- Most of the advice on this is probably good for larger size pins and did not work for this situation including: 5)
 - Pick = no good
 - ∘ Heat / pick = no good, it's jammed.
 - Pack with grease and use pressure to push it out = Too mangled, too small.
 - Easy out = if I had one that small, I think it would just expand the pin.
 - Hardened drywall screw to yank on = screw too big / pin too hard for softer screws.
 - Try annealing pin to allow drilling = maybe a jeweler's torch setup would be good for this.
- Other trial methods might include:
 - A long drill bit to go through the center of the roll pin and out the bottom.
 - A left handed drill bit ⁷⁾

- On further attempts, I succeeded in blocking up the hole with a welding rod, which was supposed to have fused itself to the inside of the pin at low amperage, allowing me to yank it out. Instead it broke off at the top of the pin. 8)
 - I managed to drill out the welding rod, snapping a succession of cheap solid carbide drill bits used in PCB manufacture.
 - A step before trying to spark erode the little sh!t out of there (machine paid for itself, removing broken easy outs, I hear) when I tried a carbide burr. Snapped that too, but it got deep enough to hog the old pin out before that happened, and I managed to pick the broken bits out.

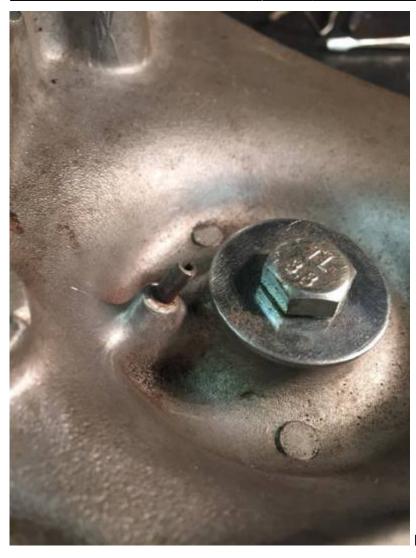
New 1/8" roll pin fitted. If this bigger size makes any difference, you can always relieve the arm a touch. ⁹⁾ but the larger pin would help with shearing. ¹⁰⁾

Now I can adjust the clutch!!! 11)
