IH: Transmission & Final Drive - Sub-03F

1957-1985 Transmission Trapdoor Pics and Information

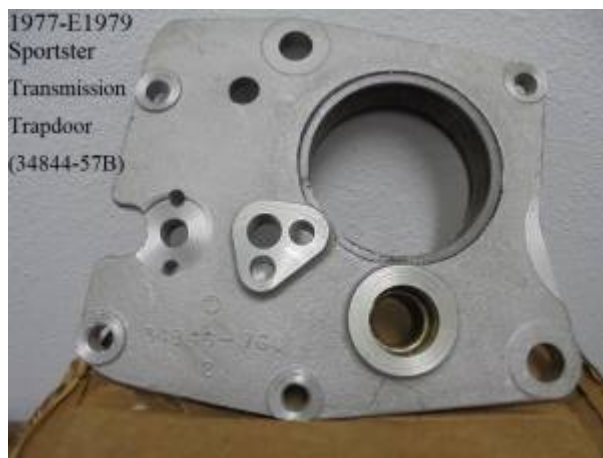
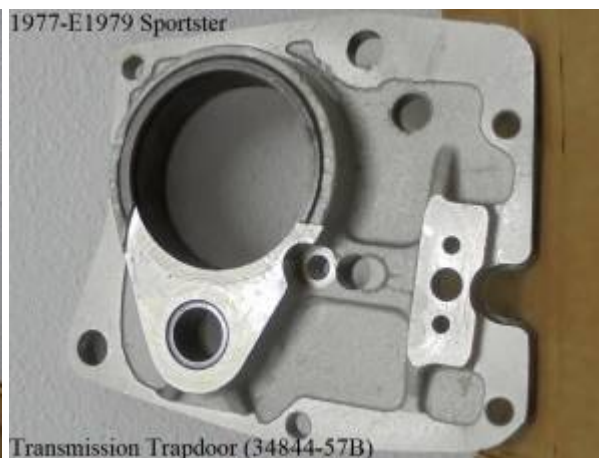
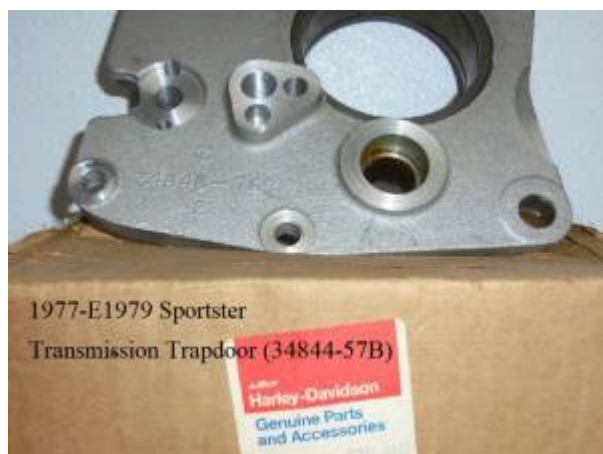
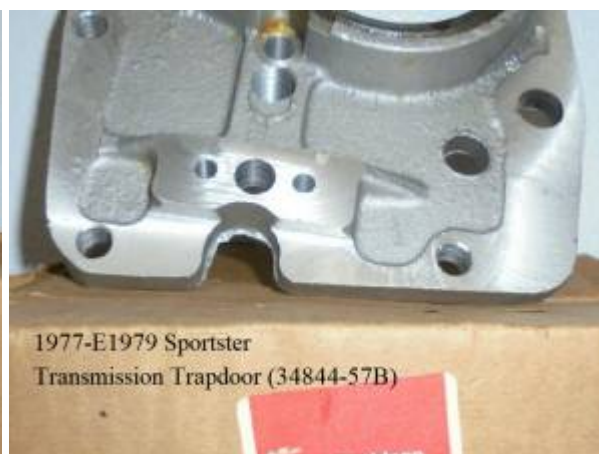
1977-E1979 Sportster Transmission Trapdoor Pics:

HD Part# (34844-57B)

Casting# (34846-76) Machined cutout for left side shifter shaft protrusion.

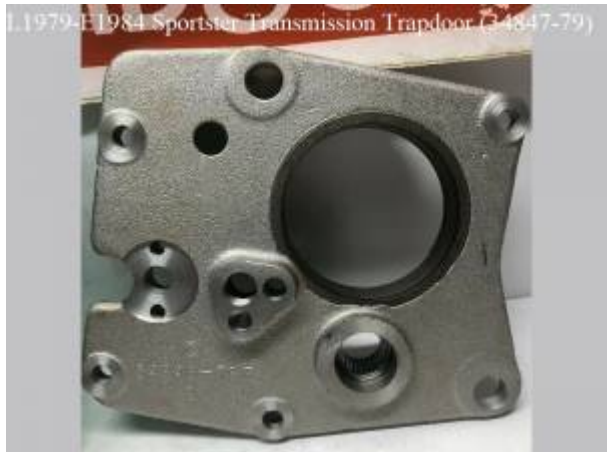
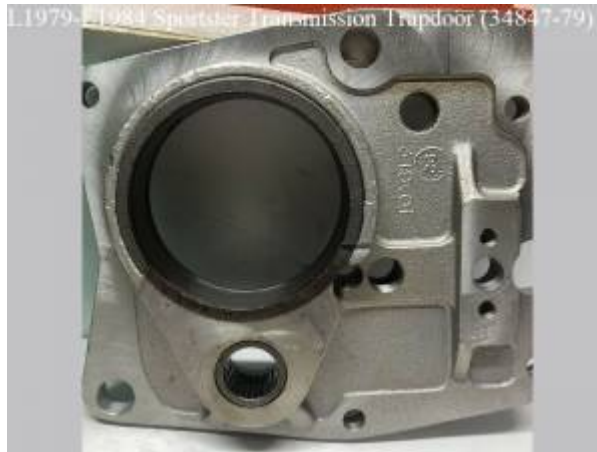
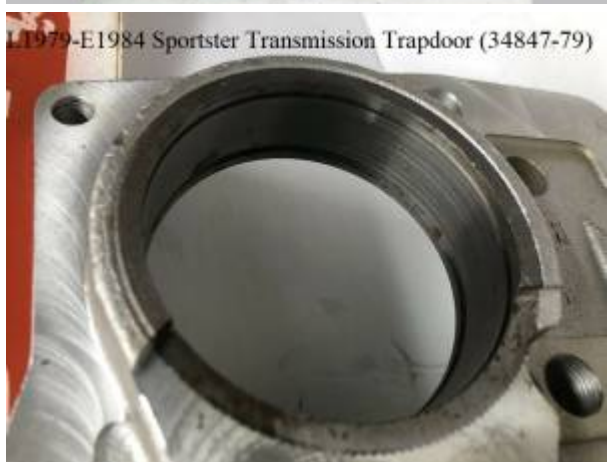
L1979-E1984 Sportster Transmission Trapdoor Pics:

HD Part# (34847-79)

Casting# (34846-76F)

Machined cutout for left side shifter shaft protrusion.
