TT260 – August 16, 2006

## Radio Diagnostic Trouble codes B2007 and B2010

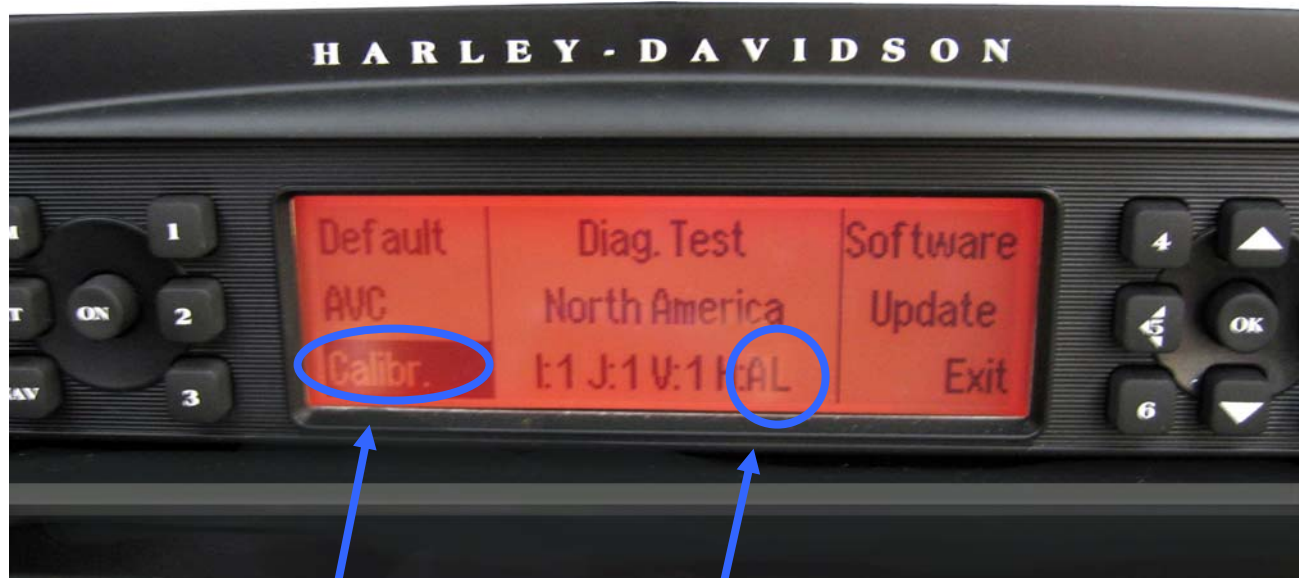
Radios that have a calibration I.D. that ends with the letters “AN” have this issue. Calibration I.D.’s that end with “AP” are the current production and do not have this issue.

Calibration button

Calibration ID

If you encounter a radio with these trouble codes and a calibration I.D. that ends with “AN”, ignore the codes.
