TT296 – March 8, 2007

## Screamin' Eagle Big Twin Camshaft Kits

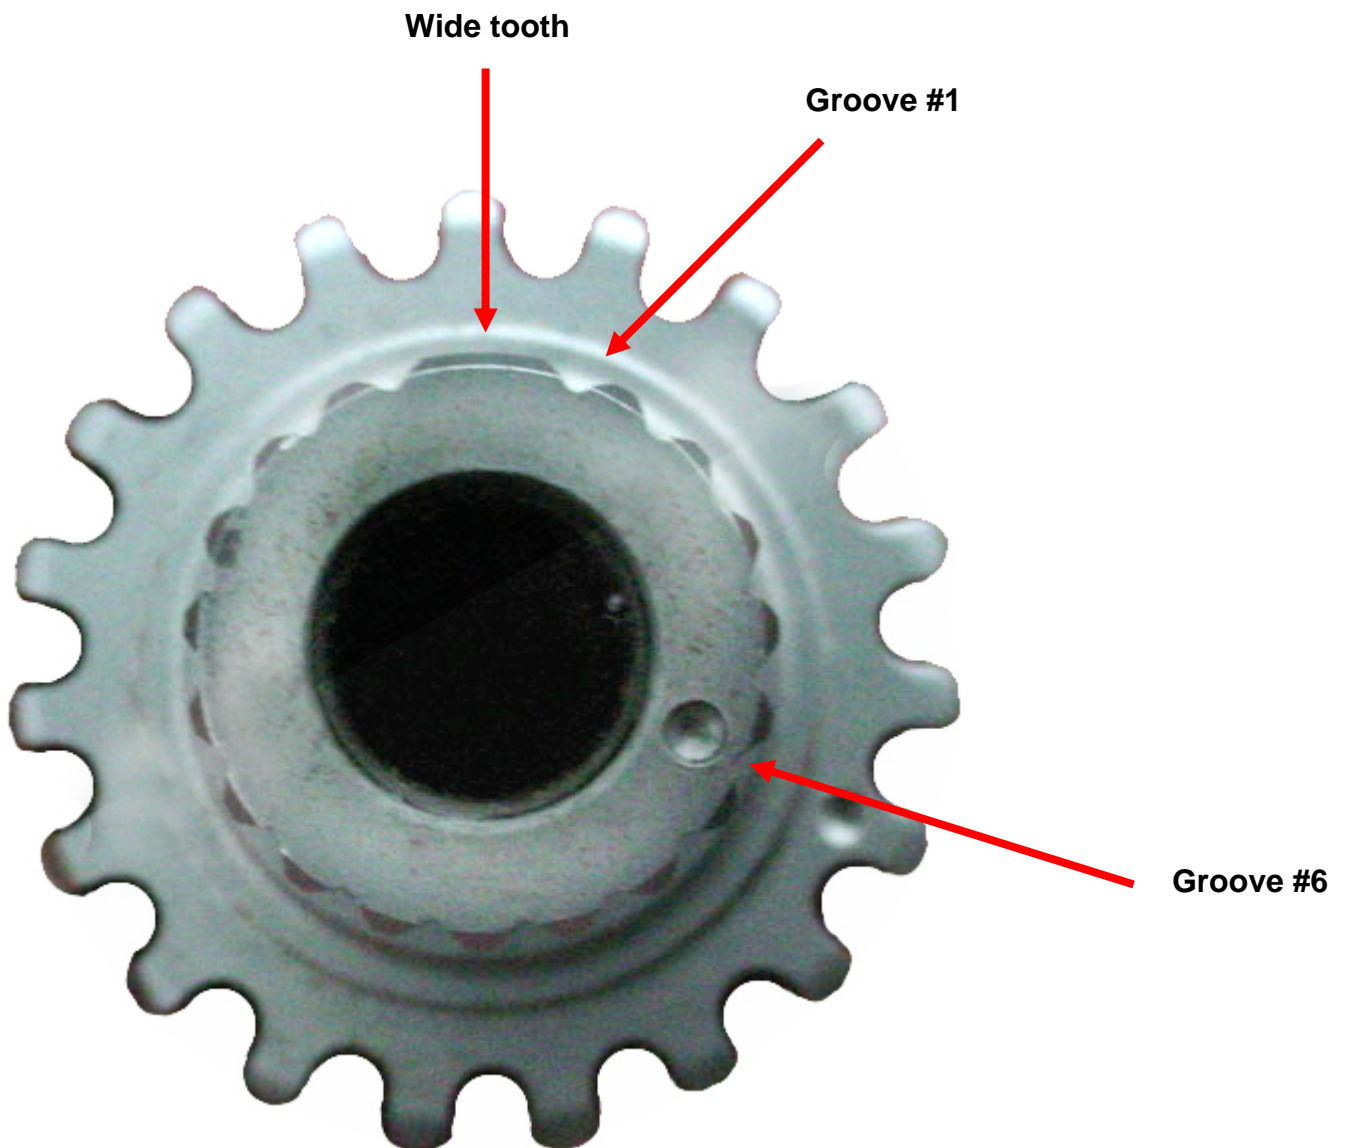
It has come to our attention that some of the PNA rear camshafts may have timing marks improperly located on the camshaft.

1. See picture below. Look at the splined end of the camshaft, and locate the **WIDE** tooth.
2. In a clockwise direction, count the number of grooves to where the timing mark is located.
  - Timing marks in the 6<sup>th</sup> groove are **CORRECT**.
