## TT442: 2015 STREET PERFORMANCE DIAGNOSIS

APPLIES TO	SYMPTOMS
2015 Street models	<ul style="list-style-type: none"> <li>• Performance Concerns</li> </ul>

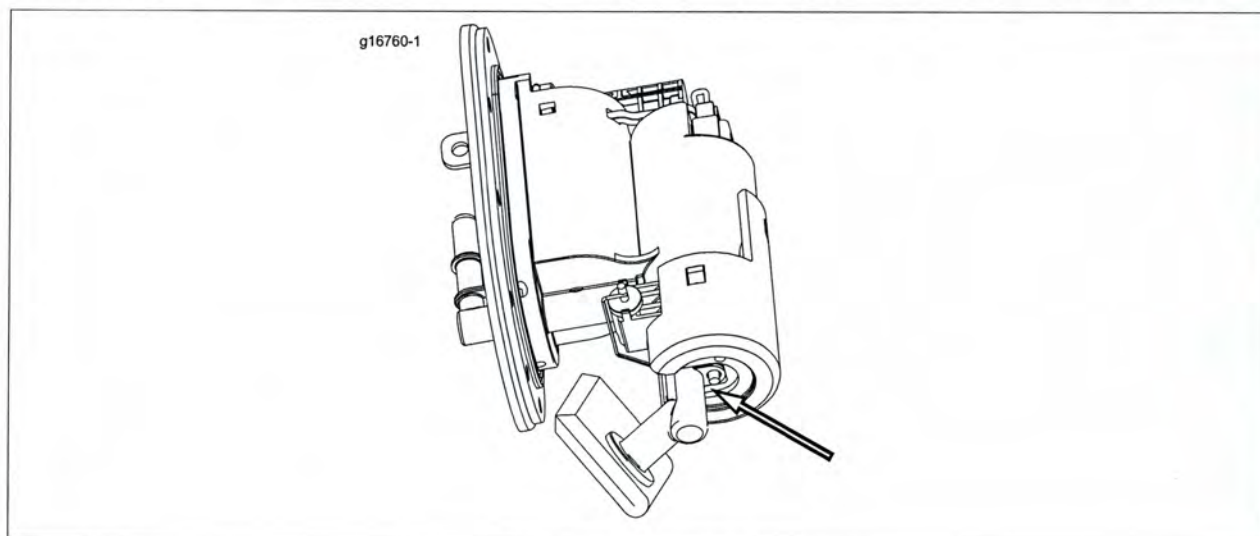
**Figure 1. Fuel Pump Assembly**

See Figure 1. One possible cause is a loose fuel inlet filter connection at the main pump body. The connection is a one-time push-on fit that is not serviceable. Vehicles and parts built October 15, 2014 and later should not experience this condition.

Perform a fuel pressure test. See the service manual. If low fuel pressure is observed, remove and inspect the fuel pump assembly. If a loose connection is found, replace the complete fuel pump assembly.

*Always inspect the new service part before installation to verify that the connection is solid.*
